INFLUENCE OF PREVIOUS OPERATIONAL CYCLE ON THE MICROSTRUCTURE OF REJUVENATED NI-BASE SUPERALLOY GAS TURBINE BLADES AFTER THEIR RETURN TO SERVICE

Preco Turbine & Compressor Services, Inc.

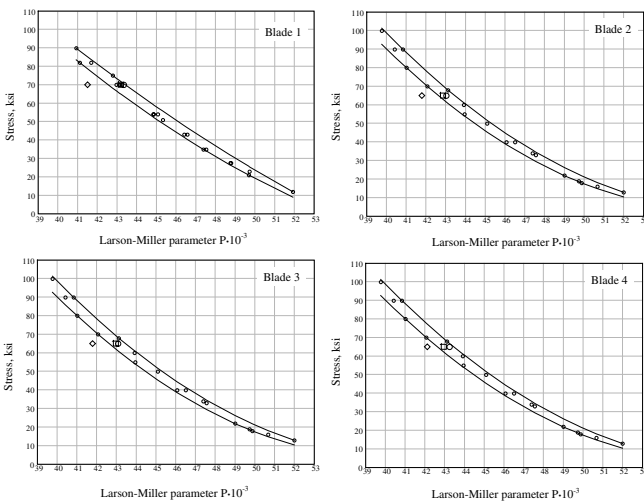
The stress-rupture test results were compared to published data for new fully heat-treated alloys (*Aerospace Structural Metals Handbook*, 1997; *Heat-Resistant Materials*, 1997; *Atlas of Creep and Stress-Rupture Curves*, 1998). Larson-Miller parameter P for the rejuvenated airfoil is shown to fall within the scatter band for a new fully heat-treated material, which indicates complete stress-rupture properties restoration (Figure 10). The microhardness of the leading edge specimens after the rejuvenation has also increased significantly reaching the values of the shank (Table 5).

Figure 10. Stress-Rupture Test Results in Terms of Larson-Miller Parameter. ((o) Published data for a new alloy; (□) Shank as-received; (◇) Airfoil as-received; (○) Airfoil after rejuvenation.)

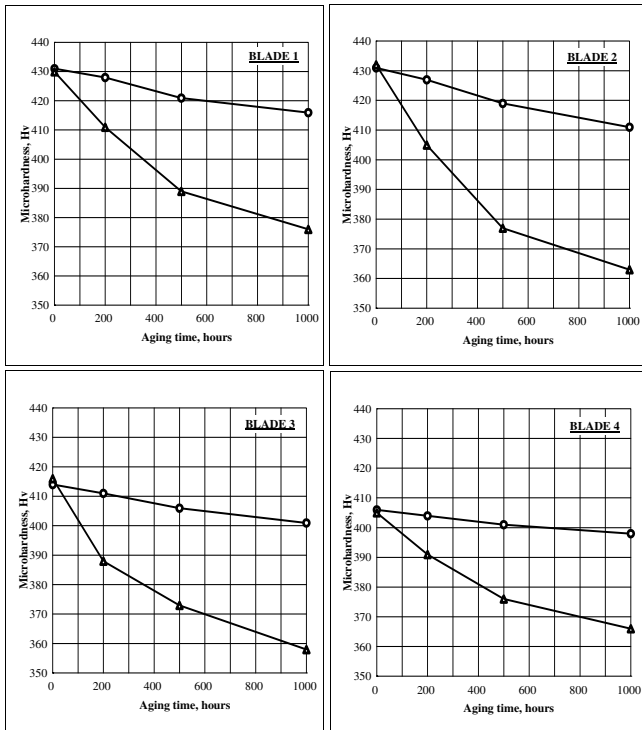
The difference in the microstructure of the rejuvenated and aged shank and leading edge specimens is reflected in their microhardness: while the shank microhardness decreases slightly, the reduction of the leading edge microhardness is substantial (Figure 19). The results of the short-term stress-rupture tests also display the difference between rejuvenated and aged shank and mid-airfoil behavior. The acceleration of the aging process in the rejuvenated airfoil caused a noticeable reduction of its stress-rupture life and plasticity compared to that of the shank (Figure 20). A comparison of the SEM micrographs of the shank and airfoil fracture surfaces illustrates the difference of the fracture mode (Figure 21). The shank specimen from the rejuvenated and aged

Figure 19. Influence of Aging at 1550°F on the Microhardness of Rejuvenated Blades. ((O) Shank; (Δ) Leading edge.)

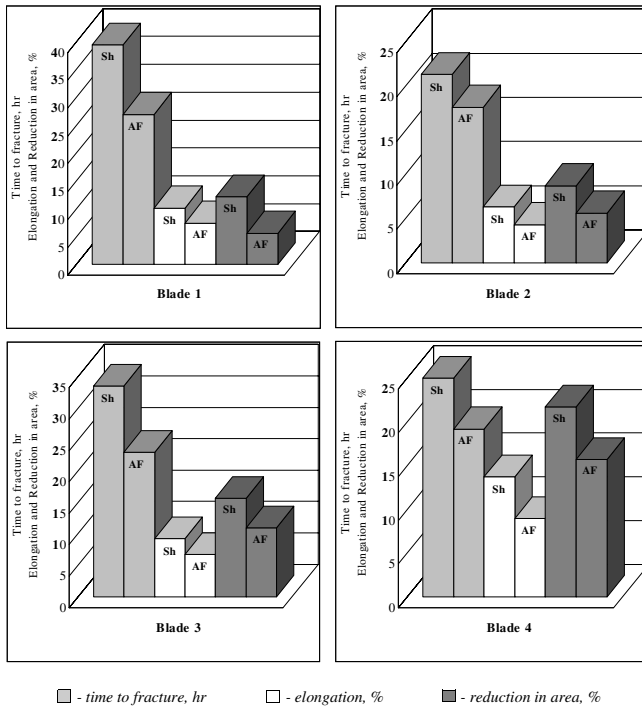
The results of the aging experiment demonstrate an obvious effect of the advanced service-induced primary MC carbide decomposition on the aging rate of rejuvenated gas turbine blades. The aging process has evidently accelerated in the mid-airfoil in comparison with the shank resulting in more rapid excessive secondary $M_{23}C_6$ carbides formation on the grain boundaries, which is detrimental to creep resistance and reduces alloy ductility. The cause of it appears to be the release of additional amounts of carbon into γ -solid solution from dissolving of the MC carbide

Figure 20. Results of Short-Term Stress-Rupture Test of the Rejuvenated Blades after 1000 Hours Aging at 1550°F. ((R) Shank specimens; (AF) Airfoil specimens.

decomposition products during rejuvenating HIP or solution annealing. The aging acceleration can be expected to be higher when service-induced microstructural deterioration is more advanced, as happens often in the modern machines with the firing temperatures above 2300°F, despite the use of protective coatings and internal cooling. In order to extend the blade's life it seems to
