# FATIGUE DAMAGE OF STEAM TURBINE BLADE CAUSED BY FREQUENCY SHIFT DUE TO SOLID BUILDUP—A CASE STUDY

The case history is presented of a large steam turbine that experienced blade damage after about eight years of service. The probable cause and subsequent solution to the problem are addressed. A discussion of the metallurgical analysis of the damage, Campbell diagram, SAFE diagram and modal test results is provided. The damage is believed to have been caused by a solid build up at the blade root that shifted a natural frequency into an interference region, and changed the response characteristic of the bladed disk assembly.

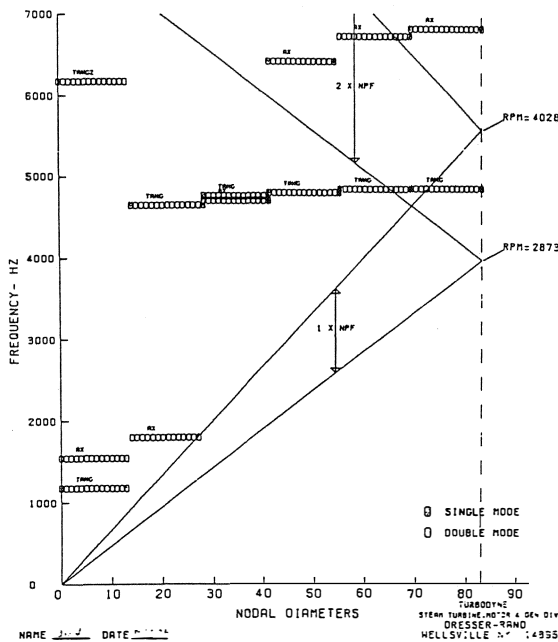
Figure 6. SAFE Diagram of Original Design Using ANSYS.

results overlaid on the analytically predicted results for a six blade packet (as shown in Figure 6). The experimental results are consistently higher than the analytical results. All the analytically predicted and experimental results are listed in Table 2. Past experience of the correlation between analytical predictions and experimental results has been very good. However, such difference has occasionally been observed. This difference is due to a change in the root attachment boundary conditions with time. The clearance between the blade root and the disk groove is small, and steam deposit build up or a material corrosion/oxidation build up can fill these clearances. This can stiffen the support of the root in the groove, and hence raise the blade frequency. To investigate this possibility, a dynamic analysis was performed to see how sensitive the blade frequency is to changing root conditions. The results are listed in Table 3 for different root support conditions together with the results of the modal test. This comparison shows that the modal test results fall somewhere between the blade root being considered at the standard location (upper root lock) and the wheel outside diameter. It seems plausible that the solid deposit build up in the root could have contributed to this condition and raised the blade frequency.

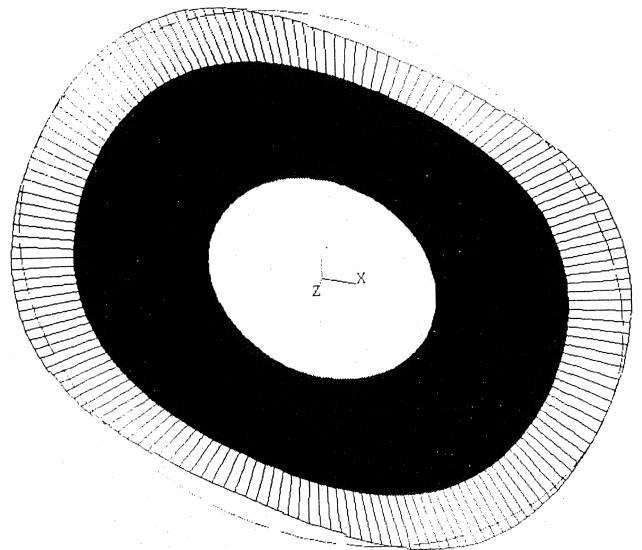
Figure 8. Three Nodal Diameter Mode of the Bladed Disk.

generated, based on the results of this analysis, is shown in Figure 7. A typical axial vibration mode of the bladed disk system is shown in Figure 8. This mode is identified as a three nodal diameter mode (3ND). This nomenclature of identifying mode shapes of a bladed disk system is described by Dello [5].
