IMPROVING THE MECHANICAL RELIABILITY OF A TURBINE-COMPRESSOR-EXPANDER USED IN A NITRIC ACID PLANT

ABSTRACT

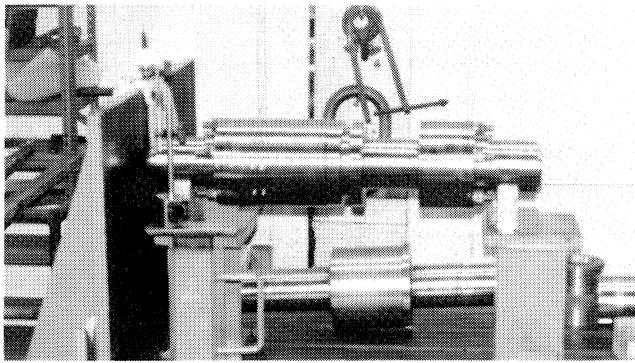
Figure 21. New Expander End Stub Shaft Being Checked for Runouts Between Balance Mandrels.

In the absence of the curvic masters, the axial runouts on the compressor wheels were individually mapped on a coordinate measuring machine. The axial runout was found to be around 0.003 in, which was considerably greater than the 0.0005 in tolerance set for these parts. The results found using the masters were in agreement with these results. A decision was made to skim grind (0.005 in per curvic face maximum) all the curvic faces to get them within tolerance. The shortening of the rotor resulting from the grinding would be compensated for by the manufacturing of slightly oversized stub shafts.

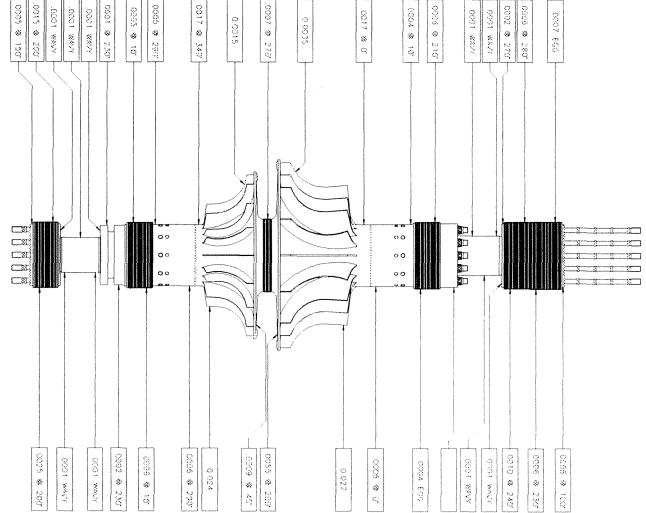
Figure 22. Progressive Balance Runouts Number 1. Center Body of the Rotor.

After the component balancing was complete, the next step was to progressively assemble and balance the rotor. The center body of the rotor was assembled, as shown in Figure 22, and runouts were checked. Even with the newly ground curvic couplings, the runouts obtained were not satisfactory. The runouts were projected in two planes to obtain the true shape of the rotor. Using this method, the curvic faces that were not seated correctly were identified. The curvics were then rotated based on the data and the rotor was stacked again. It is important to remember that grinding the curvic faces does not necessarily result in low runouts on the rotor, and that optimum stacking of the curvic couplings is necessary to obtain the appropriate runouts. The final set of runouts obtained for the center body of the rotor are also shown in Figure 22. The assembly was then weighed, the balance tolerance calculated per API specifications, and balanced by adding weights in planes III and IV (see Figure 23 for balance planes).

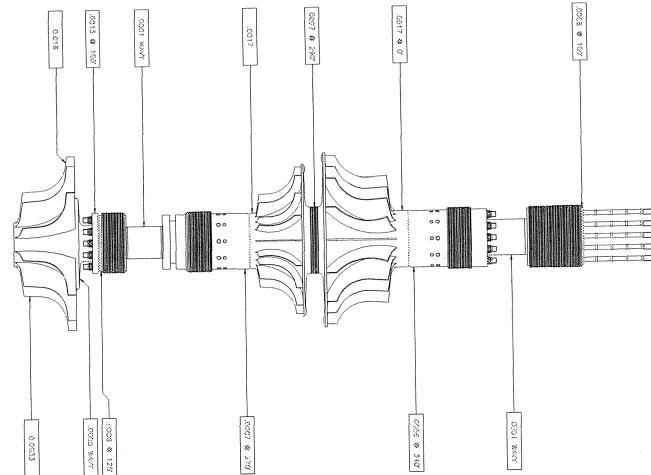
Figure 24. Progressive Balance Runouts Number 2. Expander Wheel Assembled.

The balance machine was then set up to read the imbalance in planes I and II. The residual imbalance of the rotor was thus transposed to planes I and II. The expander wheel was then assembled, and the runouts and balance were checked (Figure 24). The residual imbalance of the rotor center body (projected to planes I and II) was subtracted from the readings to obtain the actual imbalance due to the addition of the expander wheel. The expander wheel was then rotated by 180 degrees and the proce-

dure repeated. The optimum position of the expander wheel was then determined by the procedure explained by Jackson [1]. The balance corrections on the expander wheel were reduced by 45 percent using this method. The balance tolerances were calculated based only on the weight of the expander wheel. The residual imbalance of the rotor projected to planes I and II was vectorially subtracted out of the final balance readings.
