TAKE TRANSIENT STARTUP AND SHUTDOWN DATA—RULE NUMBER ONE

Charles Jackson

Turbomachinery Consultant

FIRST CASE—22 MW GAS TURBINE GENERATOR

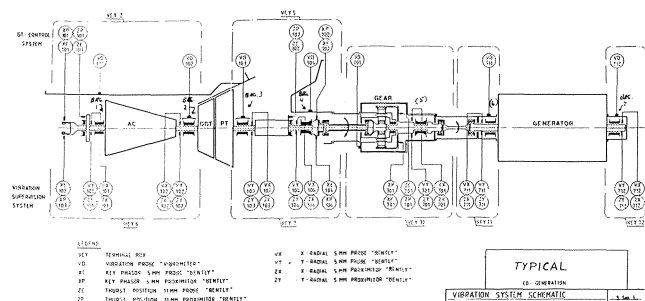
A cross section can be seen in Figure 1 of the gas generator rotor power aerodynamically coupled to the power turbine that drives a generator through an epicycloid gear reducer. The concern was the gas generator, better seen in Figure 2. This rotor has 10 rows of axial compressor blades supported between two bearings at 160/150 mm, and two overhung rows of hot turbine blades following the combustors. The total weight of this rotor is over 2300 lb and operates in the 9600 rpm range at full load. The separate power turbine rotor is held in bearings three and four operates in the 7700 rpm range, and is coupled to a gear box driving a generator.

Figure 1. Gas Turbine Generator Layout—Gas Generator (Left), Power Turbine, Gear, and Generator (Right).

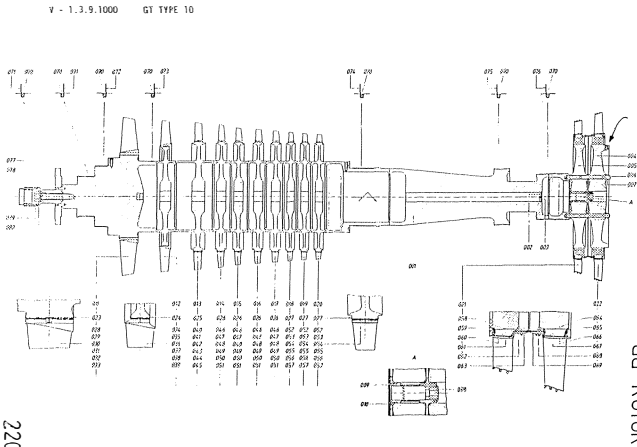
The concern was the gas generator rotor, which had high vibration tripping seismic vibration sensors at 18 mm/sec (raised from ~13 mm/sec). The corresponding shaft relative vibration

Figure 2. Gas Generator—10 Rows of Free Standing Axial Blades, Two Bearings, Two Turbine Rows, Three Balance Planes.

on this number two bearing reached 5.0 mils p/p, as measured by proximity probes. Over 19 false starts occurred in December 1993. Further, the rotor is “whip” excited at its second resonance (3450-3690 cpm) at a point when the power turbine is taking over load to be synchronized at the generator. Whip (resonance excitation) continues as load is applied.

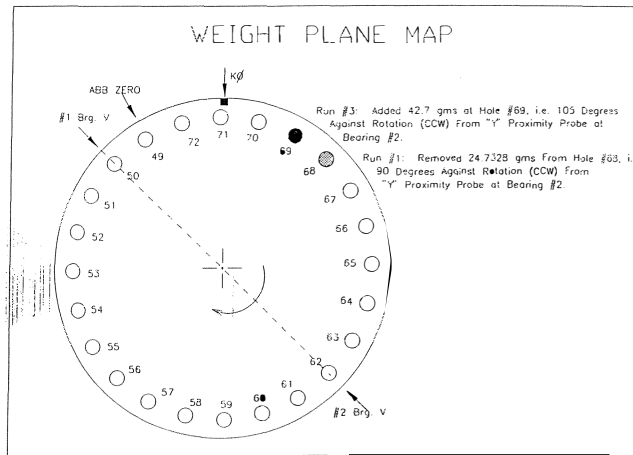
Figure 11. Layout of Field Balance Plane Number Three Past Bearing Number Two. There are three balance planes of 24 holes (15 degrees apart) with numbers against rotation (consecutive in rotation). The phasor notch is at holes 71, 47, and 23 (planes 3, 2, 1). Number two bearing, 2Y, was used for phase.

- The vibration and unbalance response is strongest at the number two bearing with a field balance plane in the number two turbine disc. Determine balance from this location. This says to the author to add a weight at hole number 72 which is 150 degrees against rotation from the 2Y probe, when the rotor is indexed-key phasor at trigger. There is an existing weight of 24 grams at hole number 68, when this data was taken. The rotor position at triggering can be seen in Figure 11, where the weight hole locations are shown from the 2Y vertical probe. It also traces the vendor’s three balance steps to find location (as defined on this first run).

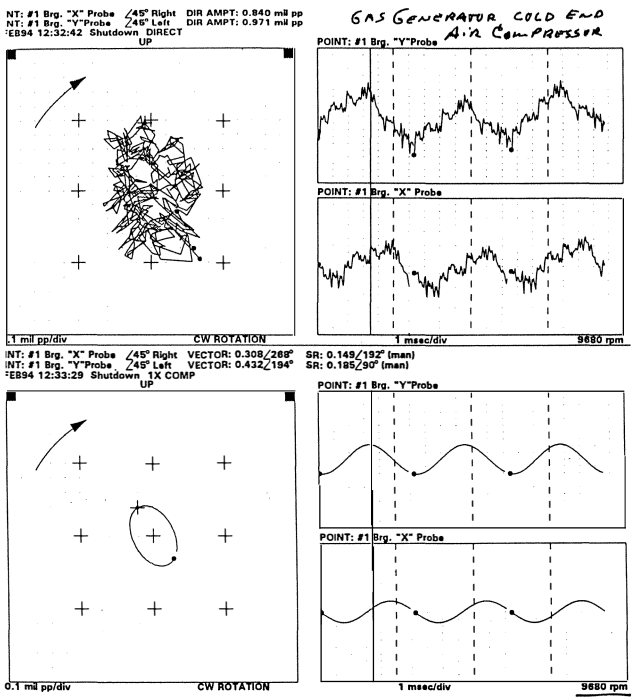
The unfiltered and filtered orbit and timewave information at full speed, 9170 rpm, and load, 21 MW is shown in Figures 18 and 19.

Figure 18. Unfiltered and Filtered Orbits @ Bearing Number One, Compressor Inlet, @ 21 MW (0.309/0.437 Mils p/p).

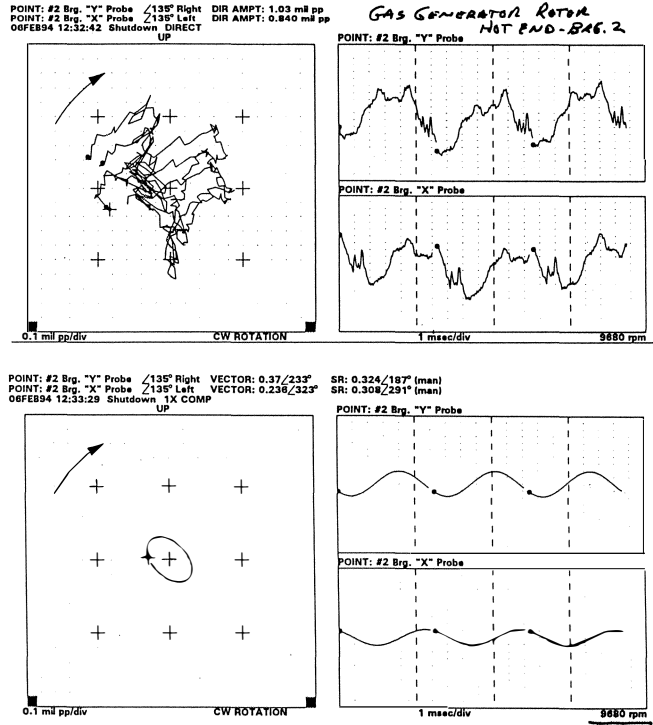
Figure 19. Same information (as Figure 18), but @ Bearing 2, Synchronous Vibration @ 0.37/0.24 Mils p/p @ 21 MW Load.

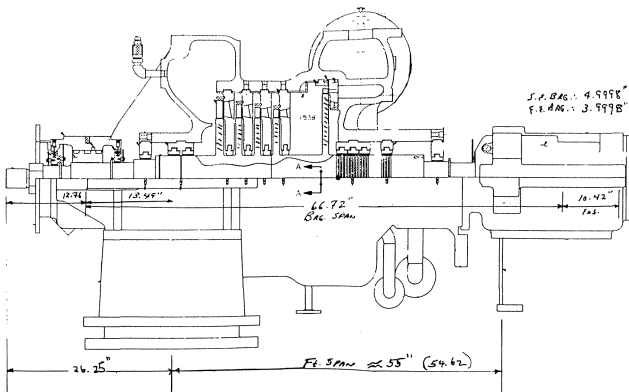
The five stage back pressure rotor using low pressure steam can be seen in Figure 22. It operates at low-to-medium speed of 4950 to 5680 rpm. It is a forged disc rotor. It drives a refrigeration compressor through a coupling that could easily be reduced about 35 lb center of gravity weight, though that is not the problem.

Figure 22. Cross Section of Turbine.

second stage rows. Therefore, the rotor shaft was turned down about 1.5 in on the diameter and a second wobble plate was installed on the steam end bearing pedestal. Further, stress corrosion cracking due to high stress at resonance operation had cracked some 80 to 90 percent through the first disc, so a built-up rotor was incorporated.

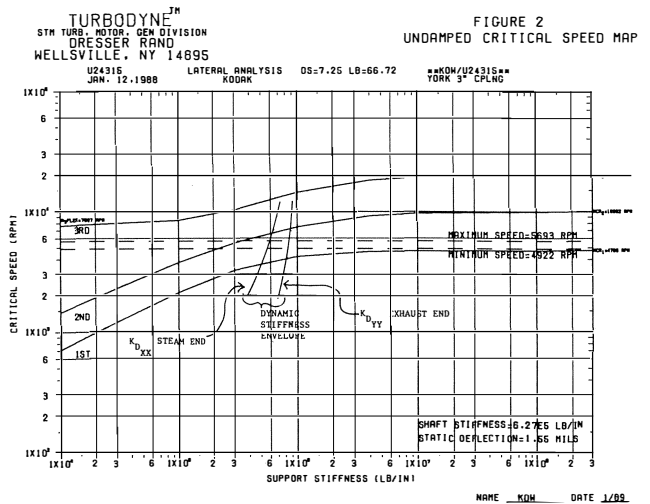
The stiffness map can be seen in Figure 23 and the rotor mass model can be seen in Figure 24 for perhaps better illustration. Therefore, it should be operating above the first mode and below the second mode.

Figure 23. Undamped Critical Speed Map—Five Stage Turbine.

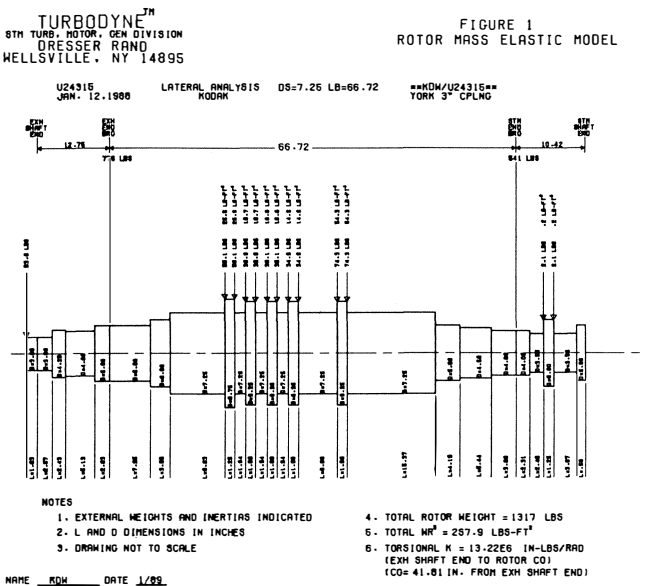
Figure 24. Rotor Mass Elastic Model.

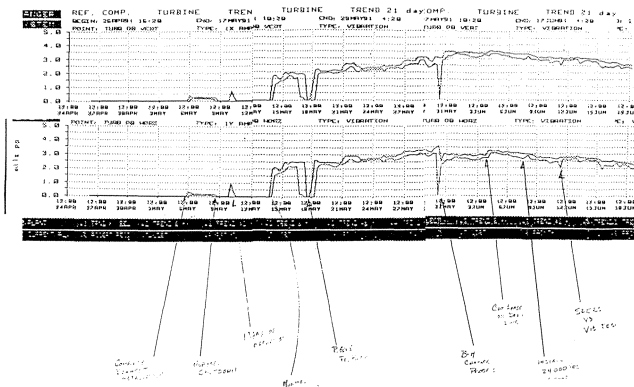
Trend data were taken continuously and when I became involved in this problem, those were the only data that I could obtain. With this data came endless questions on why one day or hour was worse than others, and why was the phase and amplitude varying continuously? Trend data took three different forms, but the typical large group took the forms as illustrated in Figures 25 (daily) and 26 (monthly +).

Figure 26. Typical Trend Data Submitted over Months of Problems Extending One and One-Half Years (Plus).

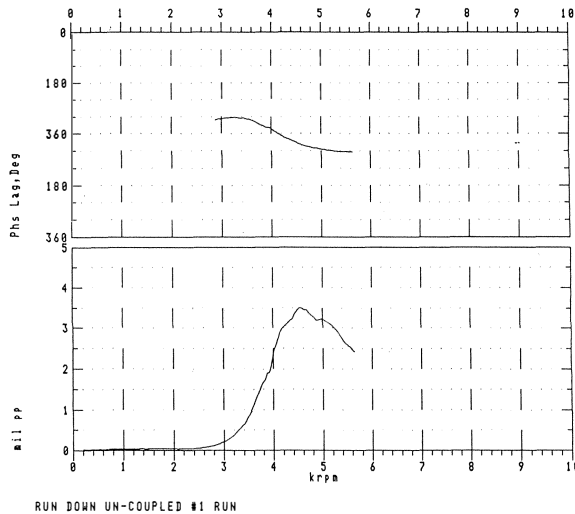
To confirm this, the Bodé plot from the automated diagnostics for rotating equipment system was predicted and fell true as is shown later in Figure 29. The owner understood this plot better, so why not?

Figure 29. This is a Bode Plot of Figure 28 Data.

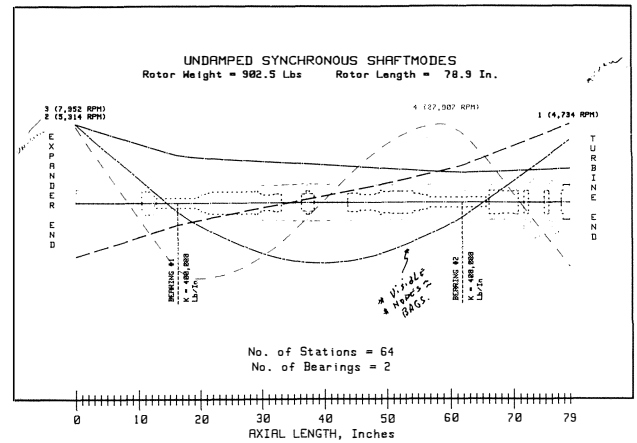
The model (by others) of the rotor is shown in Figure 30. It goes through the first two rigid modes without incident. As a matter of fact, the vibration data cannot detect these two modes. The third mode (bending with the nodes, near the bearing), is very responsive. The undamped critical speed stiffness map can be seen in Figure 31. It is desirable to keep the bearing stiffness soft and with a lot of damping to not converge the first three modes. On the first transient data taken by the owner shown in Figures 32 and 33, one can see that a subrotative excitation occurs about 16,000 rpm in runup and after hot gas has been admitted to the expander. This excitation has shut the unit down with the primary excitation coming at the subrotative speed. In my opinion, this is an excitation of the third mode. Others say the first mode. Either way, it is excited.

Figure 30. Model of Hot Gas Expander—First → Fourth Modes. Operating Speed ~18,000 RPM with Seven Curvic Couplings.

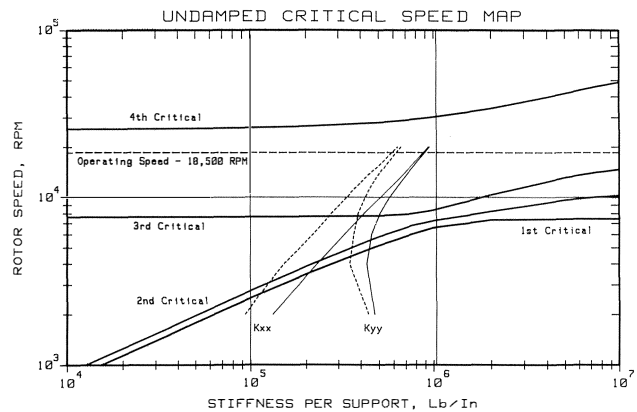
Figure 31. Undamped Critical Speed (Stiffness) Map with the Original Bearings. Load on Pad (LOP).

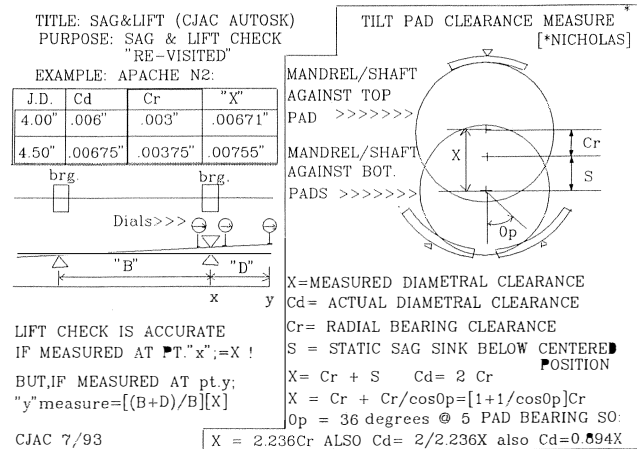
better understand the lift measurements required for a five pad bearing, LBP or LOP. In this third case, the bearing vendor had to refit the shell/retainer twice to accurately hold the proper clearance to prevent clearance whirl, at 1X.

Figure 35. Lift Check Chart Prepared for the Owner and Repair Shop, and Bearing Vendor. Helped very much. Lift values for five pad bearings from J. Nicholas.
