# RETUNING A GEAR DISC PROFILE TO ELIMINATE HIGH GEAR VIBRATION

**James H. Hudson**  
Engineering Consultant  
A/C Compressor  
Appleton, Wisconsin  
and

**Keith Rouch**  
Professor of Mechanical Engineering  
University of Kentucky  
Lexington, Kentucky

High gear case acceleration levels, experienced during shop string testing of a compressor train, were traced to gear element structural resonance, which was excited by the gear tooth meshing frequency.

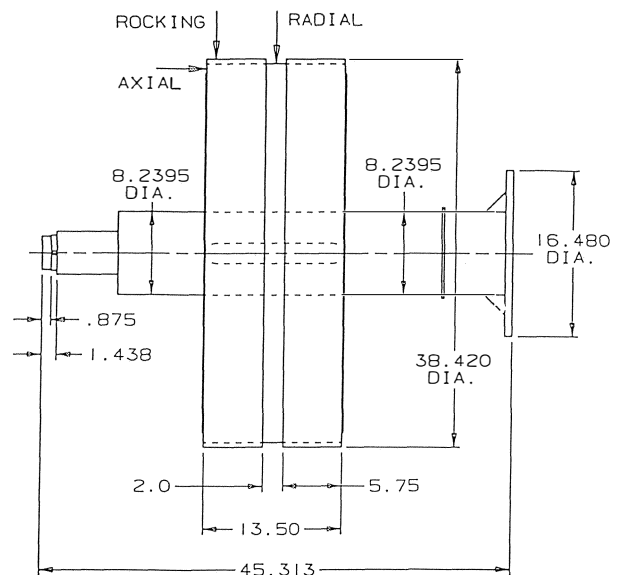
Figure 10. Gear Assembly with Accelerometer Locations to Identify Disc Modes.

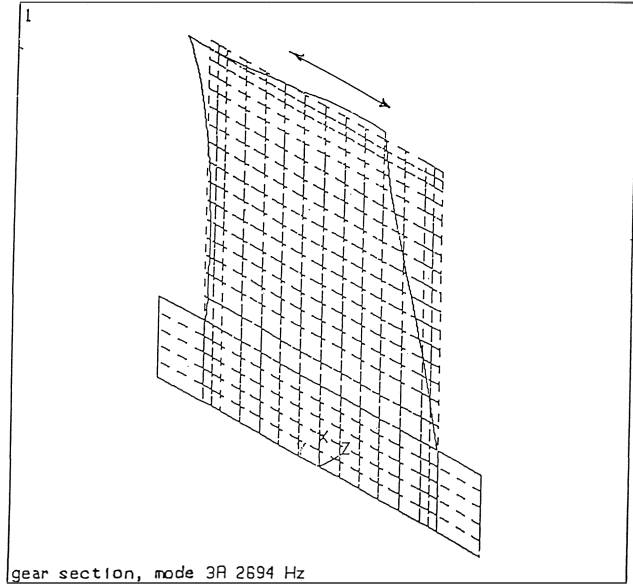
This mode contains bending of the disc in the axial direction in addition to the circumferential mode. The deflected mode shape is shown in Figure 12. This “A” mode is the classic disc mode most people would refer to as the disc frequency.

*Figure 12. N-3A Gear Mode Shape (Original Design).*

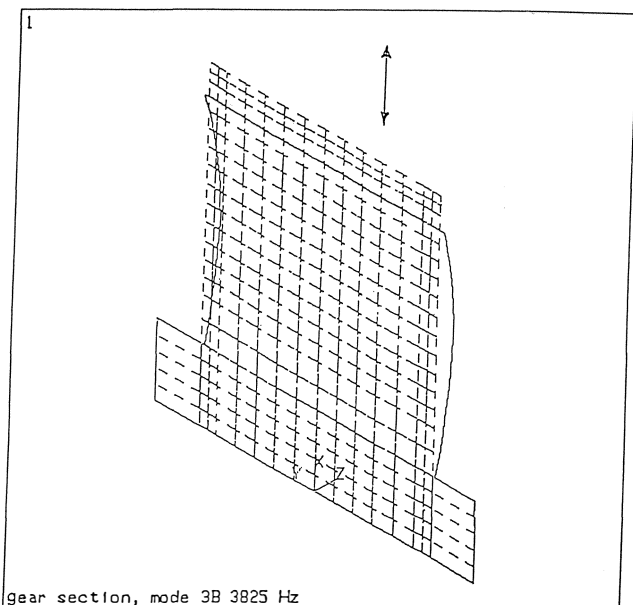
This mode contains radial deflection of the disc in addition to the circumferential mode. In addition, there are concave and convex deflections of the gear side walls. The deflected mode shape is depicted in Figure 13.

*Figure 13. N-3B Gear Mode Shape (Original Design).*

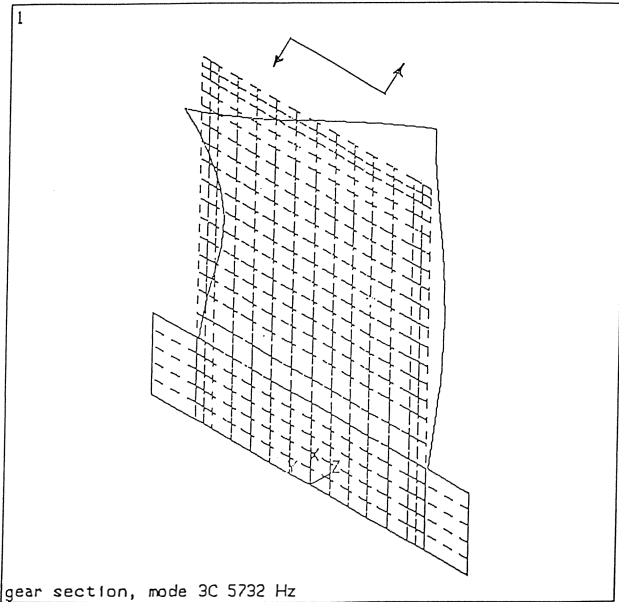
This mode contains complex bending of the side wall of the disc resulting in combined radial and axial deflection or "rocking" at the outer surface of the disc. The deflected mode shape is shown in Figure 14.

Figure 14. N-3C Gear Mode Shape (Original Design).

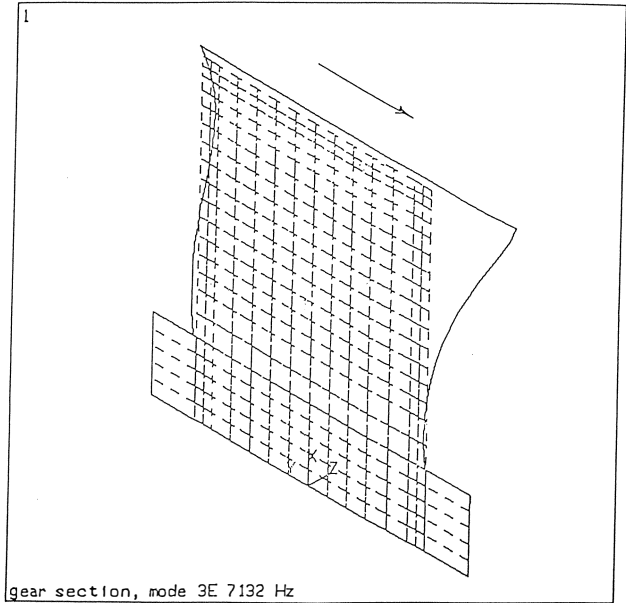
This mode consists of complex concave/convex deflection of one side wall and axial bending of the opposite side wall. A plot of this mode shape is presented in Figure 16.

Figure 16. Gear Mode Shape (Original Design).

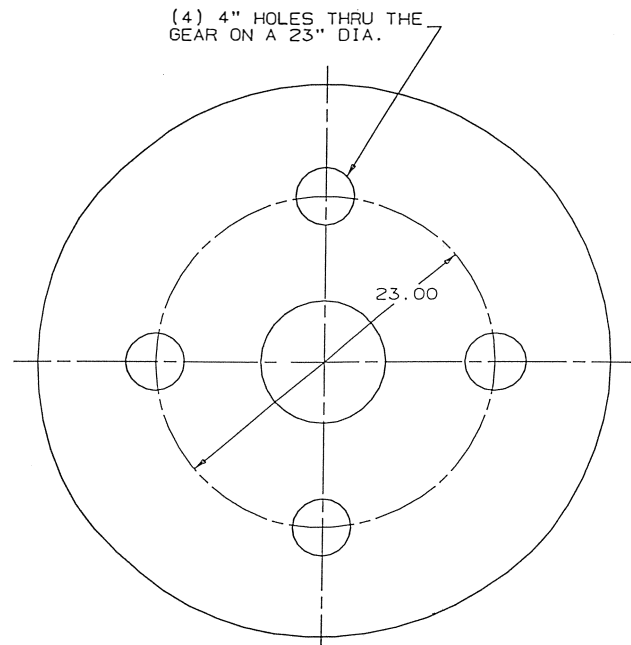
Figure 18. Proposed Modification—Four Through Holes.

Two styles of redesigns were considered. Type 1 included coped side walls. A sketch of the modified design is presented in Figure 17. Two cope depths 1.0 in and 2.0 in were analyzed. The type 2 design included four 4.0 in diameter holes entirely through the gear, as shown in Figure 18. The analysis determined that the holes made very little change. The largest change of any frequency was 2.2 percent (Table 4). It was decided not to pursue this design.

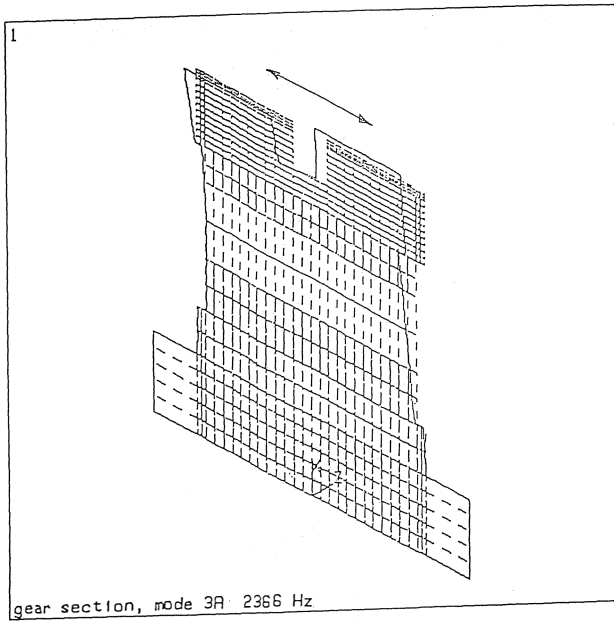
Some mention should be made of the modal configuration of the coped side wall and center groove redesign. The "A" mode remained primarily axial (Figure 19), and the "B" mode remained primarily radial (Figure 20). The "C" mode took a unique mode shape onto itself. The "C" mode consisted of significant out of phase axial displacement of the segment on either side of the center groove as shown in Figure 21. The "D"

Figure 19. N-3A Gear Mode Shape (Modified Design).

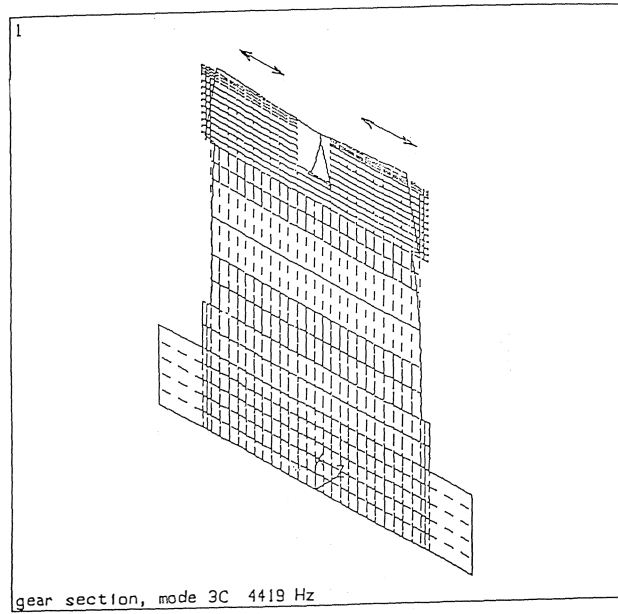
Figure 21. N-3C Gear Mode Shape (Modified Design).

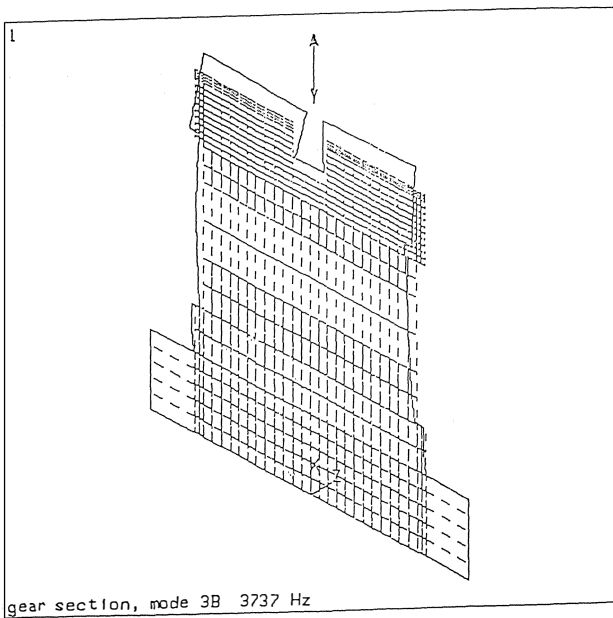
Figure 20. N-3B Gear Mode Shape (Modified Design).

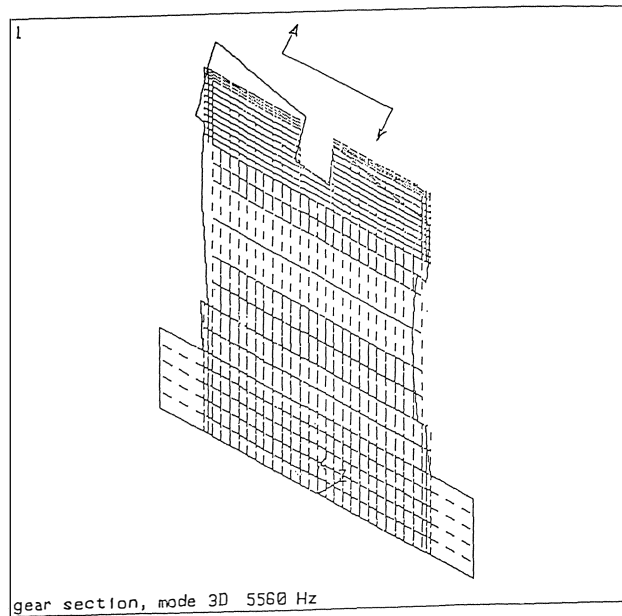
Figure 22. N-3D Gear Mode Shape (Modified Design).

mode became the “rocking mode” (Figure 22) and the “E” mode became the “circumferential/axial” mode (Figure 23).

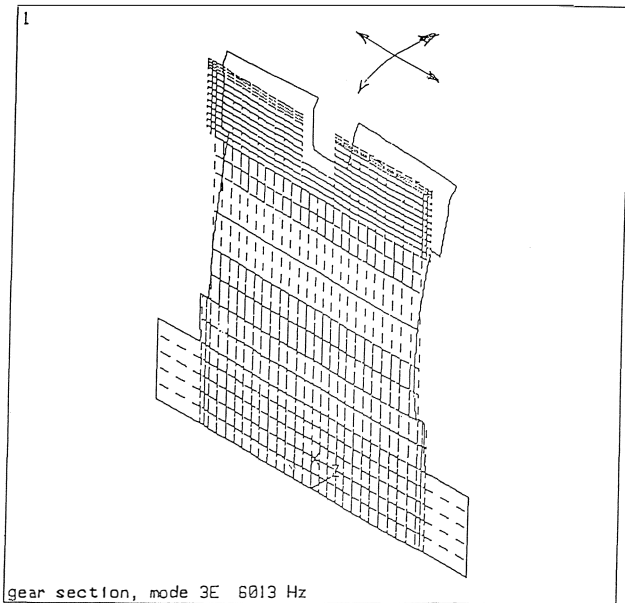
Figure 23. N-3E Gear Mode Shape (Modified Design).
