# REAPPLICATION OF AN INDUCTION STEAM TURBINE TO EXTRACTION COGENERATION SERVICE

**Richard E. Nemec**

**Barnett F. McLaughlin**

## ABSTRACT

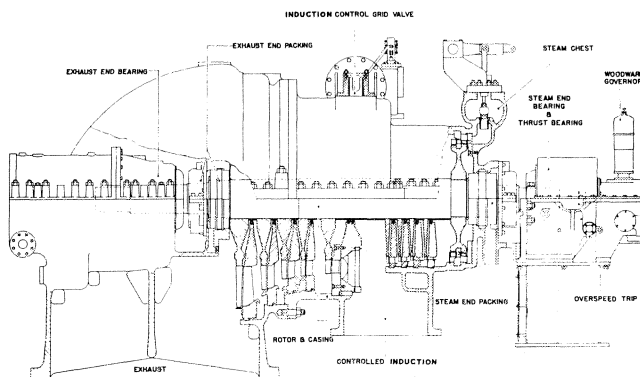
Figure 1. Sectional View of Turbine.

In the final analysis, the company chose a 20,000 hp induction-condensing steam turbine previously used to drive a refinery FCC blower (Figure 1). The turbine was manufactured by Elliott Company in 1965. It was designed to startup on 600 psig, 700°F high pressure steam and operate on 200,000 lb/hr of 40 psig steam induction to condensing. It was the only turbine offered which had more than 15,000 lbs/hr of capability for extraction/induction. The operating speed was 3300 rpm to 3650 rpm. It was built for a maximum throttle flow of 176,000 lb/hr of high pressure steam or a maximum induction flow of 200,000 lb/hr, 40 psig steam. A suitable synchronous generator (Figure 2) was also located as a match to the steam turbine. The 15 MW synchronous generator was originally driven by a gas turbine in a Gulf Coast chemical plant. Previously salvaged, it was immediately available for refurbishment, however, it had no exciter.
