ON STREAM SOLUTION OF A PROTOTYPE 8000 HP MOTOR INSTABILITY PROBLEM

Perry C. Monroe, Jr.

Dana J. Salamone

ABSTRACT

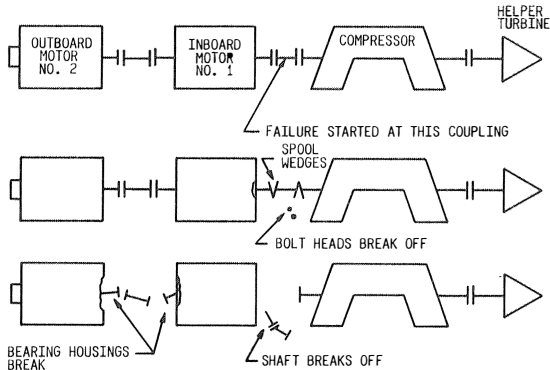
The ammonia circulation compressor had been operating continuously since 1980, except for a two week period, at approximately 92% of full load. Prior to the wreck (20-30 minutes), operating technicians had been on the compressor deck and had observed no abnormalities. Both operators were in the unit control room during the wreck and heard an abnormal grinding and surging sound. Within 15 seconds of the failure, the operators had reached the compressor deck in time to observe that the motors had stopped rotating but that the compressor had not. Due to excessive bearing housing damage, three lube oil pumps were running and spraying oil 30-40 feet into the air. The compressor-to-motor coupling guard was torn away, and a 2½ foot piece of the inboard motor shaft was lying on the compressor deck beside the motor. Both the inboard motor cast iron bearing housings and the coupling end housing of the outboard motor were shattered. See Figures 1 through 9 for details of damage.

Figure 1. Ammonia Circulation Compressor Train. 8000 hp/3600 rpm.

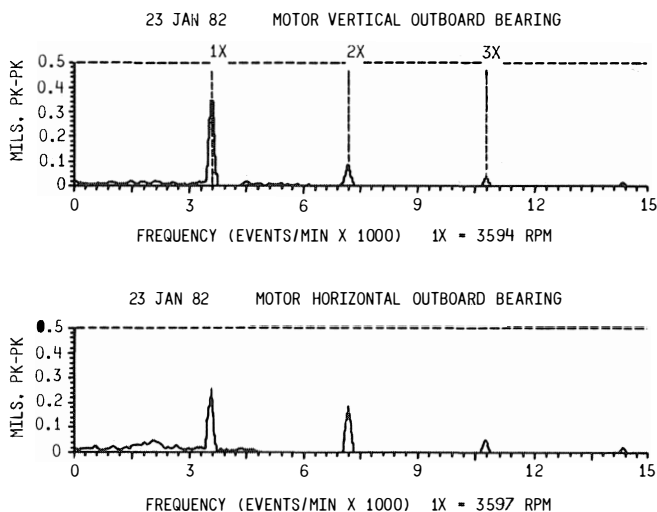
The original motor bearings were of a ring lubricated 180° cylindrical design, with .014 in. design diametrical clearance. The existing bearings were modified to a full 360° cylindrical design by puddling babbitt into the bearing housings and machining the bores to .007 in. diametrical clearance. With the 360° plain journal bearings installed, the compressor was started up on January 23. Maximum motor vibrations of 1.2 mils were recorded on the coupling end in the horizontal direction. There was no evidence of sub-synchronous vibration at the time of start-up, as illustrated by Figure 12, so the unit was brought on-stream.

Figure 12. Start-up Vibration Data of 8000 hp Motor Outboard Bearing with 360° Design.

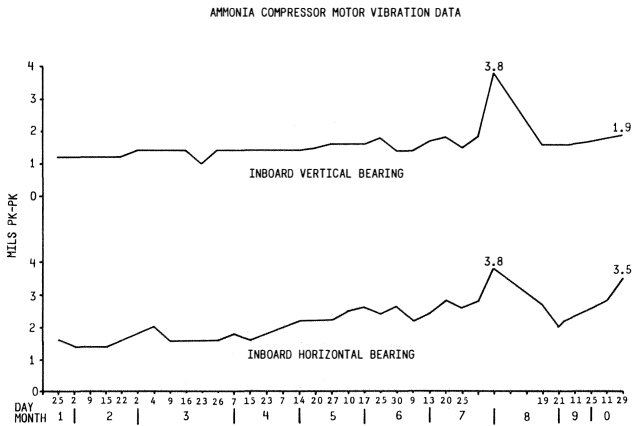
Close surveillance was maintained on the compressor train, even though all vital signs were normal. Plotting of vibration amplitudes, as illustrated in Figure 13, indicated a rising trend, which reached 2.0 mils in March. This increase occurred on the inboard end motor bearing in the horizontal direction. After reaching a peak of 2.0 mils, the vibration dropped to 1.6 mils and remained below 2.0 mils until mid-April. Orbital vibration displays would increase and decrease in diameter in a cyclic manner as if "winking at you" (see Figure 14). Continuing surveillance indicated a gradual increase in vibration levels, over a three month period, to a level of 2.6 mils (inboard bearing horizontal direction).

Figure 13. Ammonia Compressor Motor Vibration for 1982.

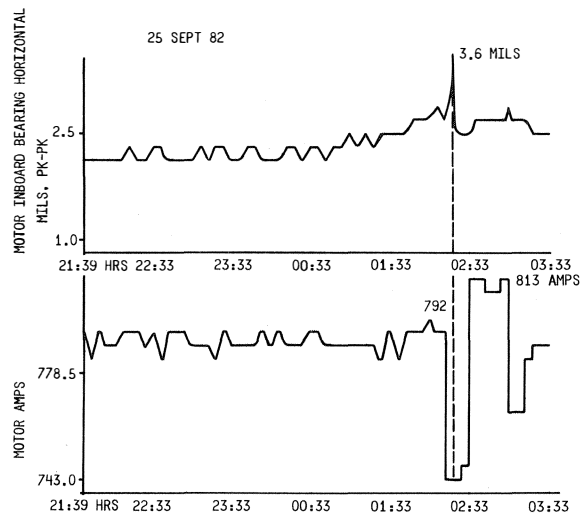
Final correlation was made on September 25, when a process problem caused a reduction in load on the ammonia compressor. A 49 amp change in motor load apparently caused the coupling to lock up and increased the inboard motor horizontal vibration to 2.6 mils (see Figure 15). When the vibration went to this level, the half-speed sub-synchronous component appeared. Figure 16 illustrates 1800 cpm vibration levels (in the inboard motor bearing, vertical direction), larger than synchronous speed vibration amplitudes. Figure 17 is a display of the inboard motor bearing vibration in the horizontal direction. Figure 18 is a computer print-out correlating inboard motor bearing vibrations, motor amps, and lube oil supply temperature. Computer stored vital signs data are a powerful diagnostic tool when trying to solve turbomachinery problems.

Figure 15. Historical Trend of Inboard Motor Bearing Vibration and Motor Load.

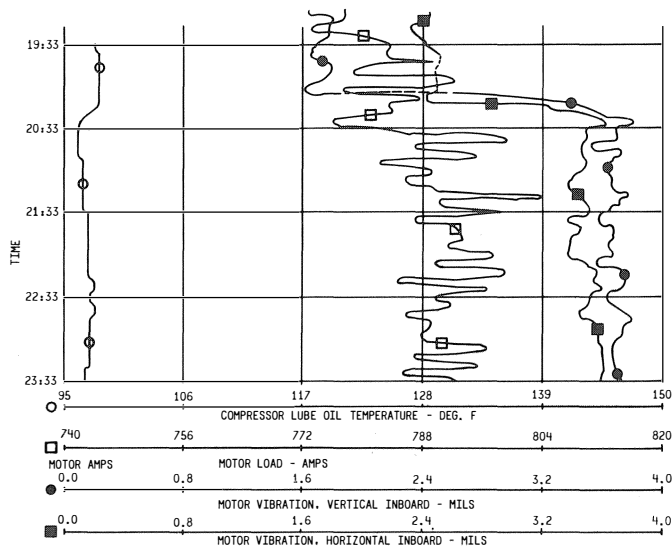
Figure 18. Historical Trend of Inboard Motor Bearing Vibration, Motor Amps, and Lube Oil Temperature. Rev. "A."

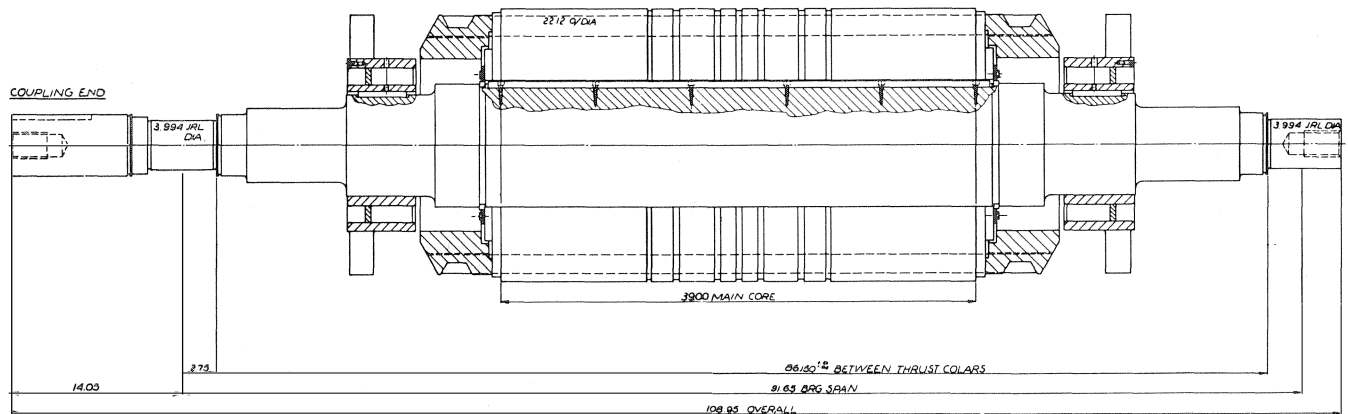
The original motor rotor, shown in Figure 25, has a 4,661-lb rotating element. The rotor is supported in two plain cylindrical journal bearings, with a span of 91.65 in. Both journal diameters are 3.994 in.

Figure 25. Induction Motor Rotor.

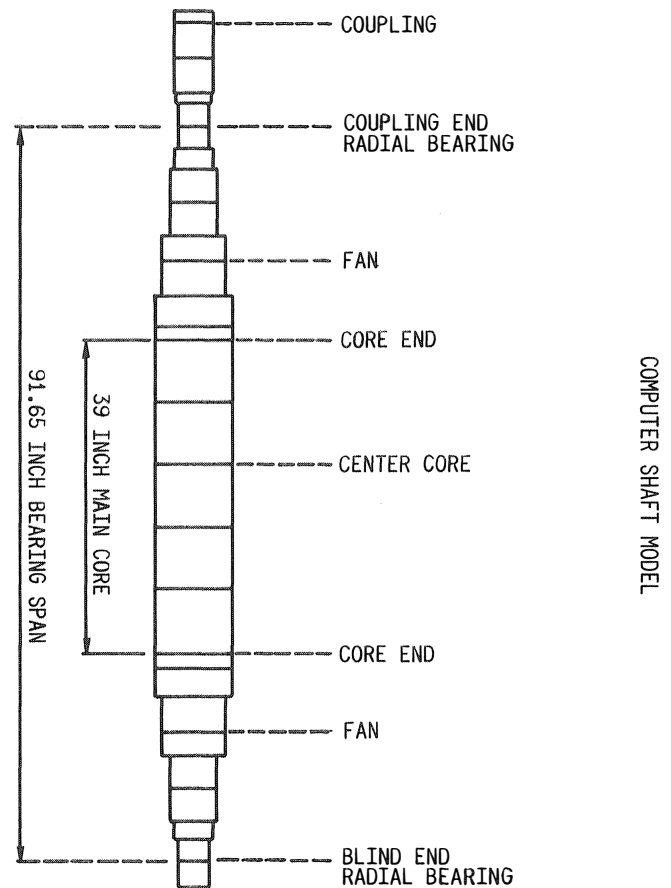
Figure 26 is the computer-generated shaft cross section plot, indicating the division of the rotor shaft into discrete sections. Each section line indicates a mass station.

Figure 26. Computer Shaft Model.

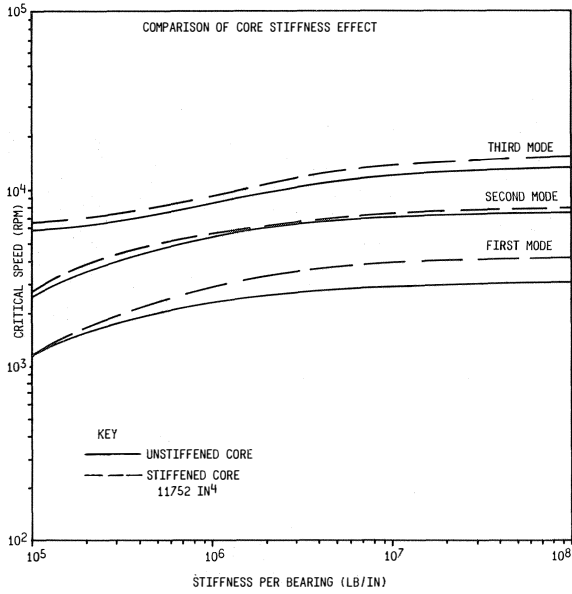
Figure 27 is the critical speed map for the original rotor, with the existing coupling. The solid lines show the criticals with an unstiffened core section.

Figure 27. Critical Speed Map.

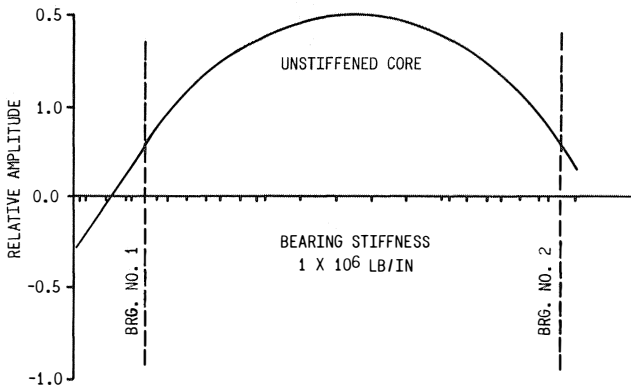
Figures 28 and 29 are first undamped critical speed mode shapes for the unstiffened rotor, considering arbitrary bearing stiffnesses of 1×10^6 and 1×10^8 lb/in. The two bearings are assigned the same stiffness values, as indicated in the figure title. Note that Figure 28 shows a large percentage of bearing motion, because a bearing stiffness of 1×10^6 lb/in is quite flexible, compared to the rotor shaft stiffness. If the bearing stiffnesses are increased to 1×10^8 lb/in, Figure 29 shows no bearing motion. This represents the rigid bearing case, in which the bearings have become far too stiff for the rotor. In this condition, the rotor has no effective bearing damping, because there is no bearing motion. Referring to the critical speed map, one can see that this condition would occur at bearing stiffnesses above 6×10^6 lb/in. Therefore, an alternate bearing design must not exceed this bearing stiffness value at

Figure 28. First Mode Shape with Unstiffened Core and Flexible Bearings.

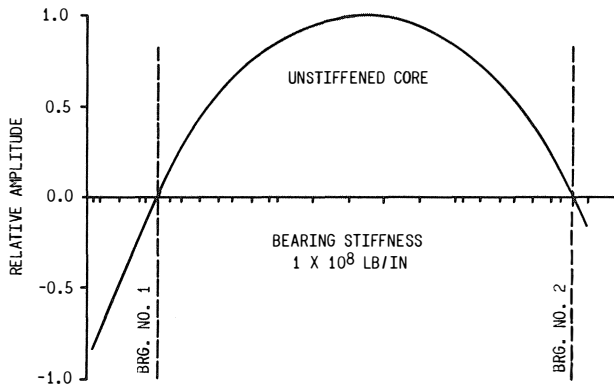
Figure 29. First Mode Shape with Unstiffened Core and Rigid Bearings.

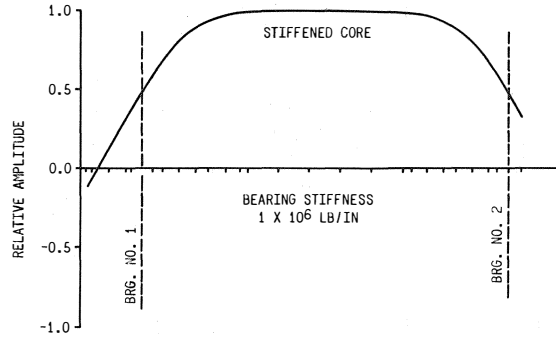
Figures 30 and 31 illustrate these mode shapes when the rotor core stiffening effect is included. Note the resistance to bending in the stiffened core section. This stiffening increases the critical speeds, as indicated on the map.

Figure 30. First Mode Shape with Stiffened Core and Flexible Bearings.

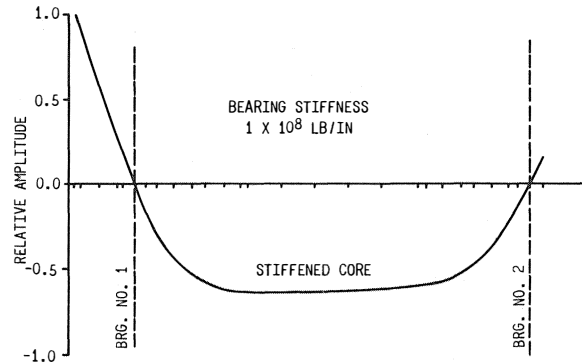
Figure 31. First Mode Shape with Stiffened Core and Rigid Bearings.

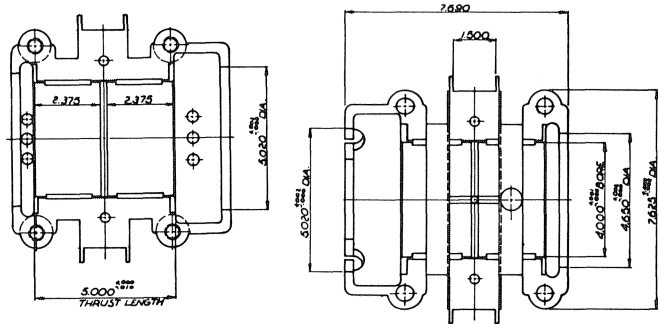
The existing bearings, shown schematically in Figure 32, are plain cylindrical journal bearings consisting of two lands, separated by a circumferential groove. These bearings were designed for oil ring lubrication, as shown in Figure 33.

Figure 32. Original Plain Bearing Design.

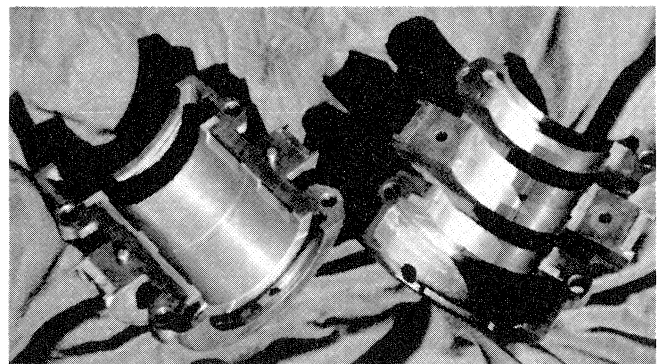
Figure 33. Original Oil Ring Lubricated Plain Journal Bearings.

Therefore, a portion of the top half is removed for the oil rings. However, the analysis assumes a 360° plain cylindrical journal bearing with oil distribution grooves at the split line. The double land is included by considering one half of the bearing load on one land. Then, each bearing consists of two "land" bearings in parallel.

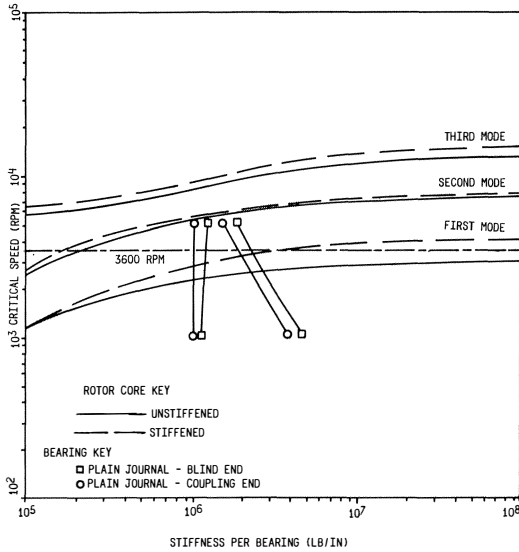
Figure 34 contains a cross-plot of the original bearings on the critical speed map for a bearing clearance of 0.007 in. Table 1 lists these intersections, which are the undamped critical speeds.

Figure 34. Critical Speed Map with Original Bearings.

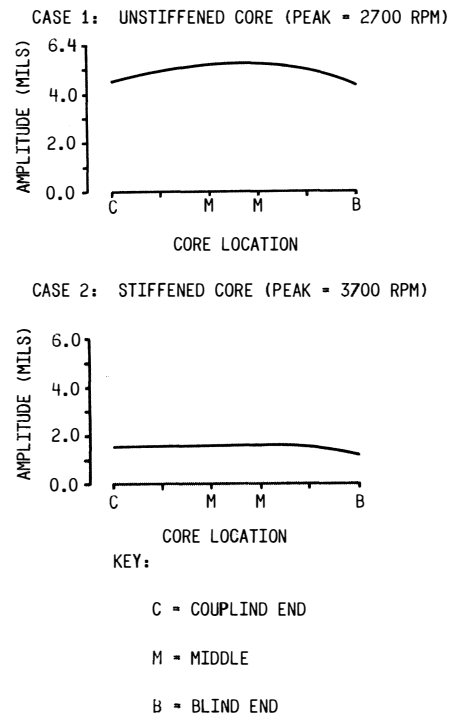
A synchronous unbalance response analysis was performed to determine the peak response speeds and amplitudes for the stiffened and unstiffened models. The analysis indicated that the core stiffening does have a significant effect on bending in the core section. This is shown in Figure 35.

Figure 35. Peak Response Amplitudes in Motor Core.

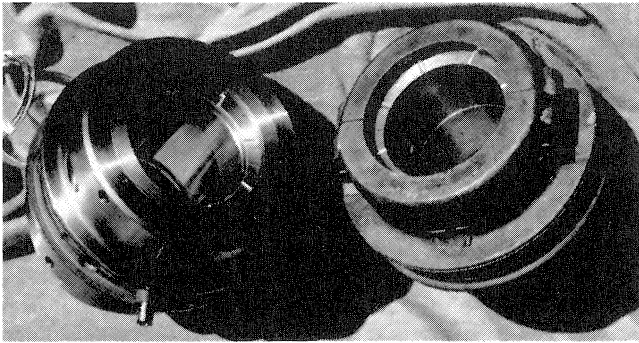
Figure 37. Original Bearing (left) and New Bearing.

Figure 36 shows the new proposed tilt pad bearings, and Figure 37 shows a comparison of the original and new bearings. The new bearings, shown again in Figure 38, are of a four shoe tilting pad design, with L/D of 1.0, preload of 0.33, and orientation load-between-pad. This design incorporates ball and socket pivots, which can be seen in Figure 39.

A new set of journal bearings was designed to eliminate the instability problem and to minimize synchronous vibration. The optimum bearing is a four shoe tilting pad type. The bearings are identical on both ends of the machine. The geometry is L/D = 1.0, preload = 0.33, and set clearance = 0.008 in., and the orientation is load-between-pad. It is also recommended that the oil be changed to ISO 68.

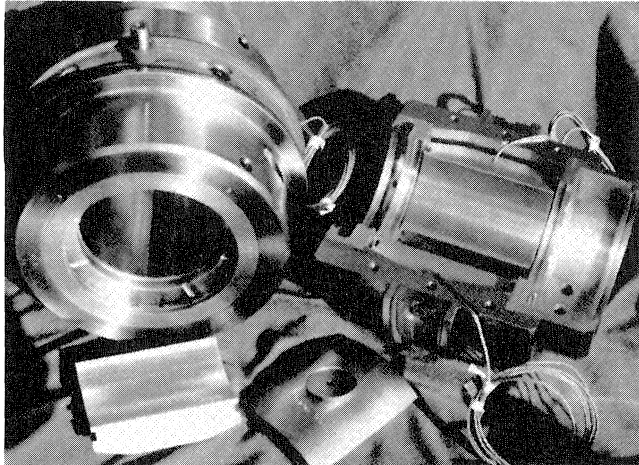
Figure 38. New Tilt Pad Journal Bearing—Four Pad Design.

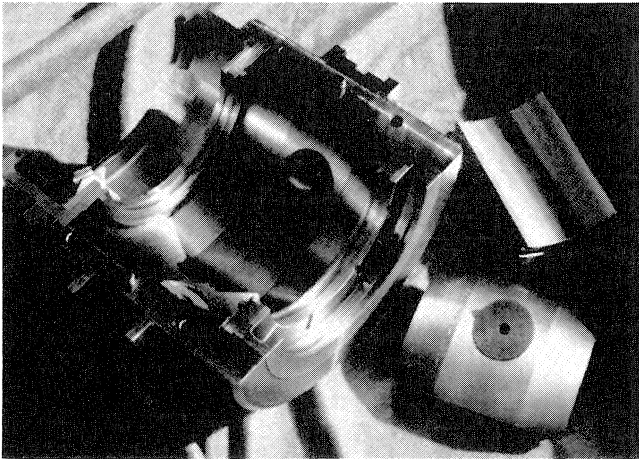
Figure 39. New Bearing Showing Ball and Socket Pivots Behind Pads.

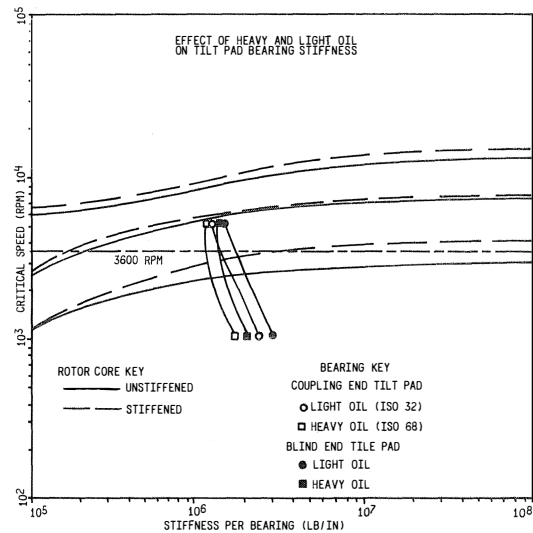
The stiffness coefficients for the new tilt pad bearings are shown on the critical speed map for the existing rotor in Figure 40.

Figure 40. Critical Speed Map with New Bearings.

The rigid bearing critical speed is 2,630 rpm without core stiffening and 3,720 rpm with core stiffening. Therefore, the rotor shaft stiffness is 4.6×10^5 lb/in without core stiffening and 9.2×10^5 lb/in with core stiffening. The critical damping values without and with stiffening are 3,318 and 4,708 lb/sec/in. These quantities were used to compute the stiffness and damping parameters presented in Table 10. Note that the original stiffness ratios were 10.7 and 5.3 for the unstiffened and stiffened conditions, respectively. With the new bearings, these values are reduced by 46%, and both are below the recommended value of 6.0. The new bearing stiffness curves cross the first mode curve below the rigid bearing limit. Figure 40 shows that the new bearing stiffnesses cross the critical speed curve between 1×10^6 and 2×10^6 lb/in.

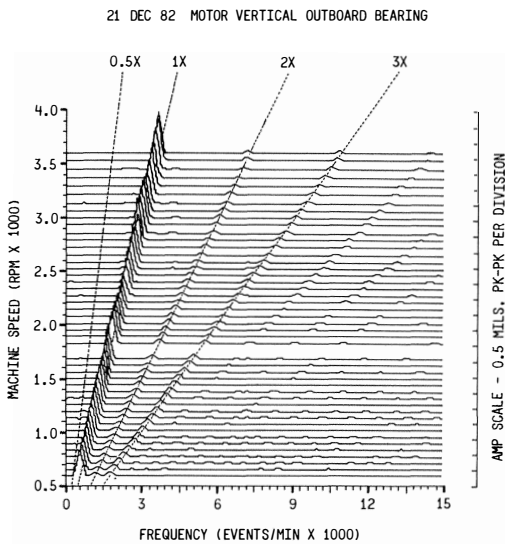
Prior to the motor solo run, all monitoring instrumentation was checked and calibrated. The motor was then run for two hours with the new tilting pad bearings and coupling hub. Vibration amplitudes stabilized within ten minutes of start-up, with a maximum level of 1.0 mil on the outboard horizontal position. The cascade plots of the vertical outboard (Figure 47) and the vertical inboard (Figure 48) vibrations showed no subsynchronous frequencies. All vital signs were normal, so the motor was shut down and the coupling installed. The coupling guard was then installed and the coupling lube oil spray nozzles checked for flow rate and position.

Figure 47. Cascade Plot of the Vertical Outboard Vibration During Solo Run of Motor.

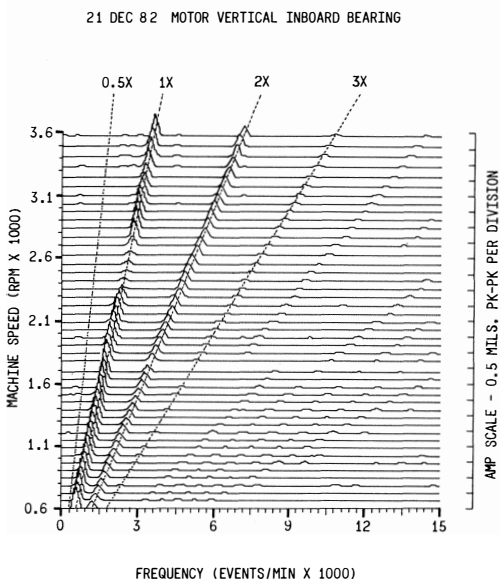
Figure 48. Cascade Plot of the Vertical Inboard Vibration During Solo Run of Motor.

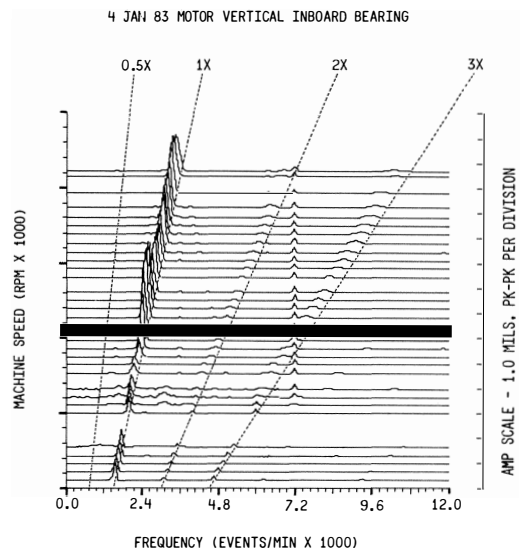
On January 4, 1983, the compressor train was brought on stream. The start-up went very smoothly, and all vibration and temperature levels stabilized in seven hours. A team recorded all vital signs for eight hours. No sub-synchronous frequencies were apparent in the motor, and the maximum vibration was 1.8 mils on the outboard horizontal position. Cascade plots of the vertical outboard (Figure 49) and vertical inboard (Figure 50) vibrations show no sub-synchronous frequencies, even with the compressor loaded. Figures 51 and 52 clearly illustrate that there are no abnormal frequency components at full speed and full load.

Figure 50. Cascade Plot of Vertical Inboard Motor Vibration During Compressor Train Start-up. Notice No Sub-Synchronous Frequencies.

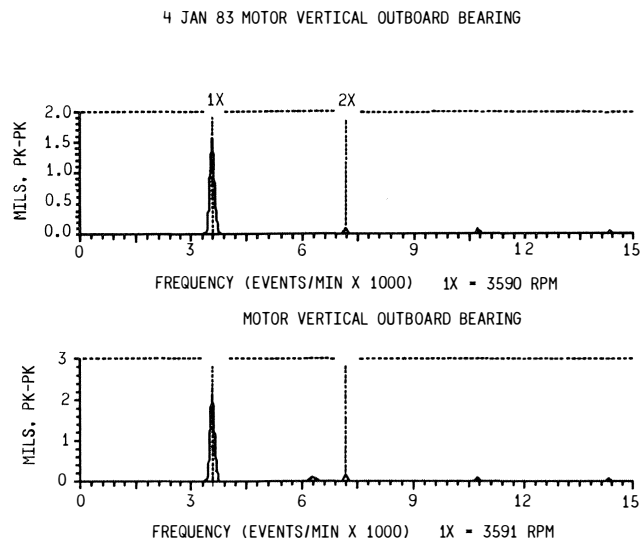
Figure 51. Frequency Analysis of Outboard Motor Bearing Vibration Signals One Hour After Start-up Showed No Sub-Synchronous Frequencies.

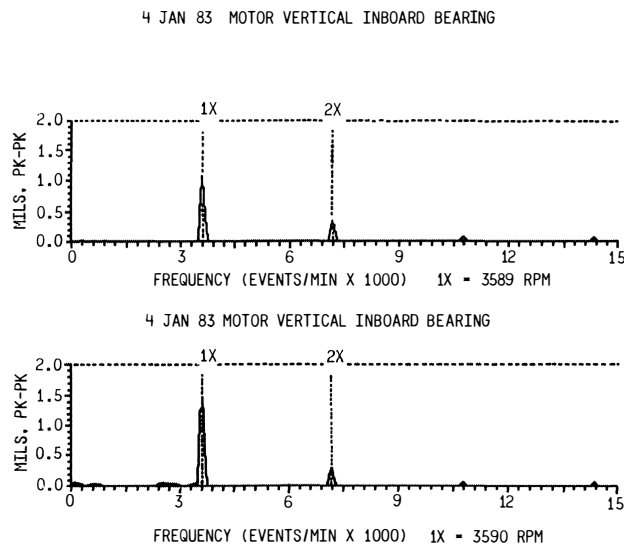
Figure 52. Frequency Analysis of Inboard Motor Bearing Vibration Signals One Hour After Start-up Showed No Sub-Synchronous Frequencies.

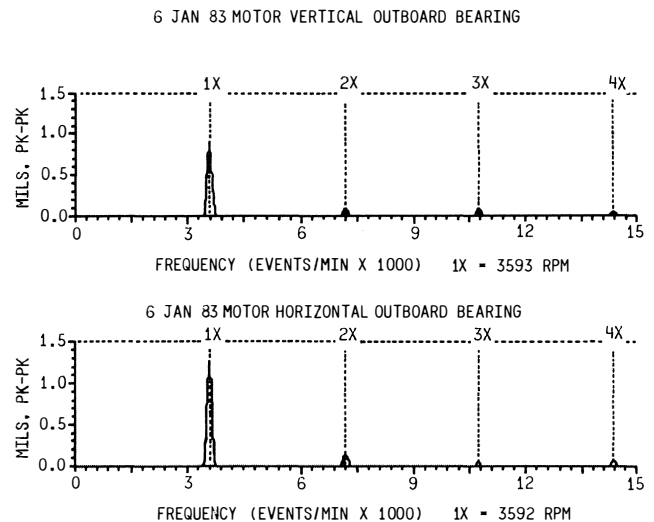
On January 6, 1983, additional vibration data were taken after the compressor train had reached a steady state condition. Figure 53 is a typical example of the motor bearing vibration amplitudes and frequencies.

Figure 53. Frequency Analysis of Outboard Motor Bearing Vibration Signals with Compressor Train at Steady State (Two Days After Start-up) Showed No Sub-Synchronous Frequencies.
