FATIGUE FAILURES OF COMPRESSOR IMPELLERS AND RESONANCE EXCITATION TESTING

Fred L. VanLaningham

Union Carbide Corporation

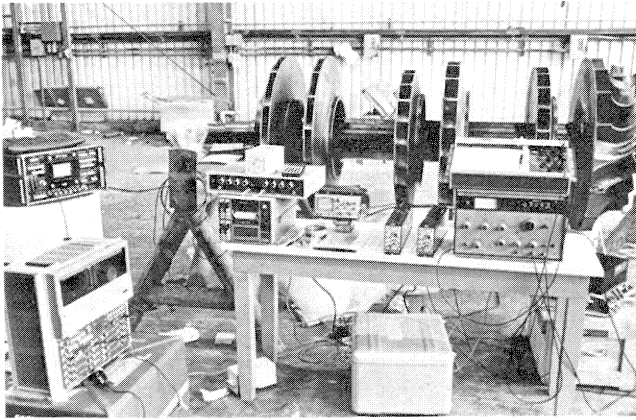
The field shaker testing definitely established the blade resonance. The set-up showing some of the instrumentation, the impeller and blades is shown in Figures 10, 11 and 12. The results of the compressor testing using high frequency pressure transducers and accelerometers indicated that the machine will develop a vibration at the measured resonant frequency of the first stage blades. The first section (first two impellers) seems to be approaching incipient surge even though the overall machine is operating well to the right of the predicted surge line. Figures 13 and 14 indicate the changes in the vibration peaks at the blade resonant frequency. Operating conditions have since been modified to avoid the condition and to allow the first section to operate at higher capacity.

Figure 10. Rotor in Horizontal Position for Excitation Testing of Open Impeller Blades.

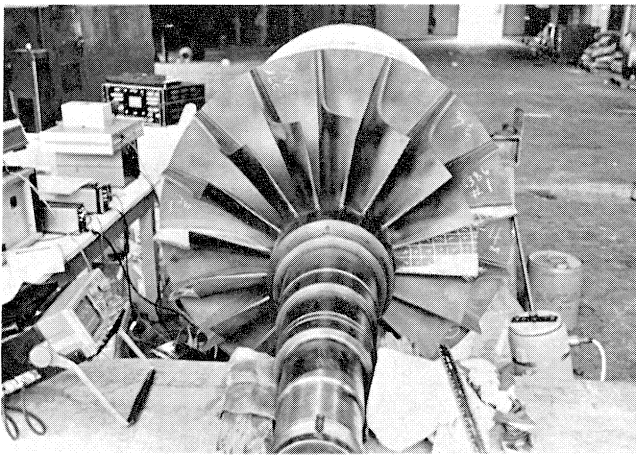
Figure 11. Inlet End View of Rotor Showing Shaker and "Stinger" on Right Side with Blade Laid Out in a Grid Pattern on Convex Side.

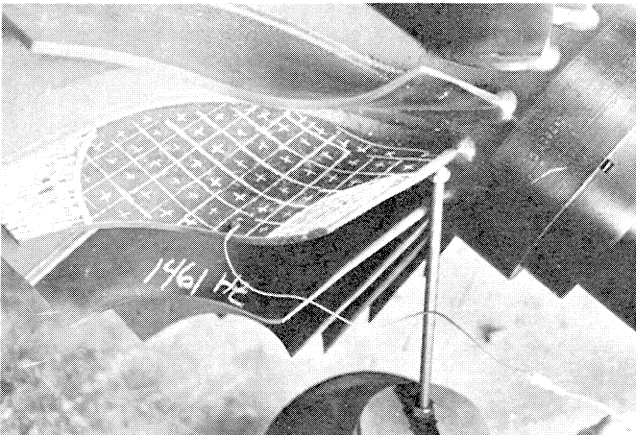
These tests seem to be conclusive in pinpointing that at a low flow-high pressure ratio condition, the open wheel blades are excited at the 1450 Hz mode, and eventually a blade will fail under *low overstress-high cycle* fatigue. The tests were inconclusive, however, in determining if a backward traveling wave existed, that is, that the first wheel was excited by a backward traveling wave from the second wheel at its blade pass frequency.

Figure 12. Blade of Open Impeller with Grid Pattern on Concave Side and Chalked Mode Shape after Survey. Shaker and "Stinger" Moved from Position Shown in Figure 11.
