# ELECTROMAGNETIC SHAFT CURRENTS AND DEMAGNETIZATION ON ROTORS OF TURBINES AND COMPRESSORS

**John S. Sohre**

**Paul I. Nippes**

A high percentage of large, high-speed compressor trains has suffered serious failures which were initiated by shaft current damage. These currents are generated by electromagnetic effects. The basic mechanics of various types of shaft currents are briefly reviewed, and the electromagnetic type is discussed in detail. Part I covers the theory of current generation, sources of magnetism, symptoms, modes of failure, remedial action, and case histories. Part II explains in more detail how small residual magnetic fields can generate currents, and how self-excitation and consequent self-magnetization may occur. Principles of demagnetization are also covered.

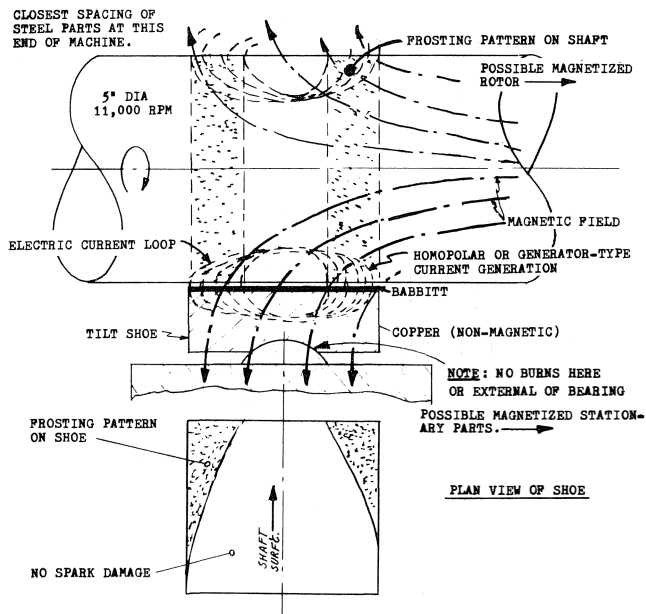
Figure 3c. Short-Circuited Current Loop Within One Journal Bearing.

A tilt-shoe bearing is shown (based on a specific case-history), but the same pattern occurs also with any other type of bearing. The shoe in this case was non-magnetic, damage would have been worse with a steel-backed shoe.

The high-pressure compressor bearing at the thrust end had a frosting pattern as shown in Figure 3c. This bearing had run only for two weeks, after a shaft-current induced failure which caused a plant shutdown. The high pressure compressor had a history of severe, locked-seal induced oil whirl, the vibration amplitude reaching 4.5 mils, with a predominant frequency at 47% of running speed. The bearings in this unit were of the tilt-shoe type.
