REPAIR AND REHABILITATION OF TURBOMACHINERY FOUNDATIONS

E. M. Renfro

Adhesive Services Company

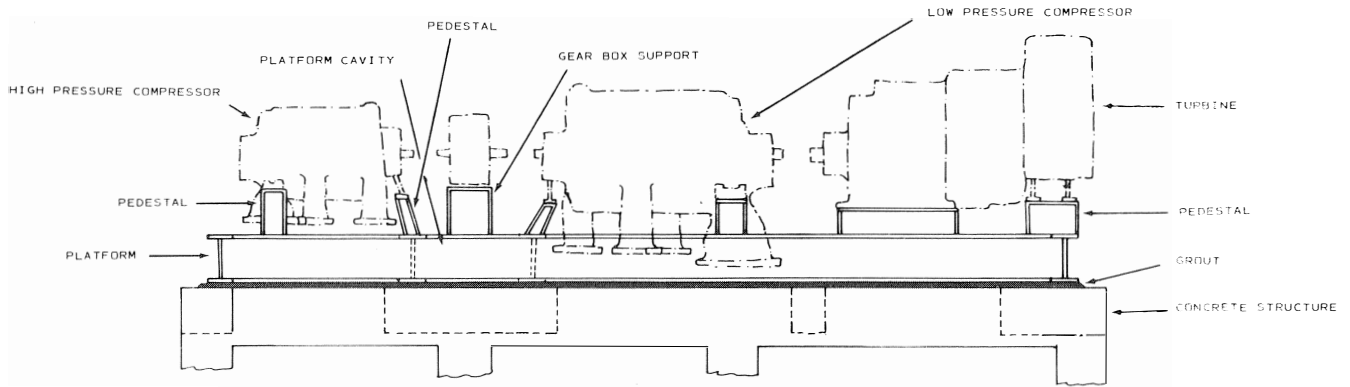
A typical compressor train containing a turbine and two compressor stages is illustrated in Figure 1. The "I" Beams on the platform are grouted to the concrete structure. When proper grouting techniques are carried out during the original installation, the grout should contact the entire lower surfaces of all longitudinal and transverse "I" Beams.

Figure 1. A Typical Compressor Train Containing a Turbine and Two Compressor Stages.

When excessive vibration is detected in the gear box of a compressor train, shown in Figure 1, and is transferred to the platform below, a dampening effect can be created by increasing the rigidity of the support below. This can be accomplished by first filling the platform cavity and then the gear box support with epoxy mortar. Figure 11 is a photograph of the gear box support after the gear box has been removed and an access hole cut in the plate at the top of the support. At the time this photograph was taken, epoxy mortar was being poured into the cavity. Since it is impossible to fill a cavity completely with mortar, filling was stopped at a level of approximately $\frac{1}{4}$ inch below the top. The access hole plate was then welded back into position, and injection sites drilled into each corner of the support. A vent hole was then drilled in the center of the reinstalled access plate to facilitate air removal when pressure-grouting the remaining air space below the top. Figure 12 is a close-up view of a typical injection site at each corner.
