SEVERE SUCTION BELL DAMAGE IN LARGE, OPEN IMPELLER, VERTICAL TURBINE PUMPS

Michael D. Smith
Pump Consultant
Dupont Company
Wilmington, Delaware

ABSTRACT

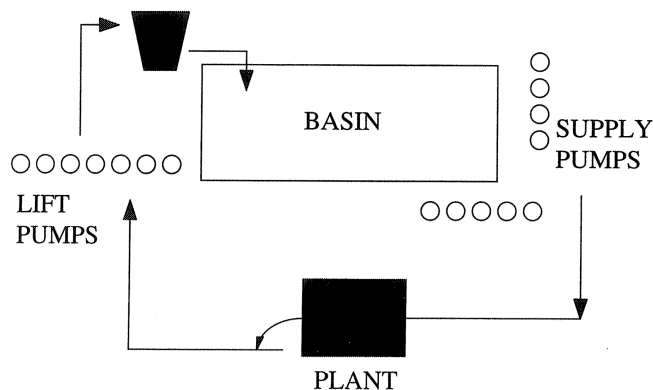
Figure 1. Cooling Water System.

A large chemical plant has used bronze fitted, cast iron, vertical turbine pumps to circulate cooling water for over 30 years. In 1994, a new cooling water system (Figure 1), including new pumps with semiopen impellers (Figure 2), was installed and began operation. Nine 1500 hp pumps draw water from a large cooling basin. The water is supplied, under pressure, to thousands of points in the plant for process cooling. It then flows back toward the basin in an open canal. Seven 500 hp pumps then lift the water to the top of a cooling tower, where it is cooled before returning to the basin.

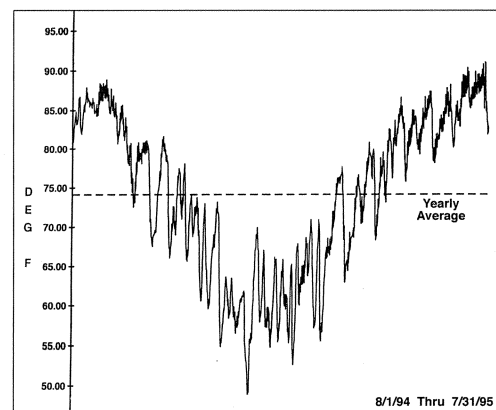
Figure 8. Cooling Water Temperature During the First Year of Pump Operation.

No evidence of an unusually high level of abrasives was found. Corrosion always plays a role in metal loss, whether due to erosion (oxidizing the newly exposed surface) or surface fatigue (corrosion lowers the endurance limit). There are several variables that impact how "aggressive" water is to cast iron. Temperature (Figure 8), pH (Figure 9), conductivity (Figure 10), residual chlorine (Figure 11), and total chlorides (Figure 12) were recorded throughout the life of the damaged pumps. While the two periods of low pH are suspicious, one supply and one lift pump were not in service during either period and accumulated the same damage as the other pumps. This indicates that the periods of low pH did not have a measurable impact.

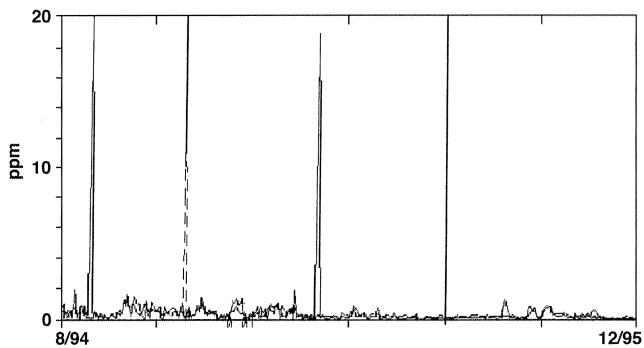
Figure 11. Cooling Water Excess Chlorine.

Additional measurements of residual chlorine near the addition points in the supply pump pits indicated some lack of mixing. This can lead to potentially damaging levels of low pH. This was also found to be insignificant since the lift pumps are not near the addition points and had similar damage.
