ASIA TURBOMACHINERY & PUMP SYMPOSIUM
MARCH 2018 | SUNTEC SINGAPORE

Technical Brief: Natural Frequency Whirl Instability in an Industrial Gas Turbine

Chris White, BSc, MEng
Principal Engineer, Rotating Equipment Reliability
Wood

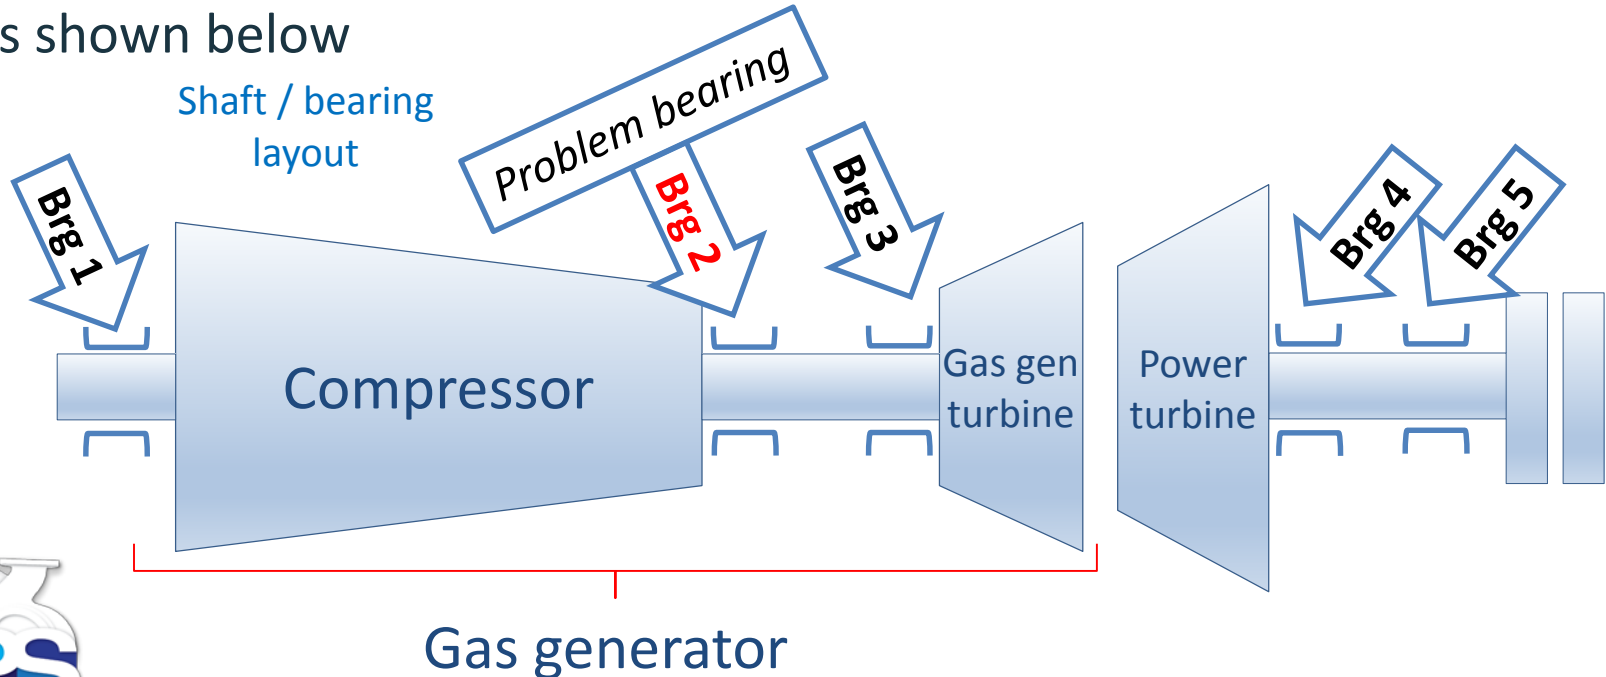
- Gas turbine driven compressor set 'A' (1 of 3)
- Engine is a two-shaft 70 MW industrial gas turbine, bearing layout as shown below

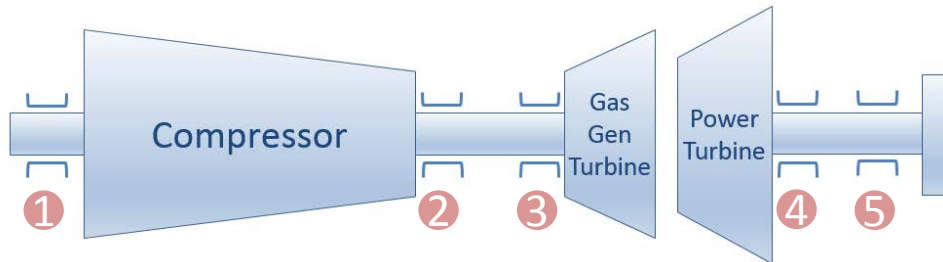
Shaft / bearing arrg't.

- Bearing 1 failed after 16,000 hours operation
- Vendor replaced Bearing 1 in situ
- Vibration returned to normal, operation continued, but:
- At 17,500 hrs, vibration at **Bearing 2** stepped up to $50\mu\text{m}$ / 2 mils pp, and continued to trend up
- Vendor recommended to remove engine from service for off-site overhaul, operator requested a second opinion

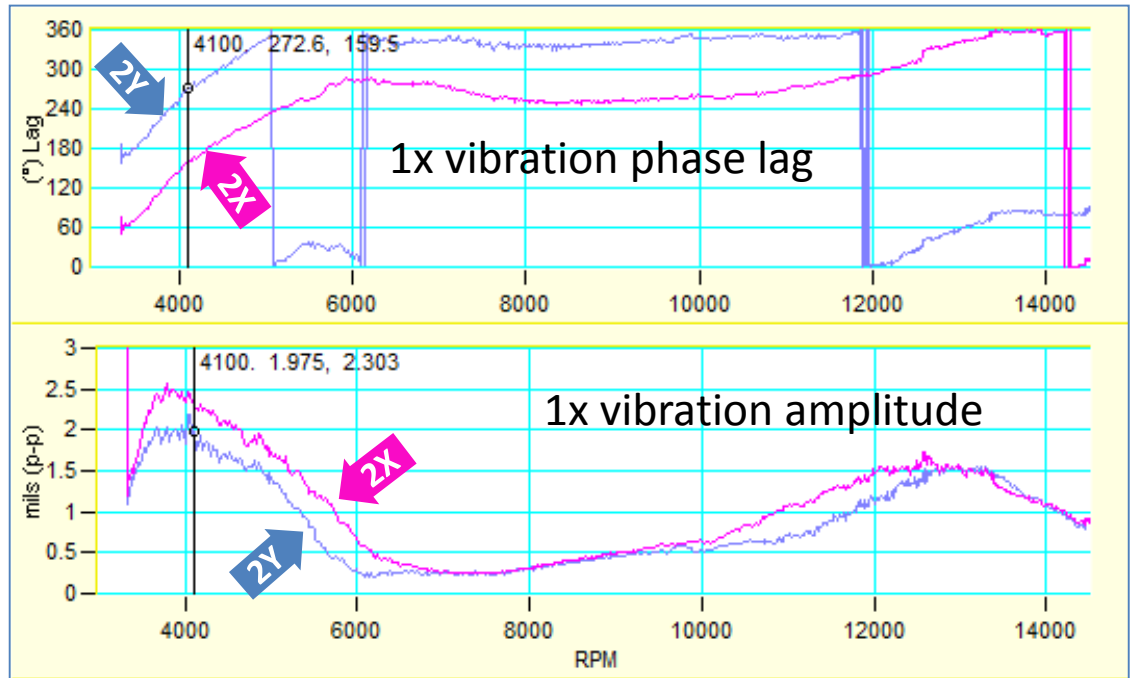
Bearing 2 bode plots

Indicate critical at around 4,100 RPM / = 68 Hz, good match for the 0.3 orders vibration which appears at 13,500 RPM

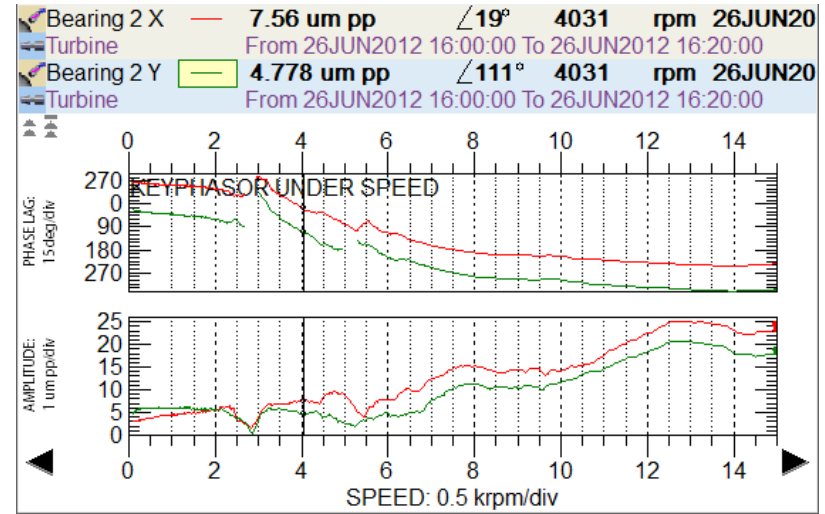
Healthy machine Bearing 2 bode plots

When compared with a healthy example of the same model, 1st critical (as determined by phase change) similar but amplification factor appears much higher

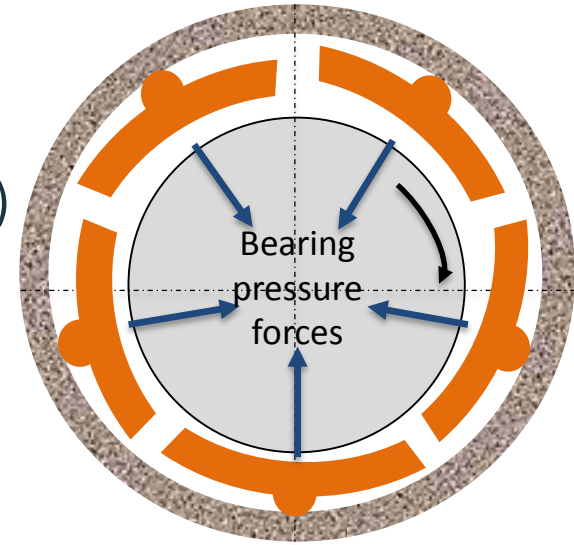
- But the machine in question uses tilt pad journal bearings (TPJBs), with 5 pads, in a load-on-pad (LOP) configuration
- As each pad can pivot, it constantly adjusts angle to maintain equilibrium pressure across its face; resultant force always points at shaft centre
- Thus each pad tilts such that the leading edge is a little further from the journal than the trailing edge – as we typically see in the wear pattern
 - This bearing type **cannot** produce cross coupling forces – but there are other contenders...

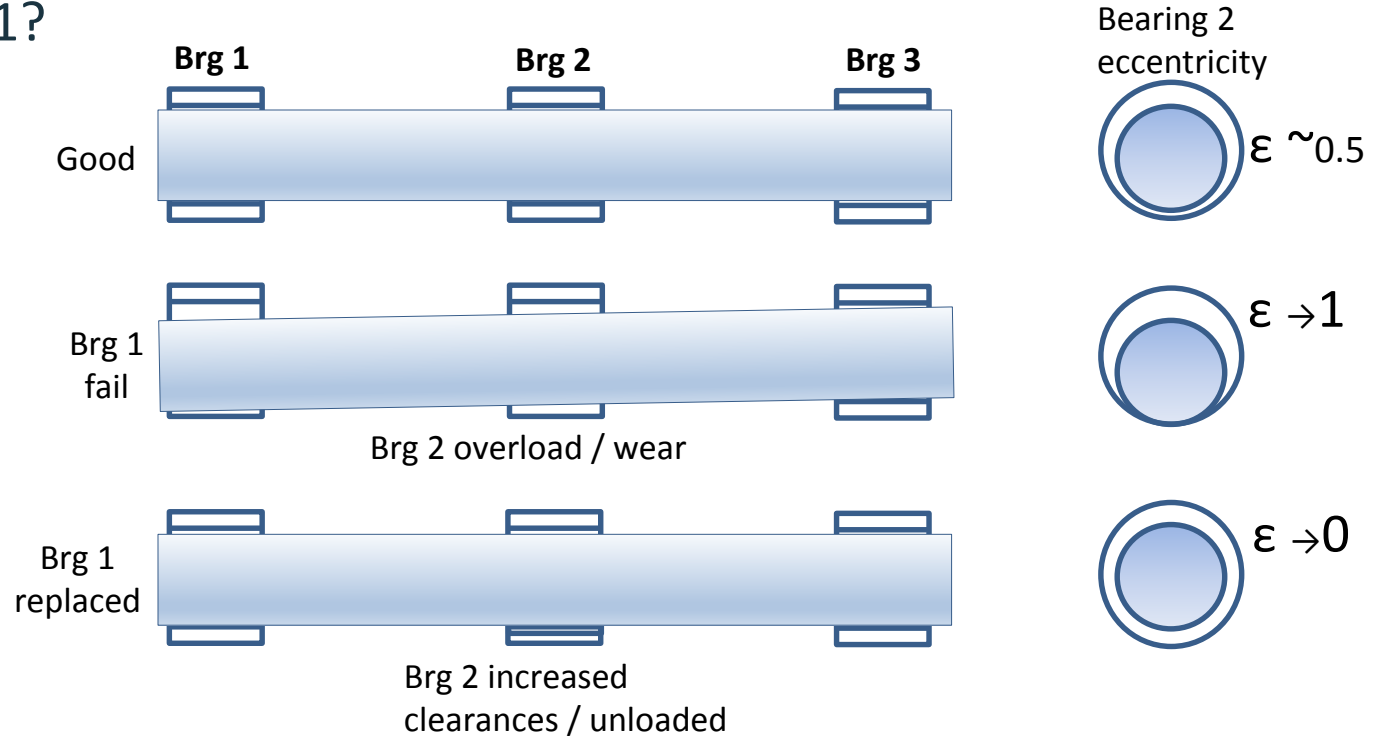
- Was Bearing 2 overloaded / damaged whilst running with damage to Bearing 1?
