Engine Driven Pumps - Vibration Problem Resolution Using Specialized Testing Techniques

A. Aziz Al-Qattan, Bahrain Petroleum Company

1st METS Turbomachinery Symposium
February, 2011

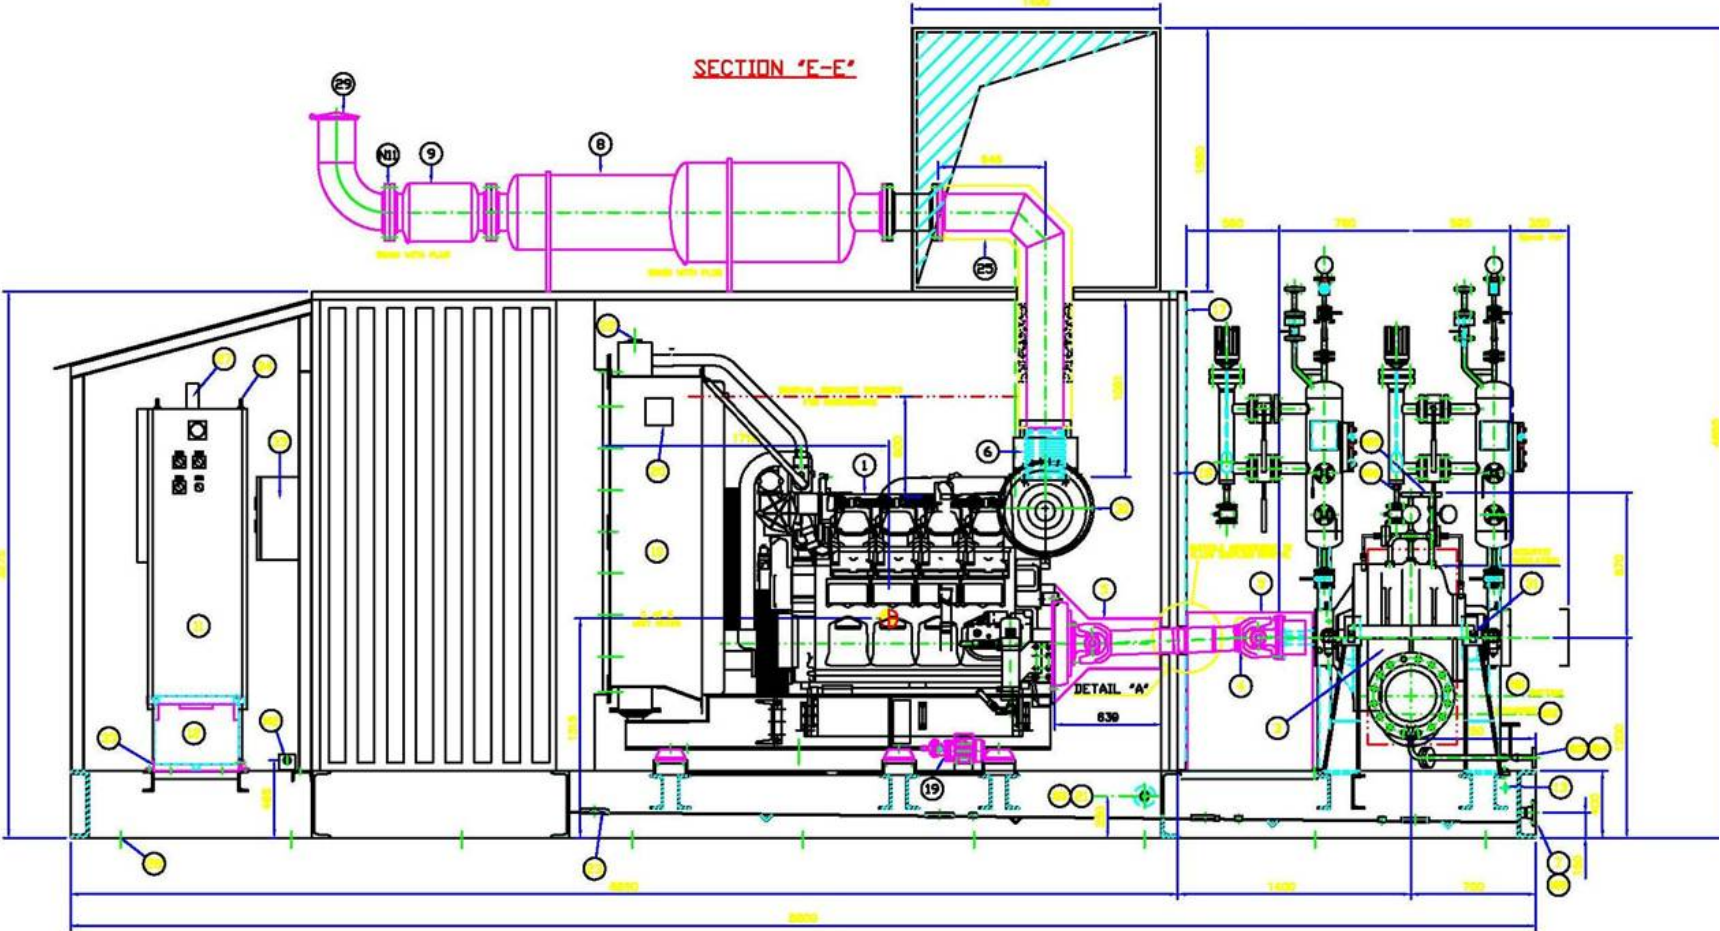
Engine driven pump layout drawing

- Engines are moving considerably relative to the pumps due to flexible mounting pad support of engine feet.
- Transmitted motion through shaft to other system components including the P2952X steady bearings and their support beam, and the pump/pedestal.
- Vibration greatly amplified at select operating speeds leading to strong engine-driven harmonic response at multiples of $\frac{1}{2}$ x engine rpm.
- Engine mis-firing caused $\frac{1}{2}$ x rpm force response excitation (“picket fence”).
- Engine soft-mounting amplified the response levels.

- Replace flexible mounts with single or two-piece shim pack of equal height (no stacking of thin multiple thin shims). Retune engines to minimize mis-fire ($1/2 \times \text{rpm}$) excitation.

- Flexible rubber mounting pads replaced with appropriate metal shims.
- Engine tuning verified.
- Grout added under the engine.
- Engine rpm reduced.
- Impeller diameter increased to meet flow and head requirements at lower engine rpm
