**Innovative Design in Expander Wheel-Shaft Attachment Replaces
Hirth Coupling
for
High Speed, High Temperature and High Power Applications**

Houman Shokraneh, Ph.D.
Director of Engineering
L.A. Turbine

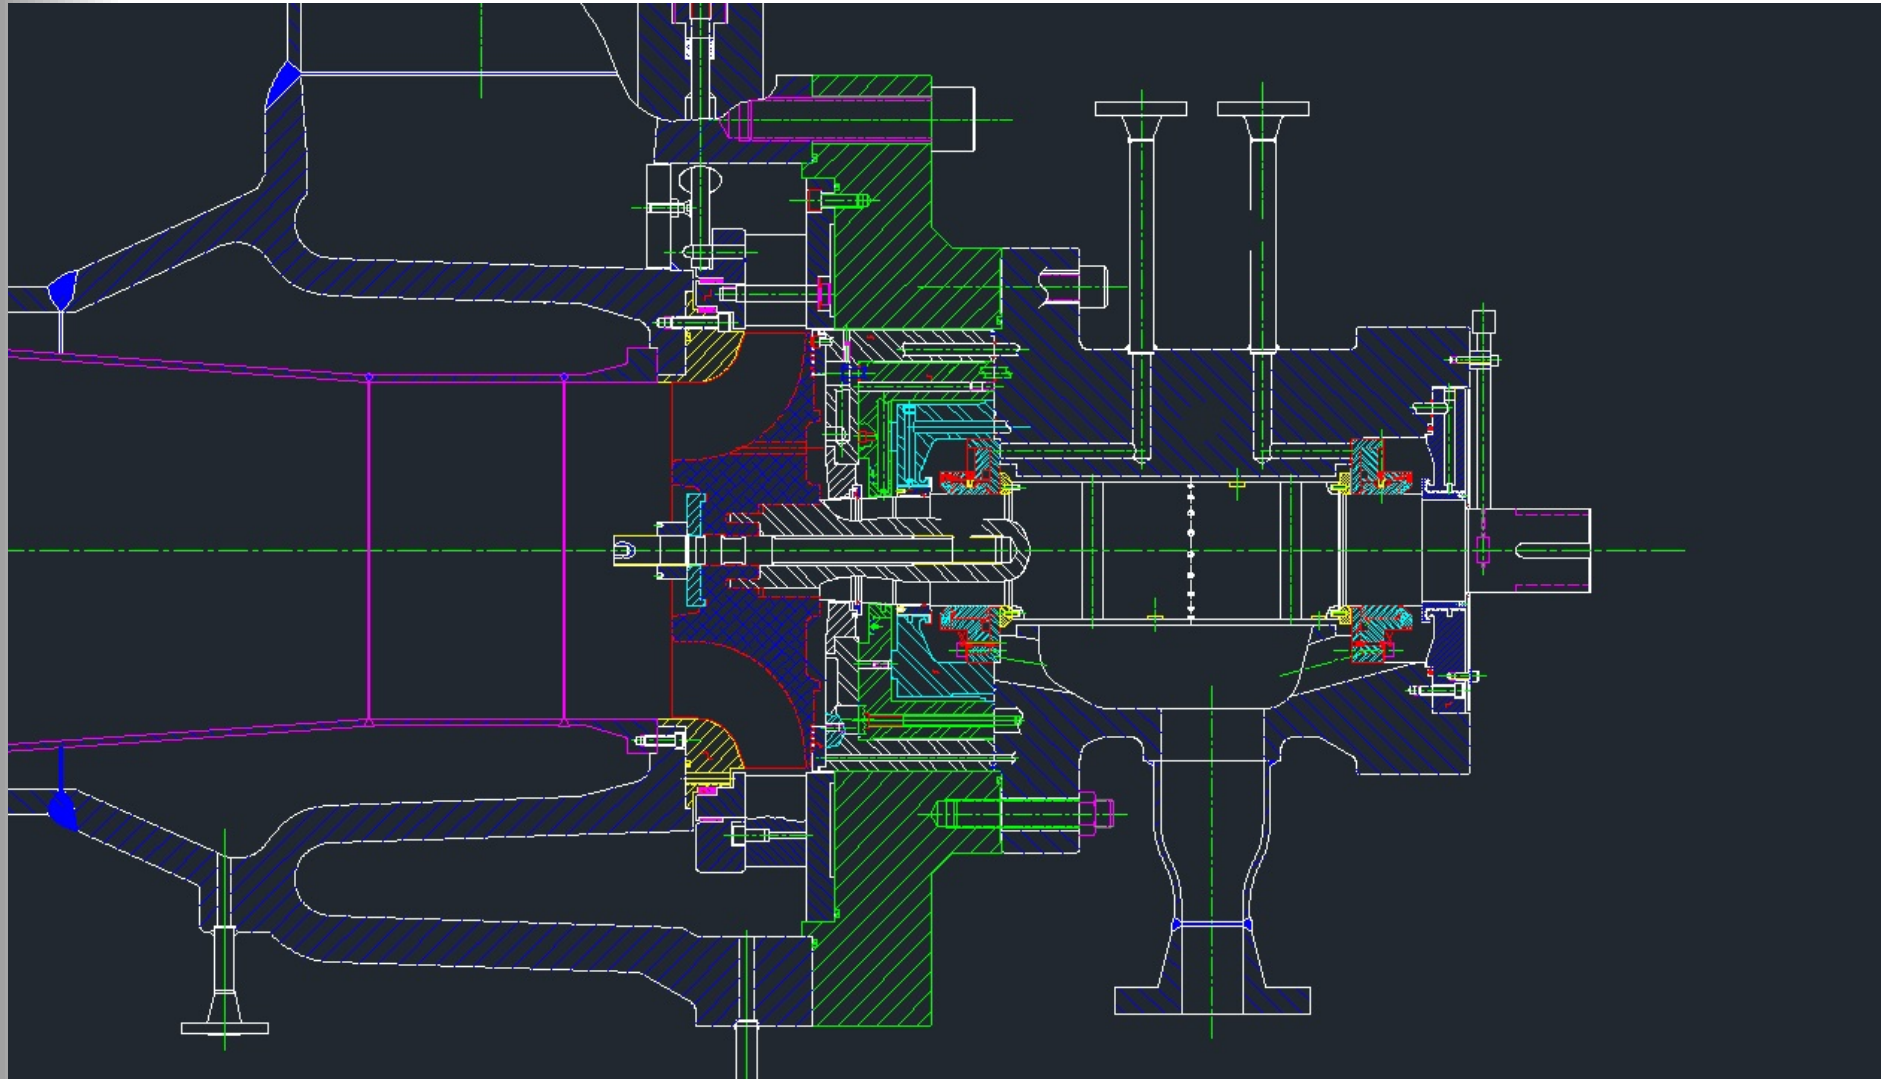
(Cross Section)

- An Expander-Generator unit for geothermal application was commissioned in 2000.
- The expander wheel failed continuously since commissioning of the machine.
- Machine experienced very high vibration (0.13 mm and higher) during operation.
- During a 10-year period, the machine was redesigned several times yet the problems remained.
- When the machine operated close to the designed power (10 MW), the average time between failures was less than three months.
- On one occasion, the unit ran for 18 months but on a lower power (6 – 8 MW).

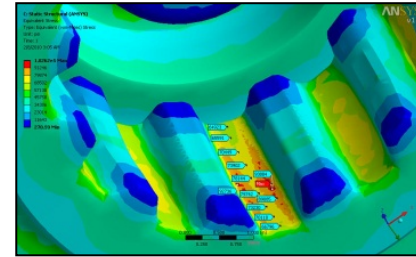
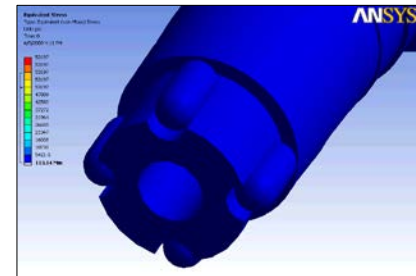
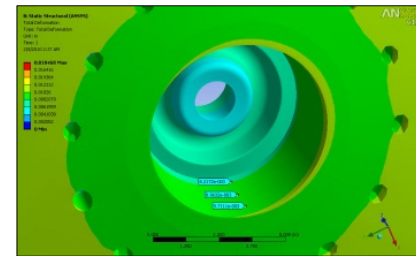
- Combination of heavy wheel weight and high operating speed causing very high stress on any opening inside the wheel.
- Traditional keyway design ruled out as key's weight would apply additional stress to the hub.
- Centrifugal force opens up the hub diameter by a minimum of 0.5 mm and reduces effective contact area to transfer the torque.
- Hub expansion for any opening inside the wheel, caused by high temperature and centrifugal force make it difficult to hold the wheel C.G. close to the center of the shaft and hold the imbalance.

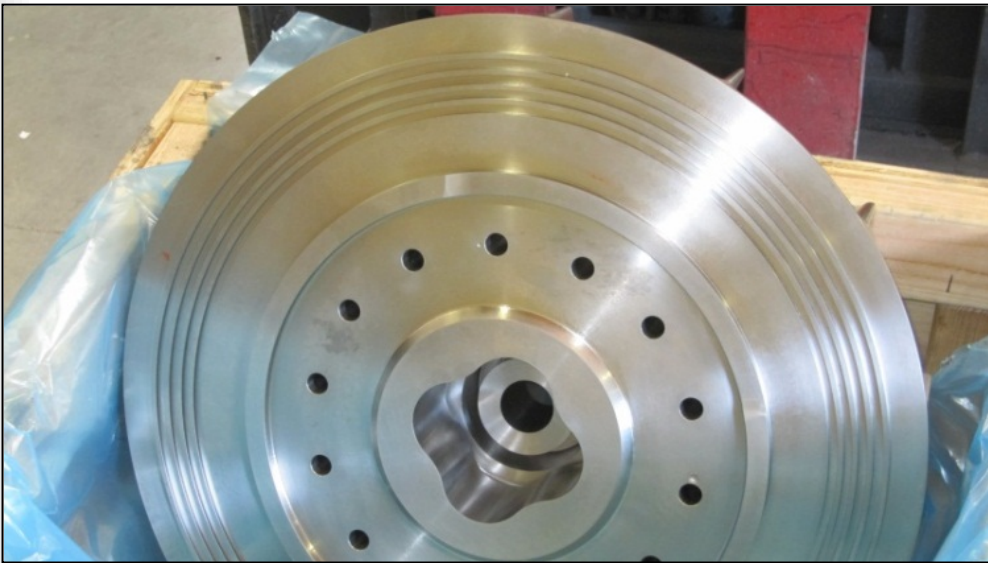
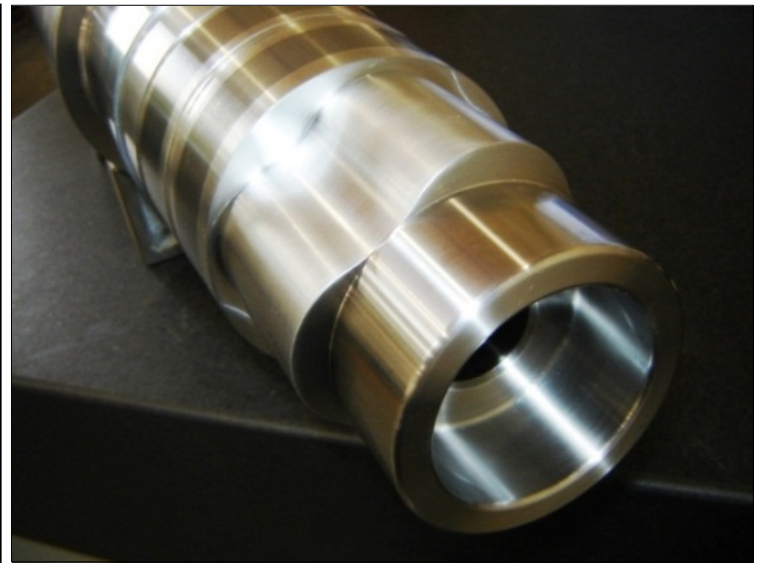
- In addition to the problems with Hirth coupling, this unit originally was suffering from high vibration and high temperature on bearings. As a result, the bearings needed to be replaced after each crash.

- New machining design applied to the shaft and wheel.
