# Premature Dry Gas Seal Failure on a Sales Gas Centrifugal Compressor

Sergio Vidal  
(Saudi Aramco, Hawiyah Gas Plant - Reliability Unit)

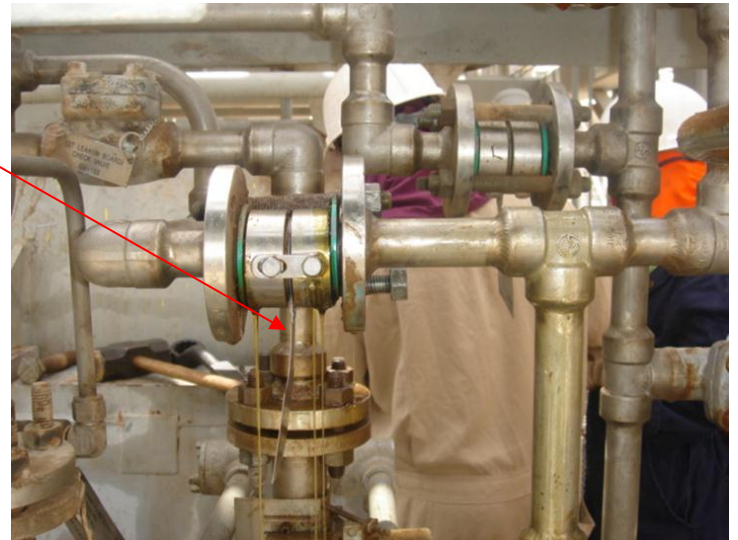
Outboard dry gas seal 1st and 2nd leak lines were completely filled with lube oil.

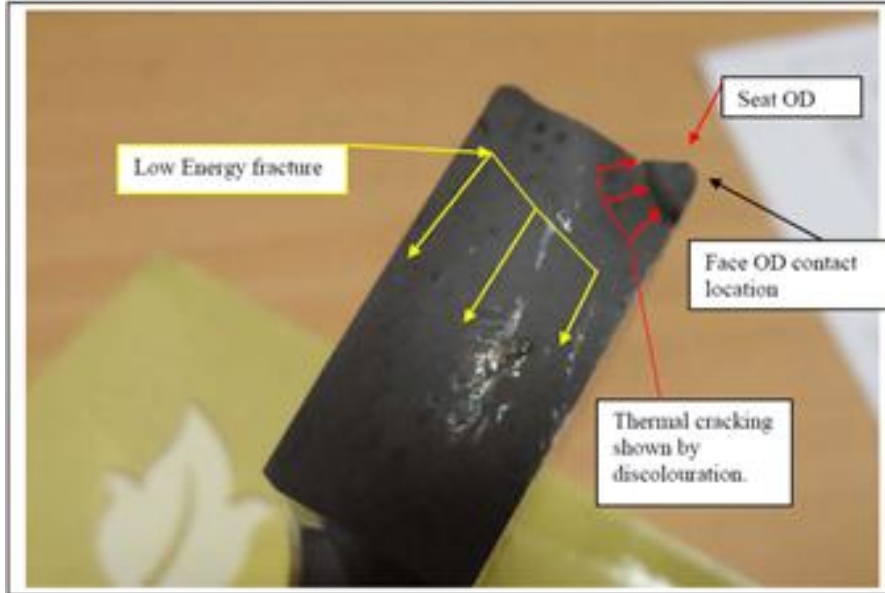
- The DGS manufacturer investigation report states the cause for this seal failure was due to **reverse pressurization of the dry gas seal 2nd seal, outboard side.**
- Reverse pressurization occurs when the **pressure on the ID of the seal is higher than the OD of the seal** (normally the seal operated with the pressure on the OD higher than on the ID of the seal).

- **Reverse pressurization tends to close the faces at the outside diameter producing a divergent gap**, which can cause thermal stress at the OD of the tungsten carbide seat due to localized high temperature.
- The localized **thermal stress create and propagated axial cracks** through the seat which can cause a catastrophic DGS failure.

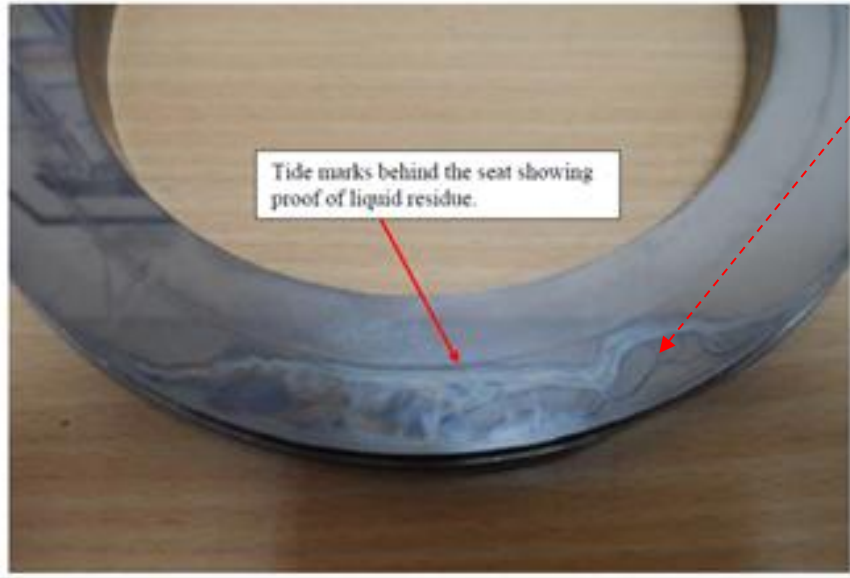
- There were traces of liquid residues on the dry gas seal 2nd leak seat, outboard side;
- API 617 "Axial and Centrifugal Compressor and Expanders for Petroleum, Chemical and Gas" identifies the possibility of **reverse pressurization causing DGS failure**:

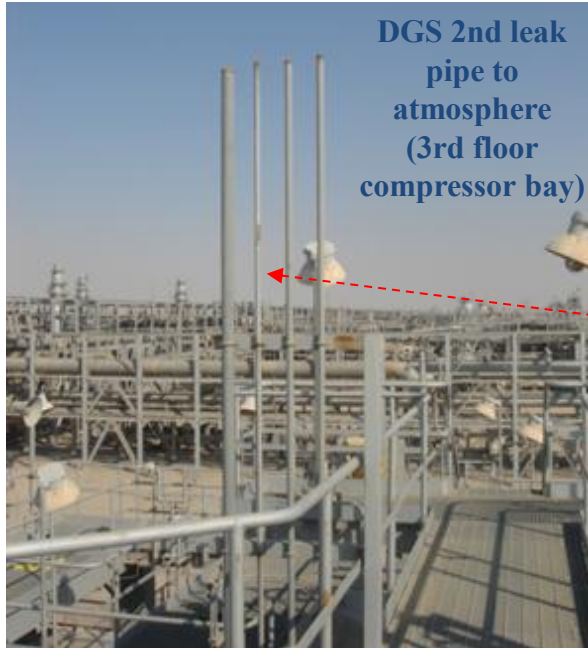
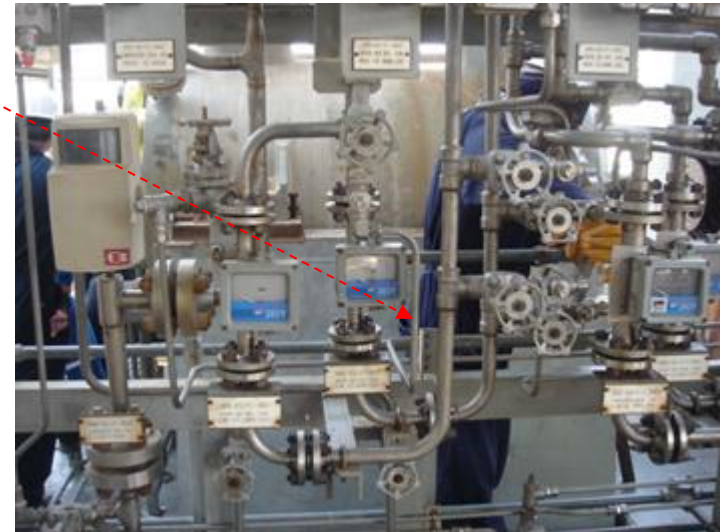
- The possible causes for reverse pressurization of the dry gas seal 2nd seal in running conditions are:
  - N2 supply failure or contamination (*already ruled out before*).
  - N2 barrier seal failure.
  - 2nd leak vent line blockage.
- DGS manufacturer **didn't find any major or severe damage to the N2 barrier seal failure.**
- On the K002D failure of September 2011, **all the dry gas seal console and pipe was found completely full with lube oil for both DGS ends.**
- There is the possibility that **some oil from the September 2011 failure to have been trapped** on the 2nd vent line low points (between the 1st and 3rd floor of the compressor bay), which may have **contributed to the 2nd vent dry gas seal leak line blockage** of July 2012.
