47TH TURBOMACHINERY & 34TH PUMP SYMPOSIA
HOUSTON, TEXAS | SEPTEMBER 17-20, 2018
GEORGE R. BROWN CONVENTION CENTER

Investigation and Resolution of Governing Valve Linkage Failure for Compressor Drive Steam Turbine

Kenichi Nishiyama – MCO
Mayank Jain – MCO
Elumalai Subramani – ExxonMobil

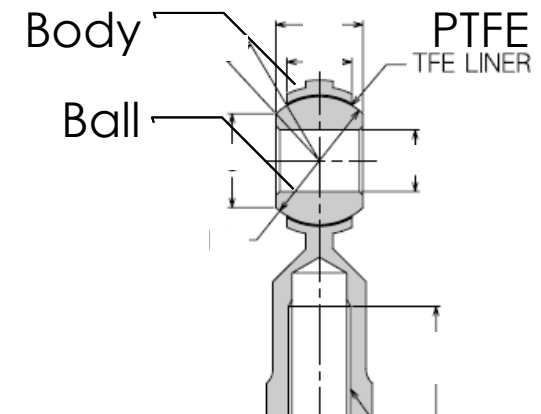
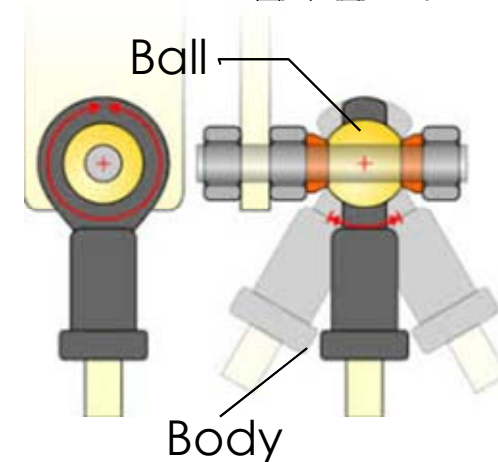
Rod-end Bearing Design

Material specification:

M8 and M16 are same design

They are comprised of the same materials.

Material	PARTS	Hardness (HV)
Martensitic stainless	Ball	≥ 653
Austenitic stainless	Body	≤ 200
PTFE	Liner	N/A

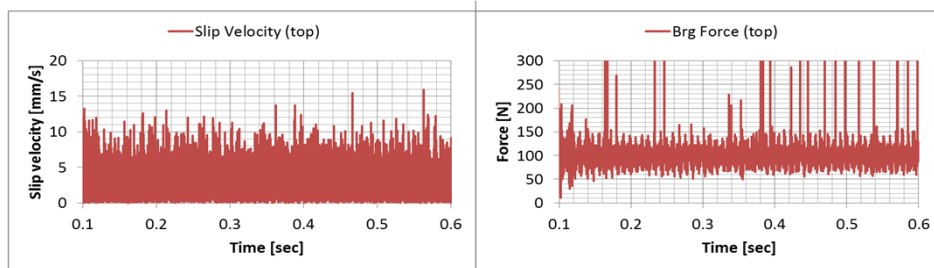
Motion Analysis

Output data
(Sliding velocity and force)

Excitation force was estimated using motion analysis with the help of static force.

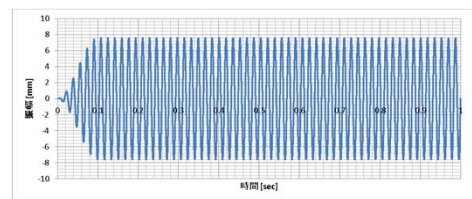
Input value
Measured Vibration on pedestal.

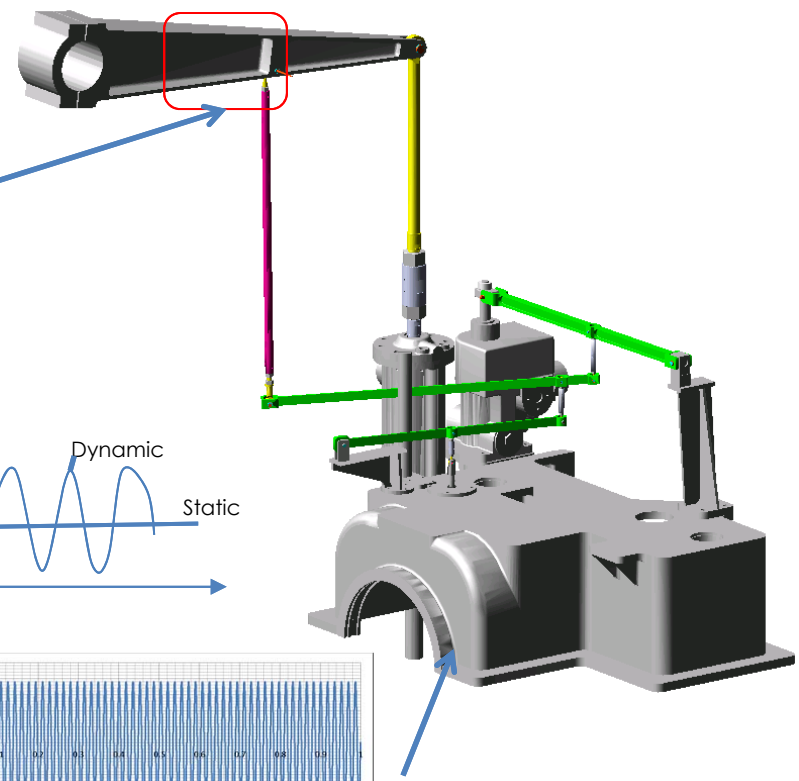
Bearing life estimation

Slip velocity (5.6 mm/sec),
Lh = 16,644 hr (1.9 years)

Under resonance condition, PTFE liner will wear out within 1.9 years of operation.
