TURBOMACHINERY
& PUMP SYMPOSIA

Analysis and troubleshooting of a piston rod failure of RC

Sanghun Lee / Jinseok Yang

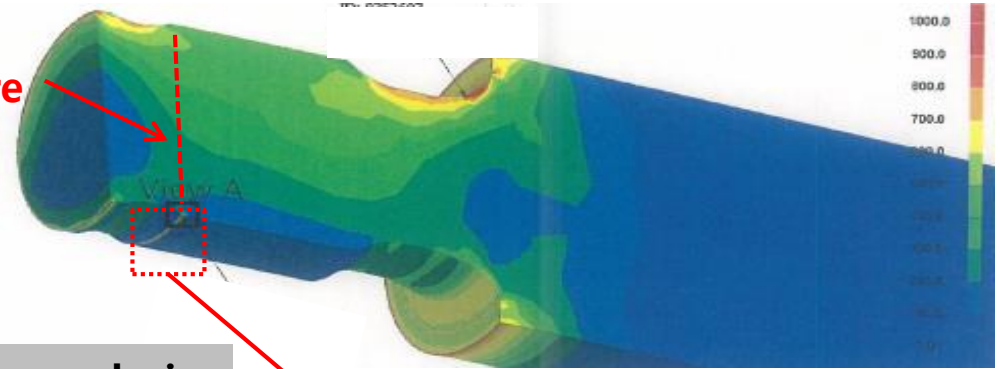
Stress analysis

It means the rod may break if the inclination is greater than 0.7mm during assembly.

Piston Rod Broken

- Incorrect tightening of bolts can cause fatigue failure by stress concentration, even if there are no problems in design and operation.
- It is most important to assemble the piston rod nut in parallel, to avoid excessive stress.
- The proper procedures should be provided to prevent maintenance errors regardless of the worker's skill. And it is highly recommended to inspect and verify the critical points.
