Measured Seepage Losses of Canal 6.0 La Feria Irrigation District – Cameron County No. 3

April 2011

Texas Water Resources Institute Technical Report No. 373
Texas A&M University System
College Station, Texas 77843-2118

**MEASURED SEEPAGE LOSSES OF CANAL 6.0
LA FERIA IRRIGATION DISTRICT-CAMERON
COUNTY NO.3**

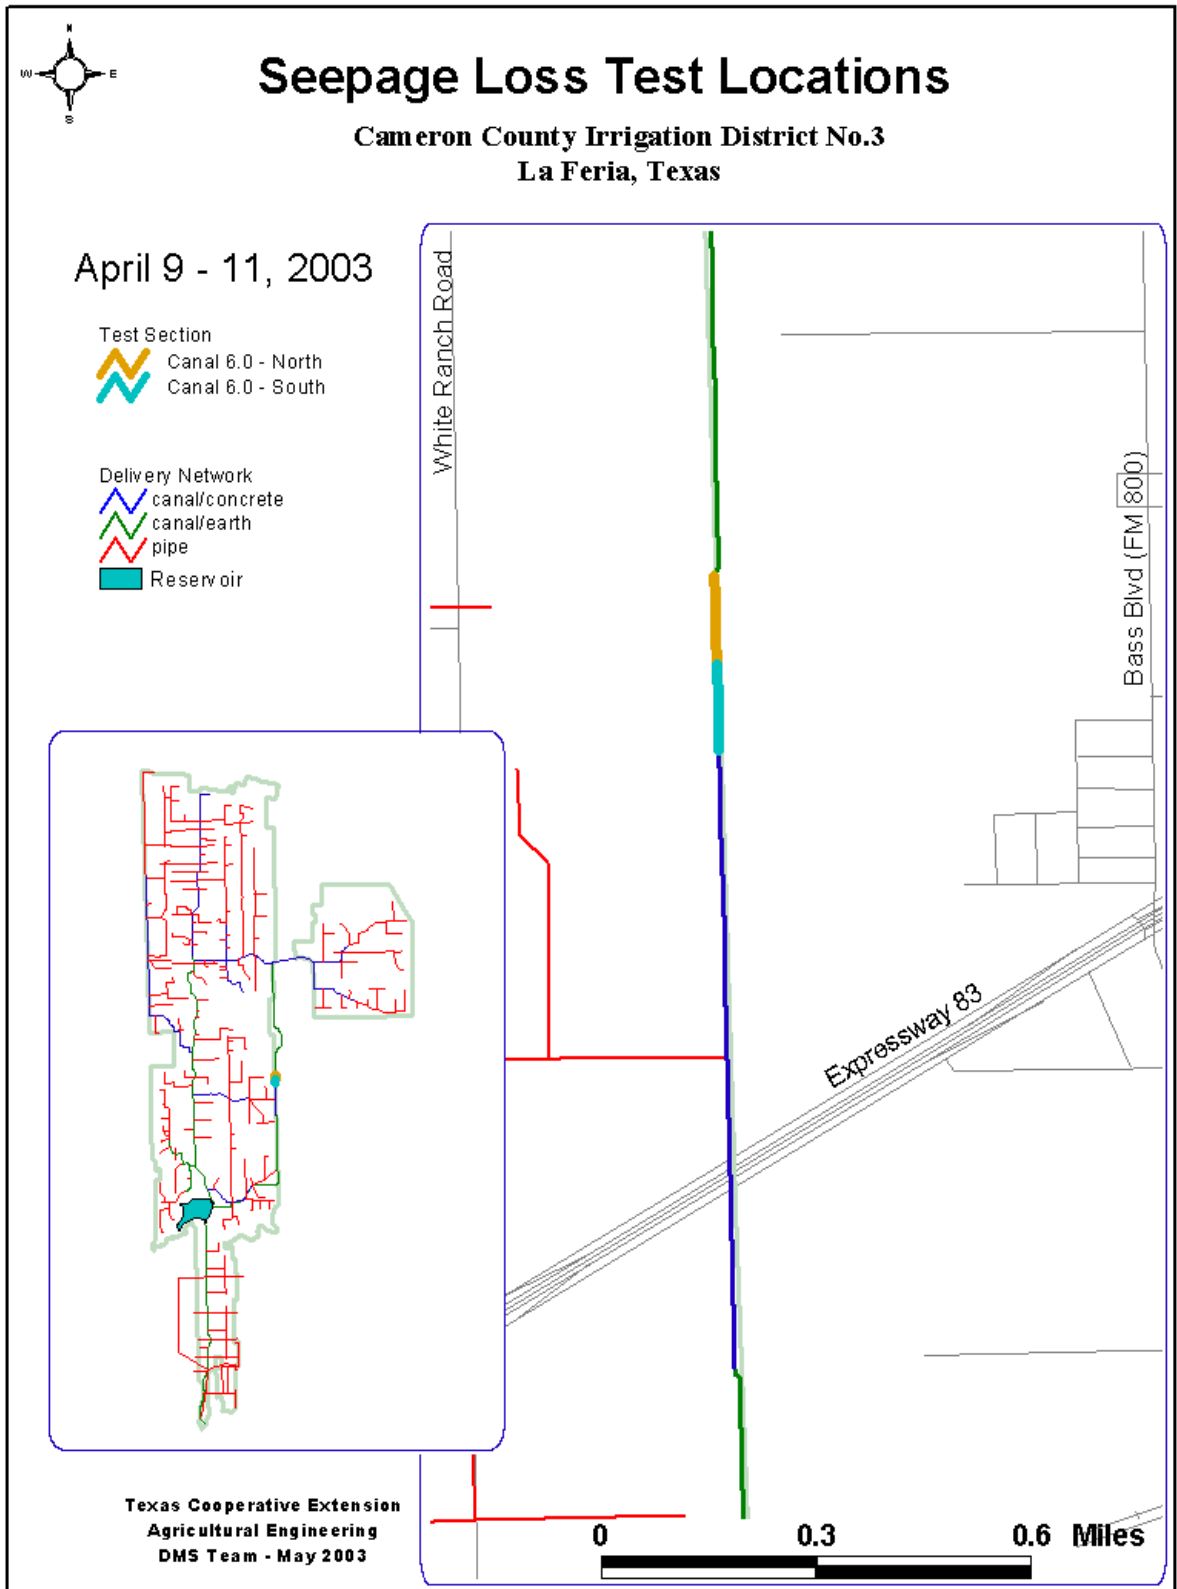
Figure 1. Map showing the locations of seepage loss tests conducted on Canal 6.0.

Two segments of the brick/concrete section was tested (Fig. 1), referred to here as the *north* and *south* segments. Test results are summarized in Table 1. Seepage losses were measured at 1.77 and 4.61 gal/ft²/day for the north and south segments, respectively (or 153 and 369 ac-ft/mile per year). Table 2 lists seepage losses in four methods commonly used for characterizing water loss from canals. The annual water loss amounts given Tables 1 and 2 are based on an in-service life of 365 days per year.

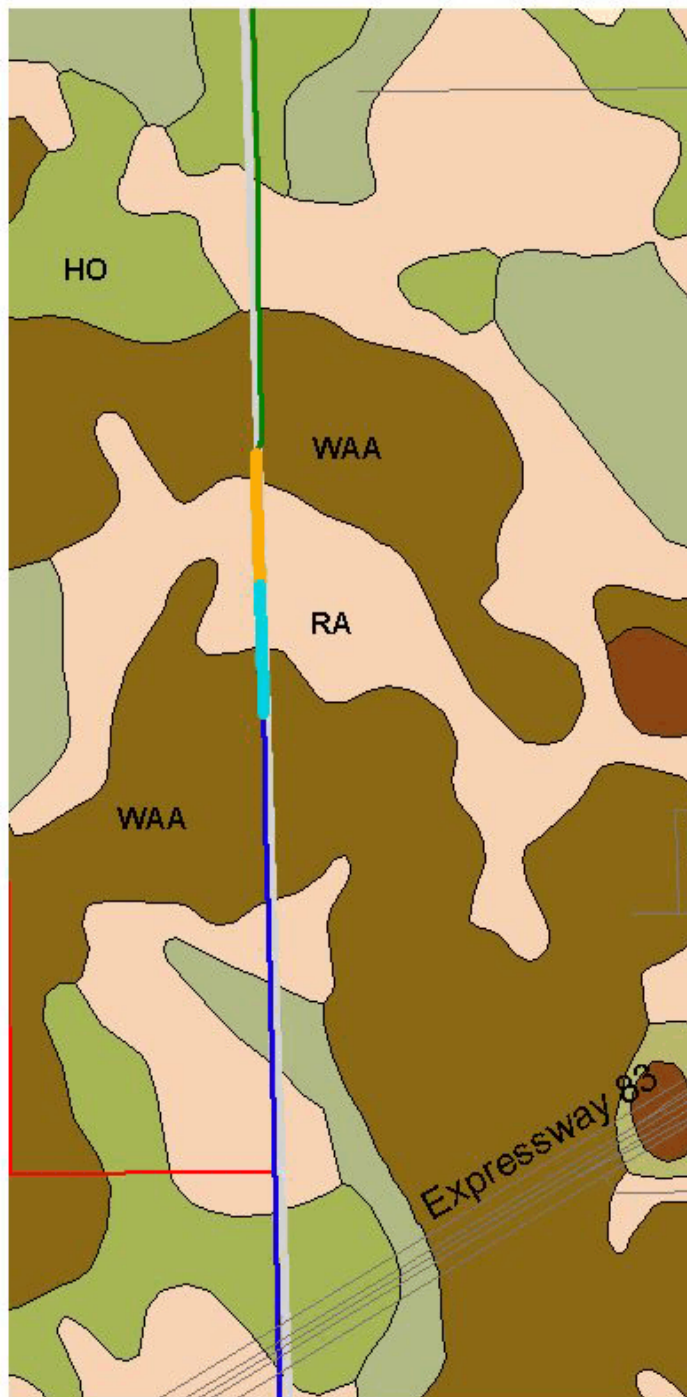
Figure 10. Detail Soil Series with (see Table 5 for soil permeability ranges and key codes).

Descriptions of the general soil types in the area of Canal 6.0 are provided in a later section, along with a map (Fig. 10) of the detailed soil series taken from the Soil Survey for the county. Table 5 gives the key codes and corresponding soil series and permeability range for the units shown in Figure 10.
