Documentation and Conditions Assessment of High Knoll Fort, St. Helena (CHC-2020-01-01)

**Report prepared for the British Napoleonic Bicentenary
Trust and St. Helena Government**

**Brent R. Fortenberry, Associate Director, Center for Heritage Conservation
Jane Ashburn, Architectural Conservator**

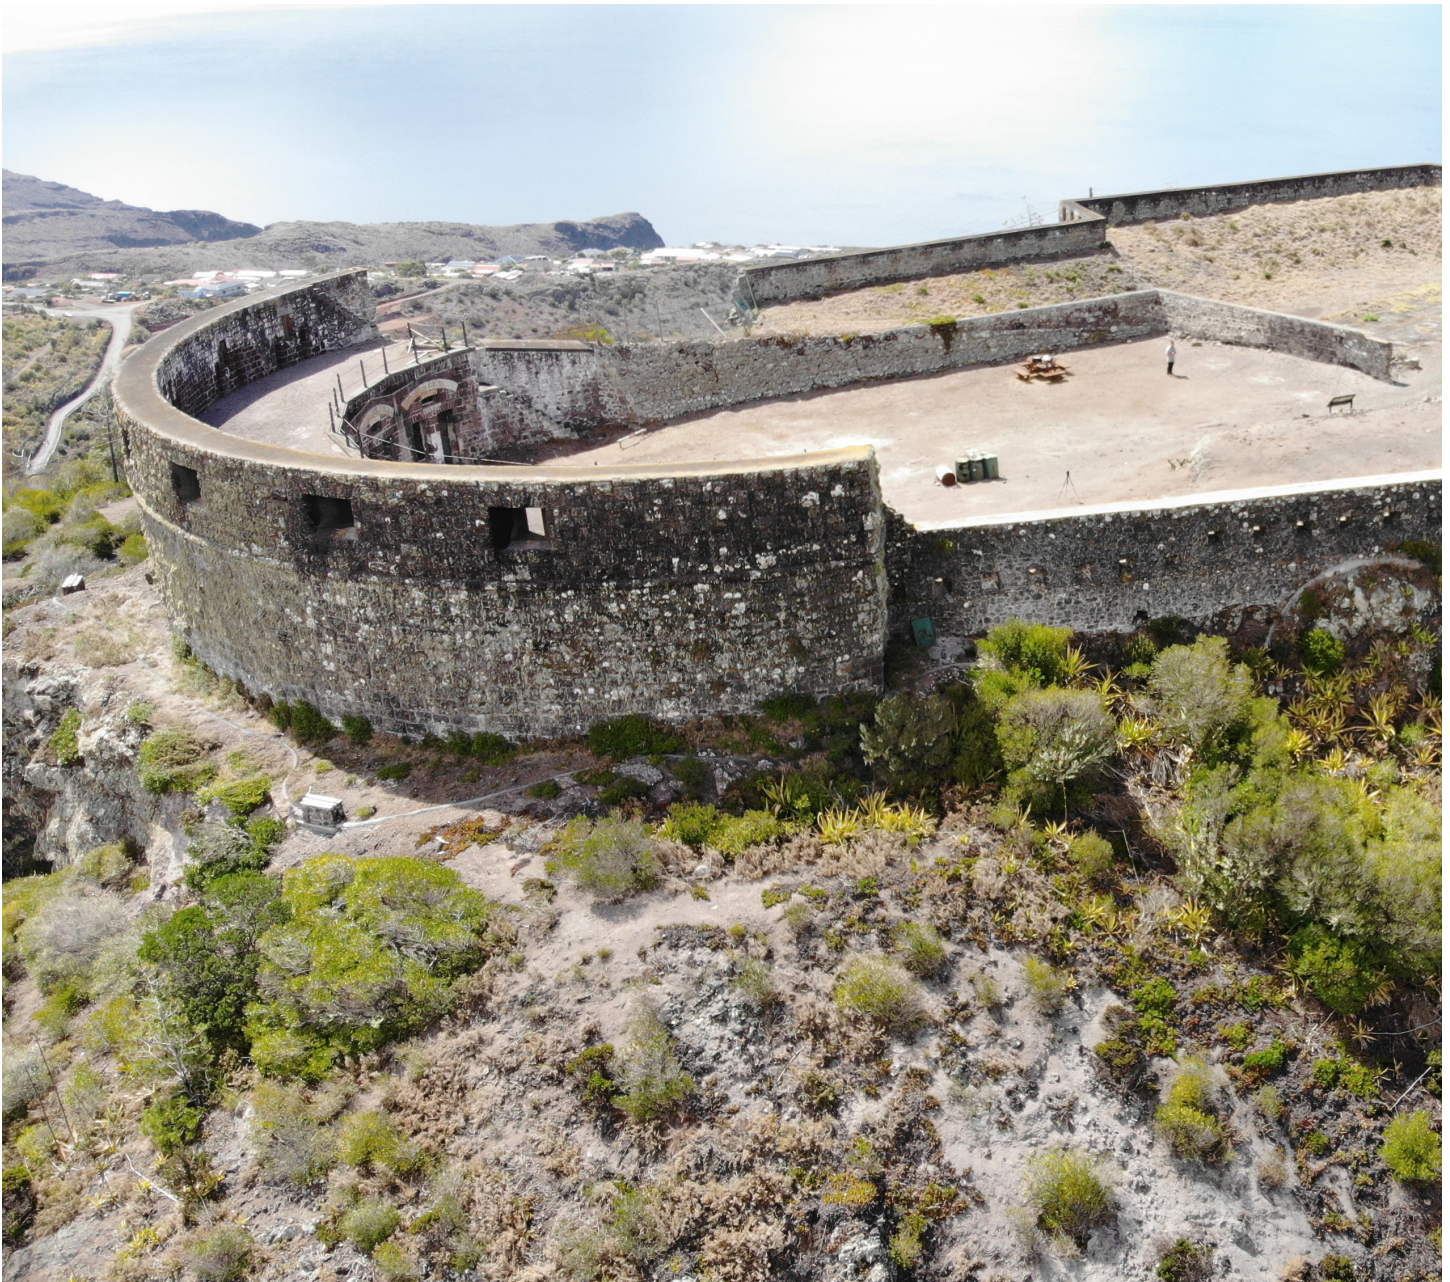
Figure 14: Oblique aerial view of southeast corner of fort (Image: B. Fortenberry).

Structural-Wall Collapse

A roughly 40-foot section of the western wall collapsed near to its junction with the southern barracks and firing platform. The cause of this collapse was likely a combination of hill erosion to the west and south as well as related deferred maintenance on the wall, for example, if large amounts of bio growth were left unchecked that could have led to the stone destabilization.

For the overall integrity of the south and west wall, this collapse, if not repaired, will cause further detriment to the standing historic fabric. Particularly along the south portion of the collapse where sections of the firing platform are now hanging in the air without support. It is only a matter of time before further wall collapse takes place.

1. The wall collapse is the most pressing condition that needs to be addressed at High Knoll Fort, and a structural engineer specializing in historic buildings should be consulted prior to any conservation work taking place. The engineer should examine the photographs, drone images, 3D models, and drawings to make preliminary determinations of the scope of rehabilitation and repair. An on-site visit is preferable for detailed inspection.

3. While the structural engineer will address the historic fabric, a geologist or environmental engineer should also be consulted to discuss how current erosion conditions contributed to the collapse and how they might be mitigated as a part of site rehabilitation. For example, could additional vegetation in the area be used to reduce soil erosion?

4. Immediate action should be taken to segregate this area from the public areas of the site. A chain-link fence is draped over the small hill to the east of the collapse that does not adequately isolate this dangerous area from visitors, still too, on the exterior of the fort complex, there is no barrier, permitting individuals potential access to hazardous areas in and around the collapse. The area needs to be marked using health and safety guidelines.

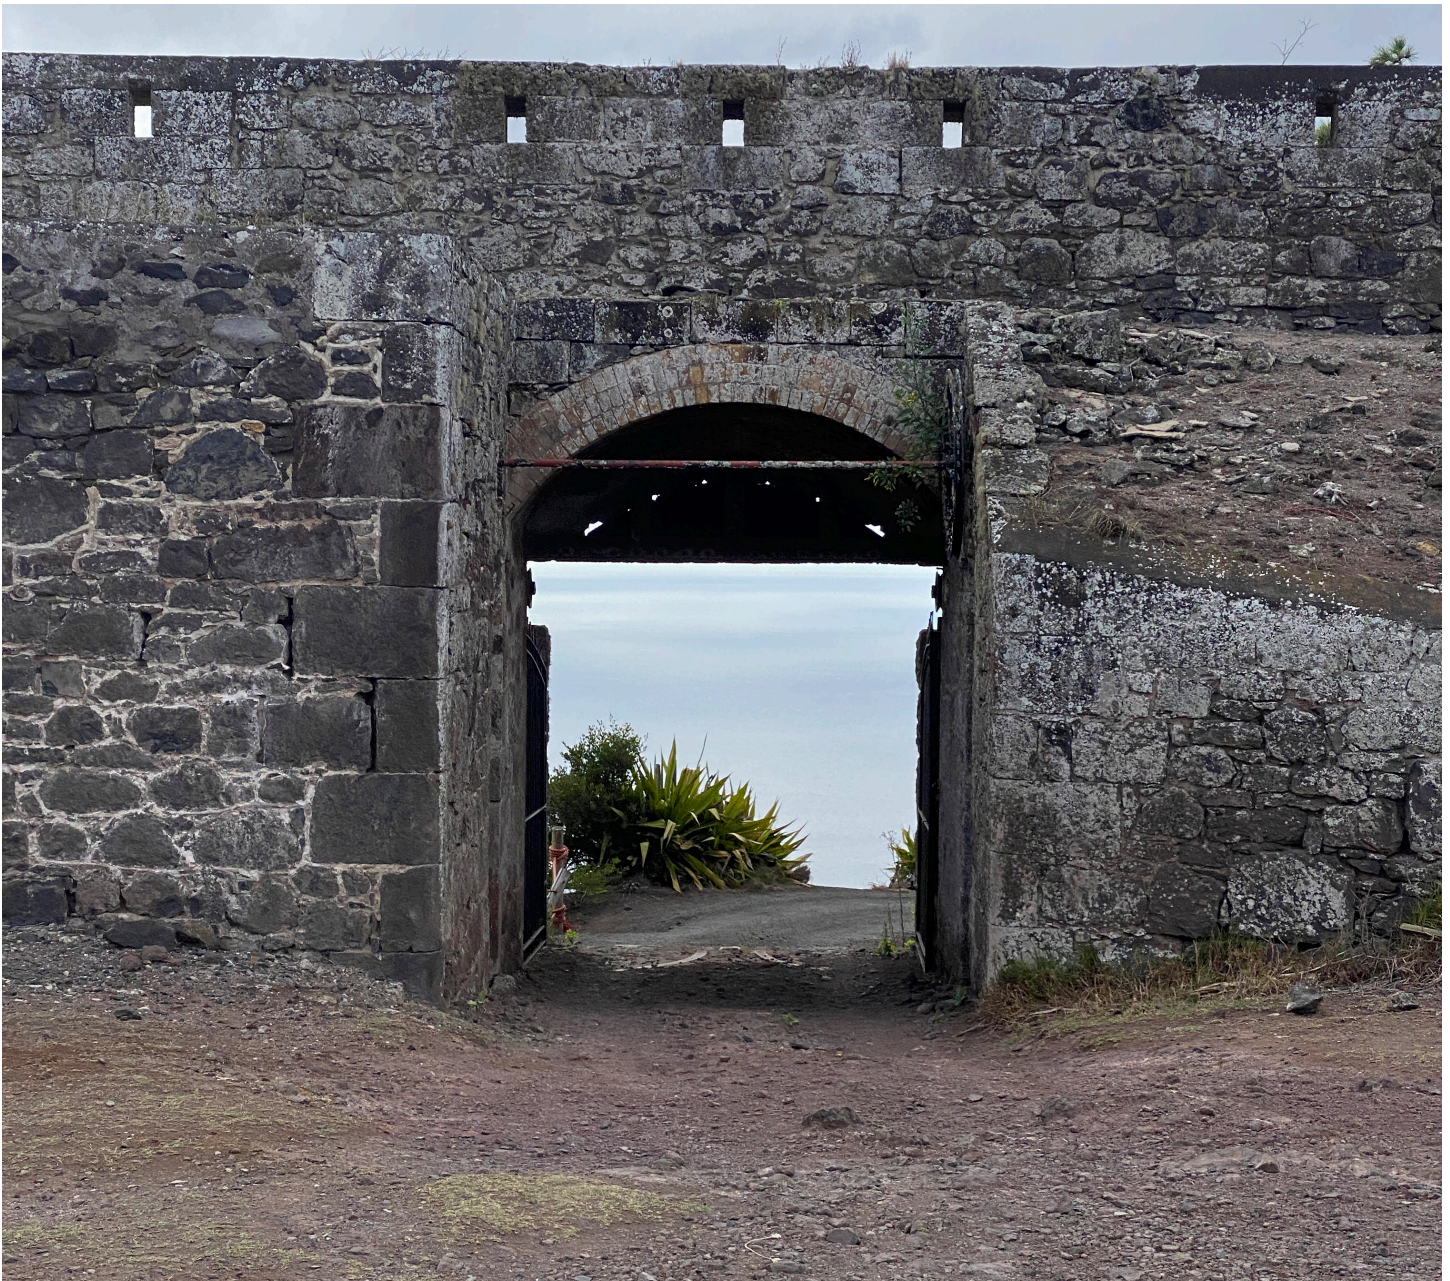
There was evidence of visitor impact, particularly in the northern complex of rooms, including the magazine and armory. Beer bottles, food wrapper waste, and other miscellaneous items suggest that individuals and groups come to the site after hours for social gatherings. While there was no evidence of negative impact on the historic fabric, their presence after dark creates liability for the site.

Health and safety signage must be updated.

Figure 64: Interior view of guard house entrance to High Knoll Fort (Image: B. Fortenberry).

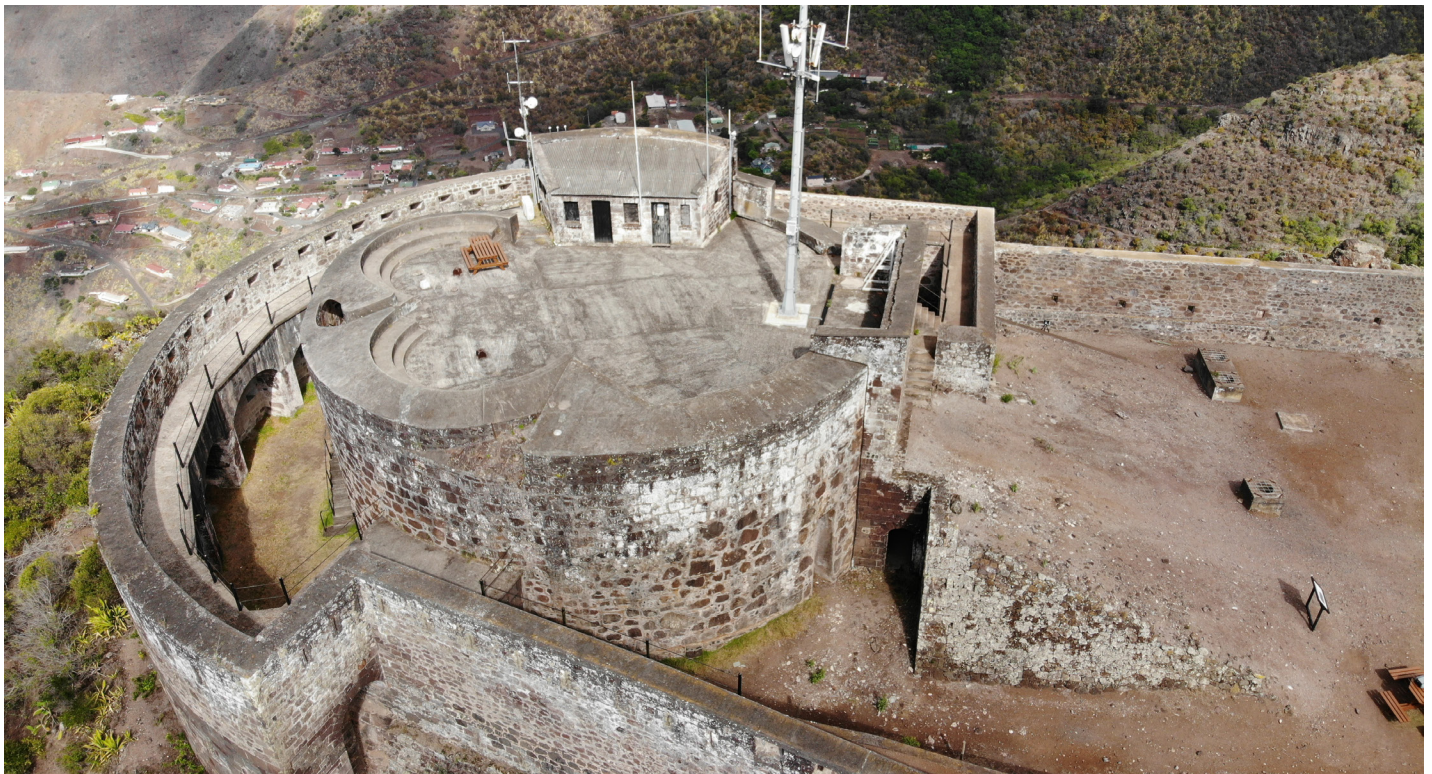
Figure 66: Picnic area on the upper surface of tower complex (Image: B. Fortenberry).
