## TURBOMACHINERY & PUMP SYMPOSIA

# Troubleshooting of Start-up for Rerated & Old Steam Turbine

# Problem Statement

During the start-up of an old steam turbine (about 30 years old), that was internally revamped, it was tripped due to high rotor vibrations.

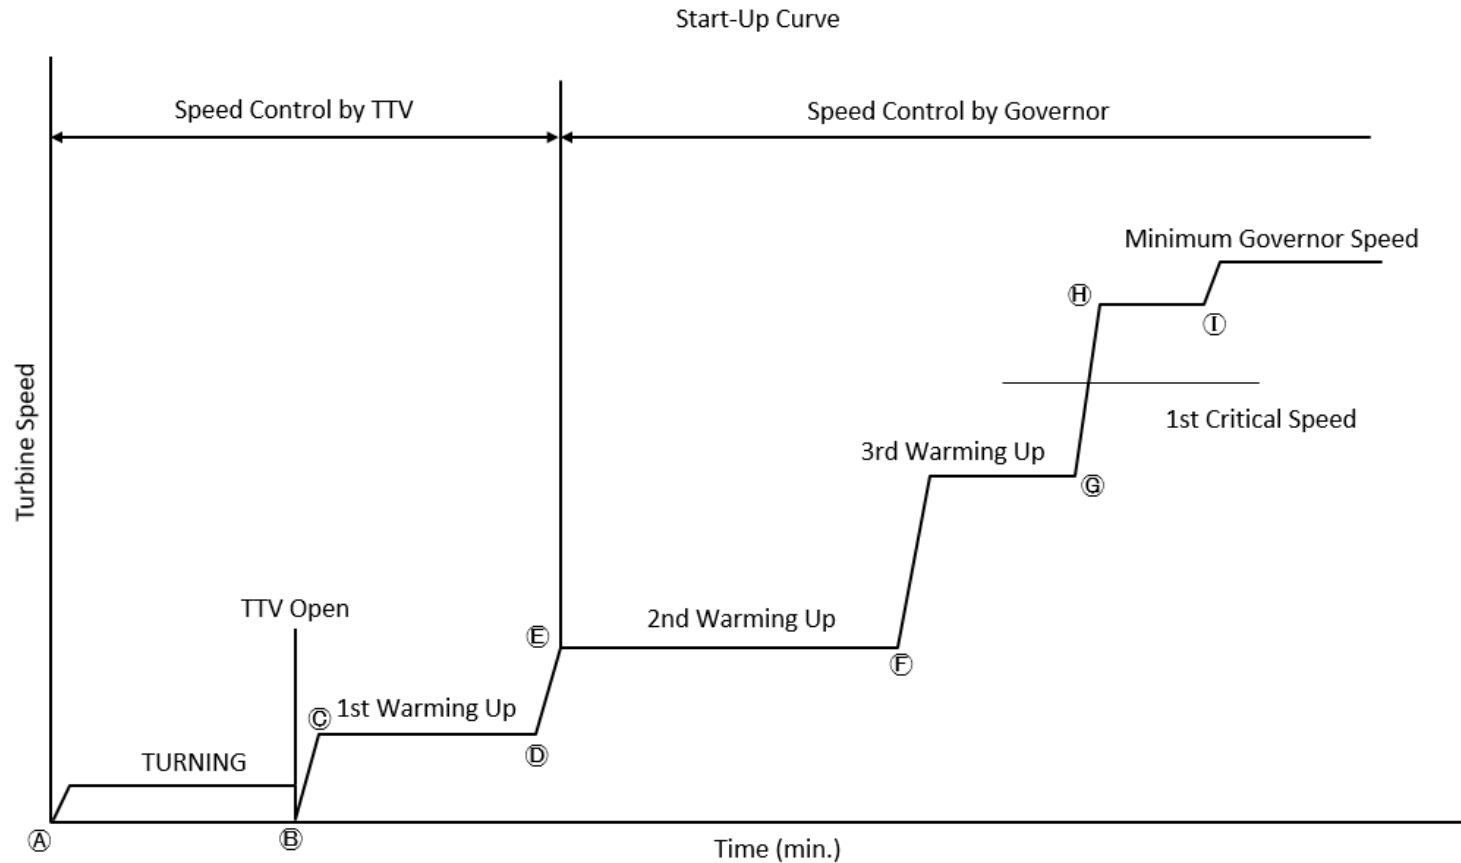
Figure-2 : Start-Up Diagram

*Upto the 1<sup>st</sup> warming-up speed, TTV speed control is applied, so that better uniform heating of turbine casing can be achieved.*

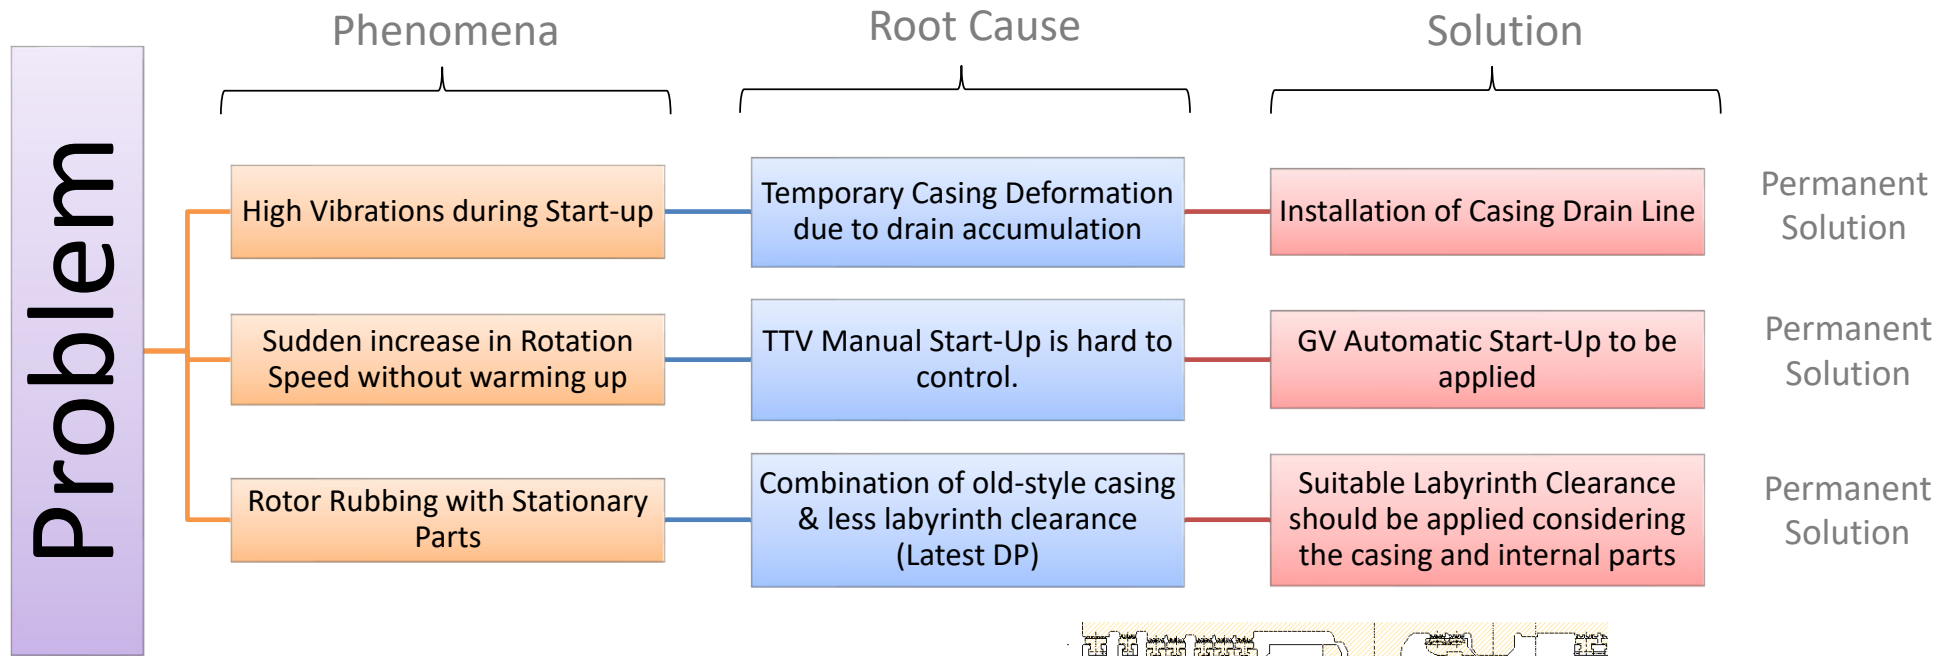
Added casing drain line is nearly low point. Casing drain line is usually installed in the lowest point and this casing drain line is used the line for casing internal pressure measurement (PG, PT) as common. In this project, the existing casing internal pressure measurement (PT) line was used as the added casing drain line.

- Casing drain line installation should be considered for the revamp of old steam turbines (Turbine age indicate if the casing drain line was installed or not).
- For turbines which are currently in operation and don't need revamp should also consider addition of casing drain line as a countermeasure for any future issues.
- Sudden change in operating conditions should be avoided to prevent any abnormal change in rotating speed.
- For deformed casing of old design style turbine start-up should be robust to prevent rotor deformation due to rubbing with stationary parts.
- If GV start-up is applied, large labyrinth clearance should be considered & customer's approval is required for performance deterioration.
- In case of internal revamp of old steam turbine, suitable labyrinth clearance should be applied.
