49TH TURBOMACHINERY & 36TH PUMP SYMPOSIA

**Multi-stage pump vibration caused
by excessive wear ring clearance,
Improper balancing, rotating stall**

Equipment Data

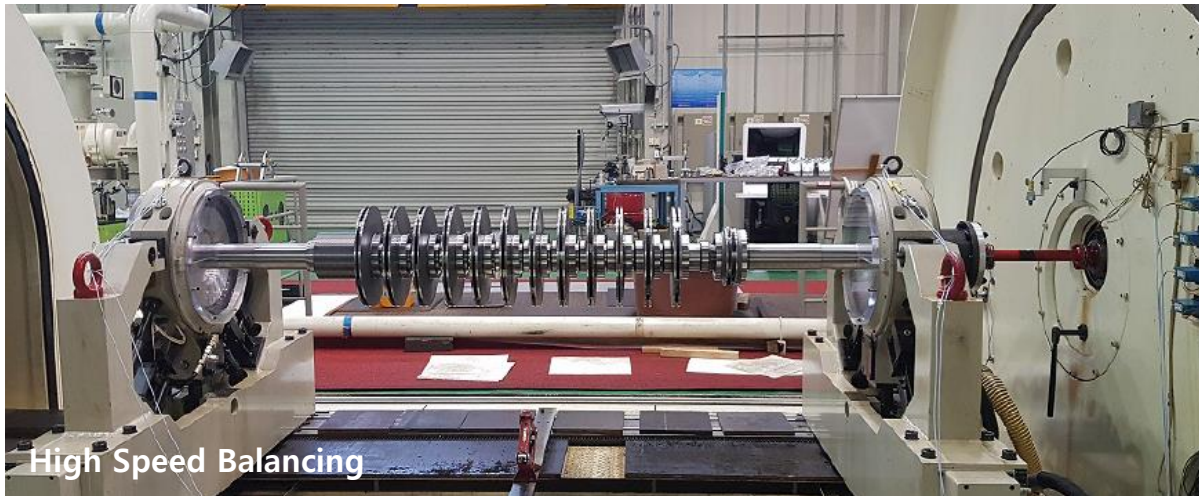
- **Pump overhauled again, DE radial vibration decreased to 12μm after repair as below.**
 - All wear rings of each impeller were replaced and clearance adjusted within design value.
 - All impellers were individually balanced before low speed assembly balancing.
 - Rotor balanced at operating speed(3,578rpm)
 - Generally, operating speed balancing is not required for pumps.
 - But, operating speed balancing conducted considering the previous high vibration issue and the slender rotor design(1st critical speed 1,837rpm)

Balancing Method	Residual Unbalance		Equivalent ISO Grade
	oz.-in	g-mm	
Before LSB	8.10	5,824	G 6.3
After LSB	0.17	122	G 0.13
After HSB	3.18	2,288	G 2.5

* LSB : Low Speed Balancing(two-plane)
 * HSB : High(Operating) Speed Balancing(multi-plane)

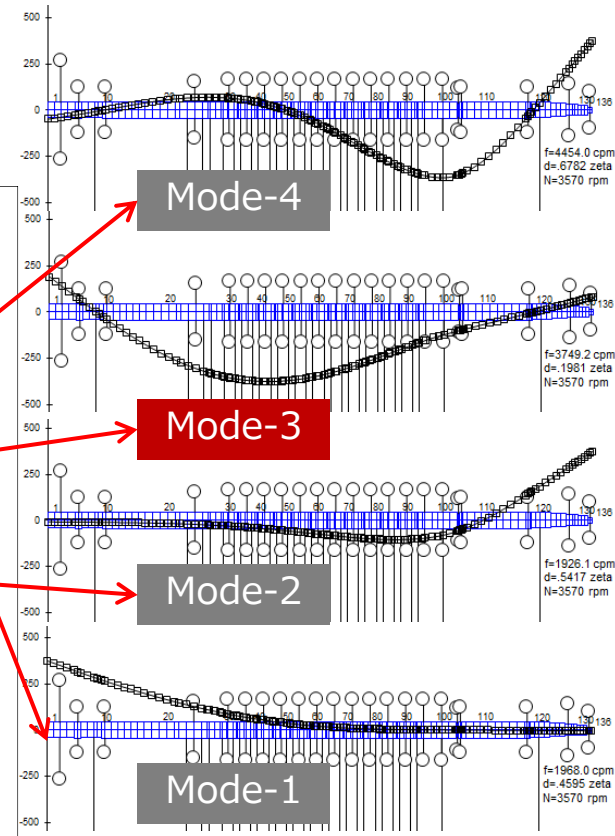
**Used Pump Condition
(Design Clearance x 2)**

- **Rotordynamic damped natural frequency map analysis(Campbell Diagram)**
 - Rotordynamic analysis conducted after repair of the pump to find out the root cause.
 - In case of impeller wear ring has excessive clearance(2x of design), the separation margin is not enough(5%) from 3rd critical speed.

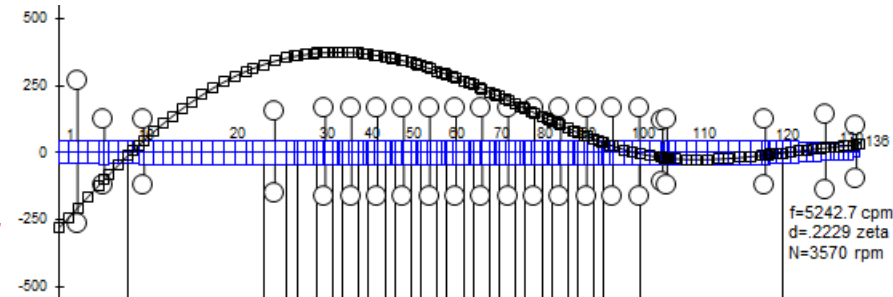
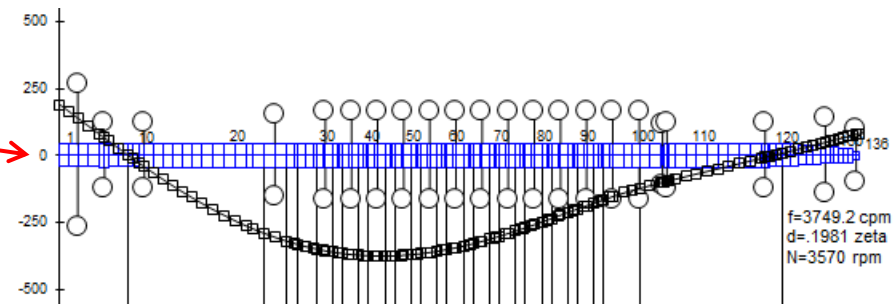
- **Damping Factor vs Frequency Ratio**

- In case of impeller wear ring has excessive clearance(2x of design), damping factor is close to the limit(0.1) of API610.

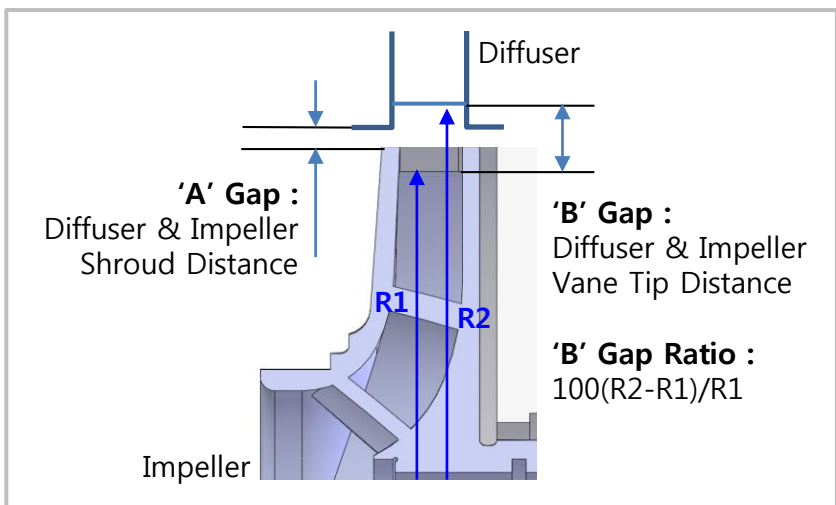
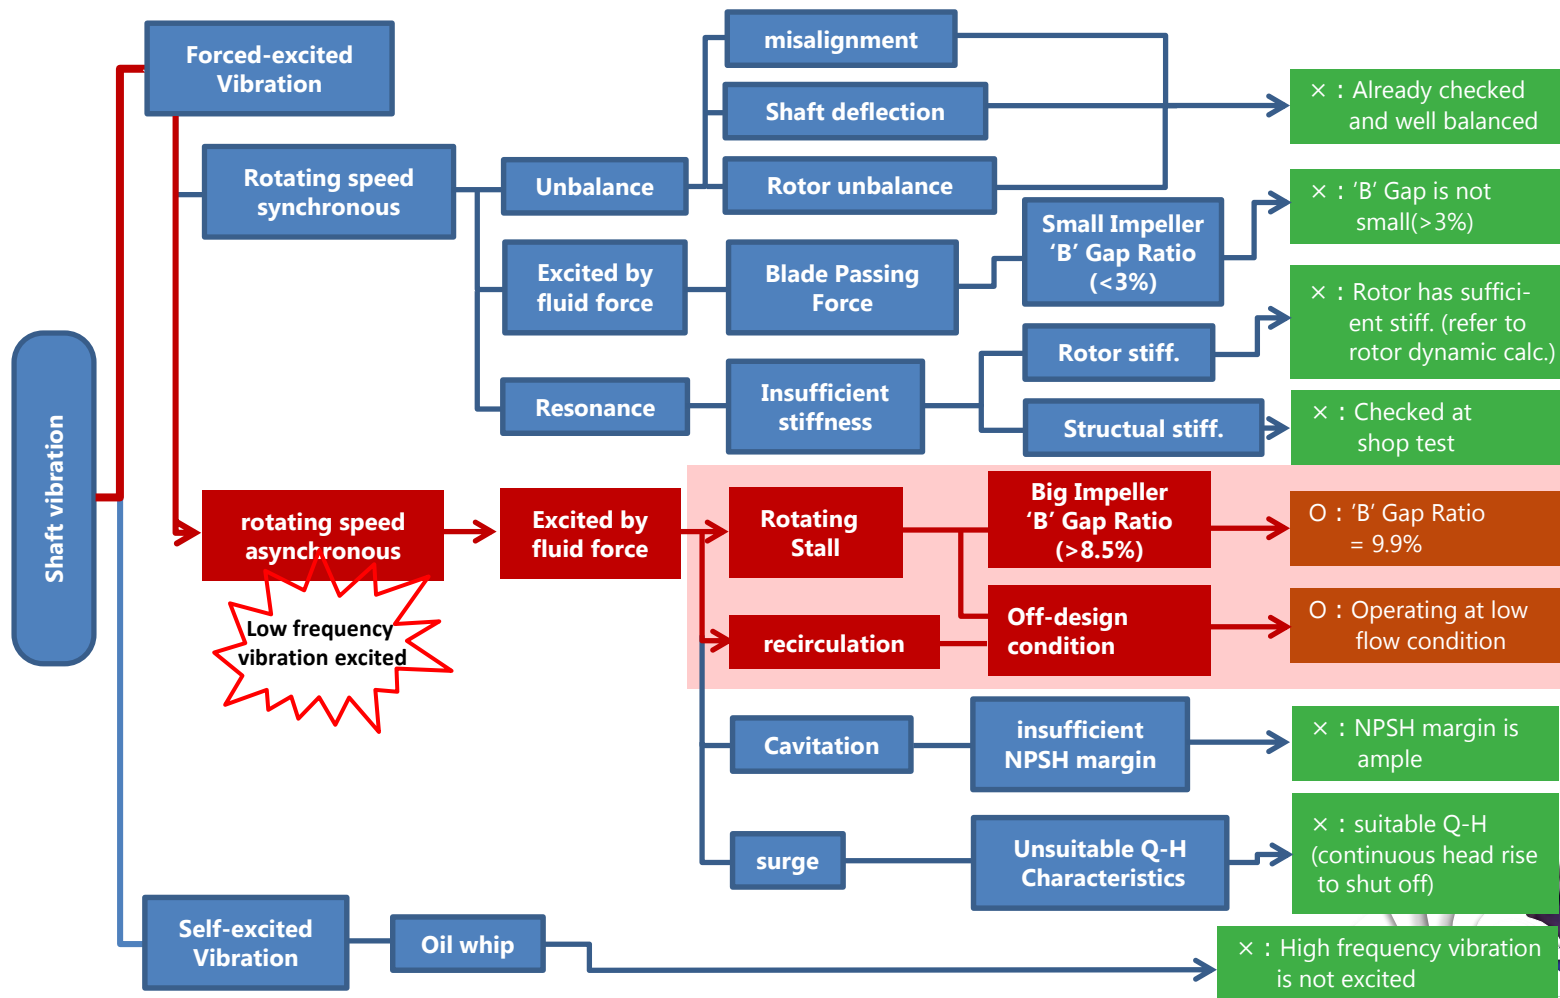
Impeller 'A', 'B' Gap Definition

- The cause of sub-synchronous vibration was rotating stall between impeller and diffuser
- Rotating stall can be generated in below cases
 - Big impeller 'B' gap
 - Low operating flow
 - Low Ns(Specific Speed), high pressure design

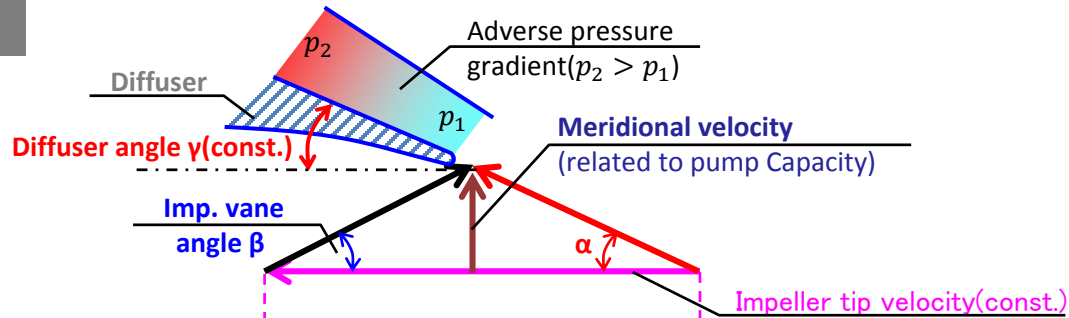
$Q = \text{BEP}$

: Flow decrease \rightarrow Meridional velocity decrease \rightarrow Flow angle deviation from designed diffuser angle (this happens easily with big impeller 'B' gap) \rightarrow Stall generation, then stall cell moves to subsequent diffuser and rotates (stall rotating frequency $< 10\%$ of rpm)

Rotating stall by low flow

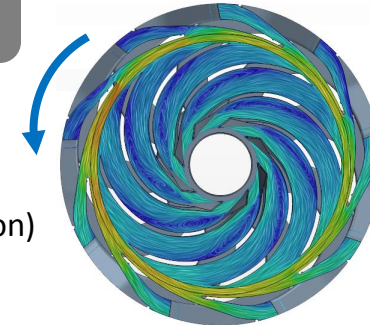
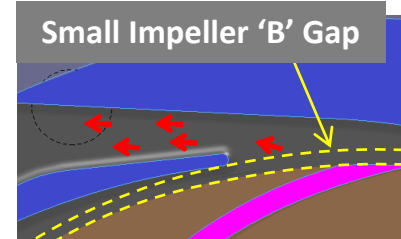
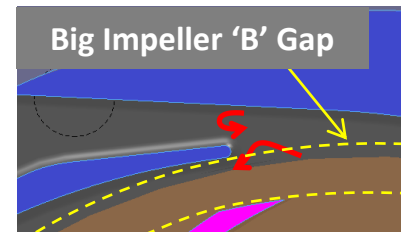
Rotating stall by big impeller 'B' gap

Rotating stall Direction
(Same as rotor rotating direction)

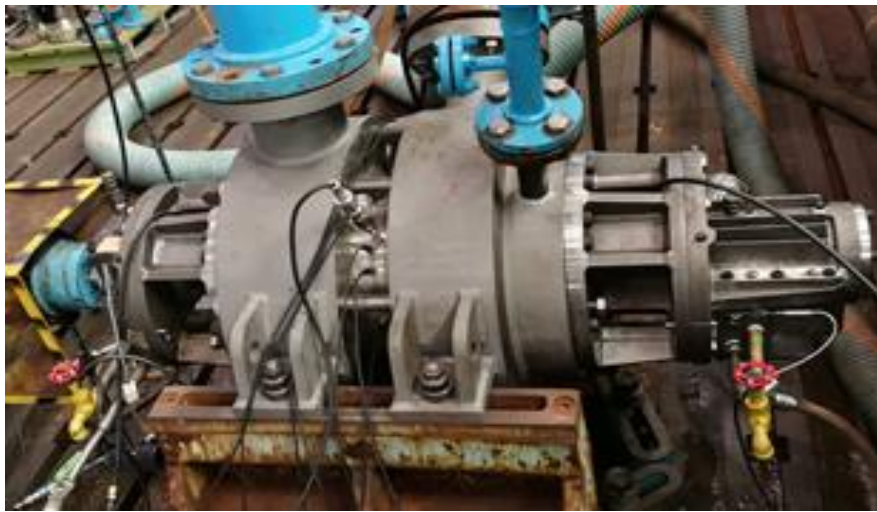
Vendor Shop Test Pump

- Test Pump : Two Stage, Diffuser type, Ns(US Unit) 4,902(\approx 95 in SI Unit)
- Manufacturer conducted test with available high pressure pump to figure out how impeller 'B' gap affect the vibration
- Vibration was measured in below condition
 - Impeller 'B' gap Ratio : 2.5%, 5.3%, 12%
 - Pump Flow : 20~130% of design capacity

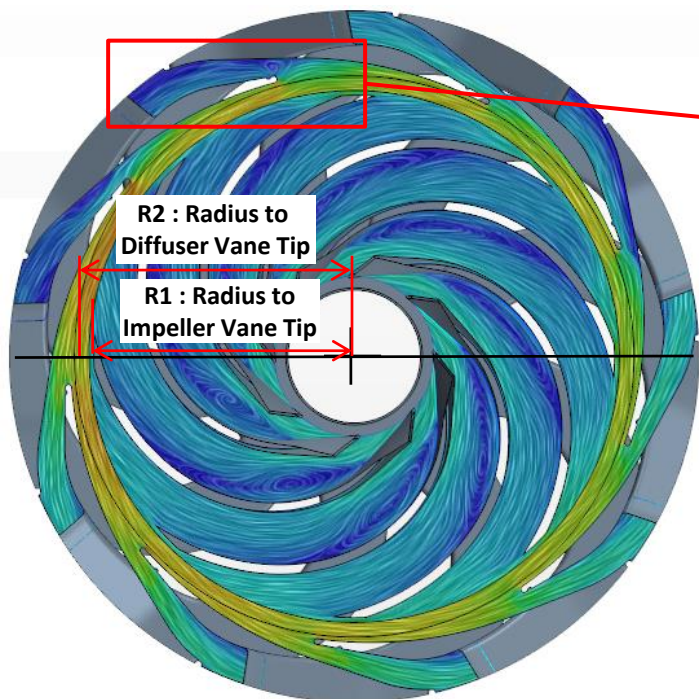
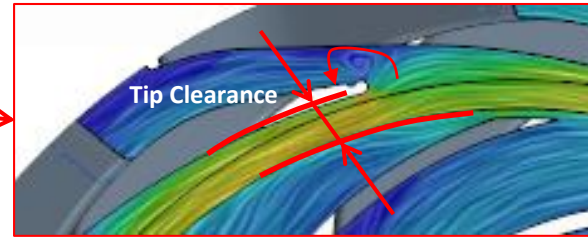
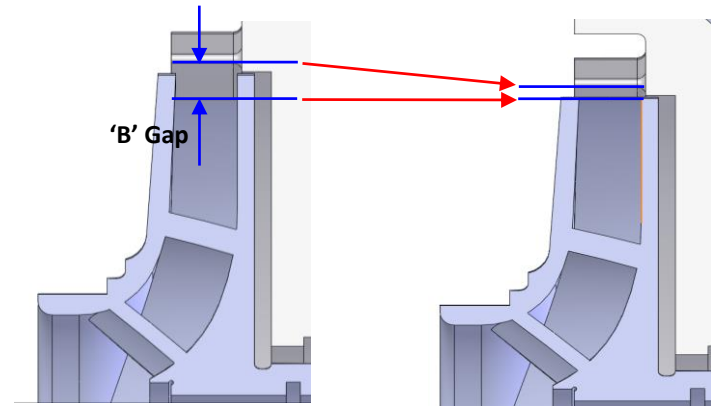
Diffuser Rotating Stall

- Pump manufacturer verified this rotating stall phenomena based on CFD and shop test.
- Rotating stall can be generated with the combination of below conditions

Rotating Stall Condition(Manufacturer's Analysis)		Issued Field Pump	Countermeasure	Field Improvement
High pressure design	Specific Speed(Ns) $\leq 5,160$ (100 in SI Unit)	5,160 (100 in SI Unit)	N/A	N/A
Low Flow	Operating Flow < 50~60%	57%	Higher Flow	Accepted
Large Impeller 'B' Gap Ratio	'B' Gap Ratio $[100(R2-R1)/R1] > 8.5\%$	9.9%	Smaller 'B' gap	Not accepted due to high cost

- Fluid: Water
- Inlet Pressure : 0 bar
- Speed : 3570rpm
- Solution : Simcenter Star CCM+
- Turbulence model : Realizable k-ε

New diffuser required to reduce 'B' gap → High Cost

Caution(API610 11th 6.1.15)
 Minimum 'B' Gap Ratio is required to prevent vane passing frequency vibration
 : 3% for diffuser type, 6% for volute type
