HIGH SPEED PUMP: MECHANICAL SEAL BAD ACTOR RESOLUTION

ABSTRACT

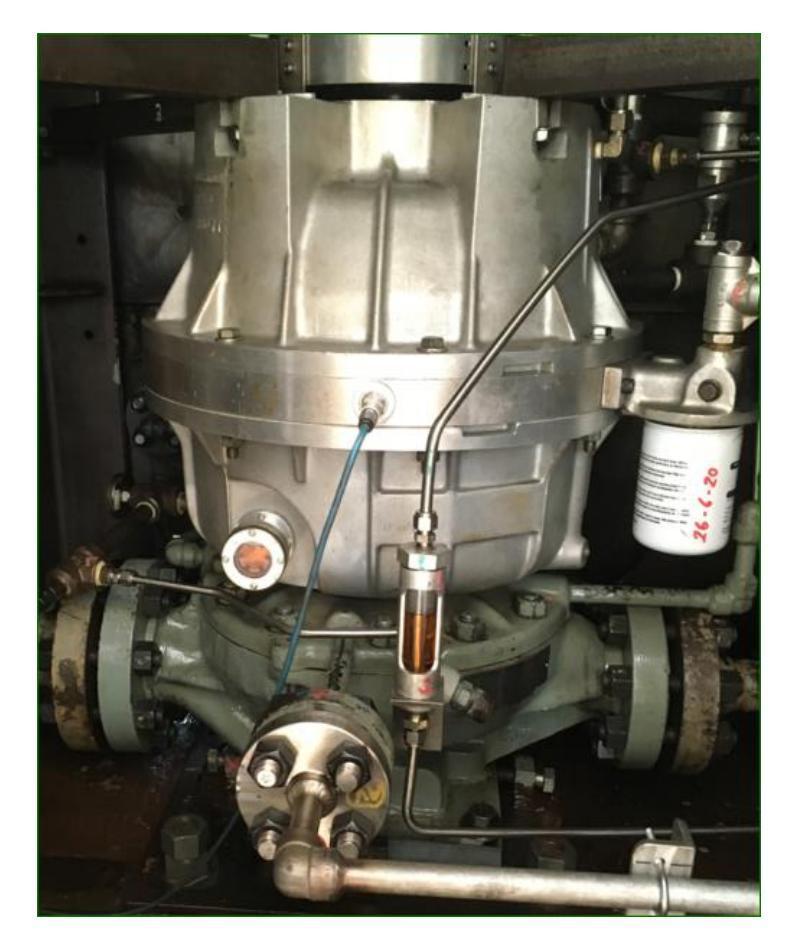
Figure: Pump at site

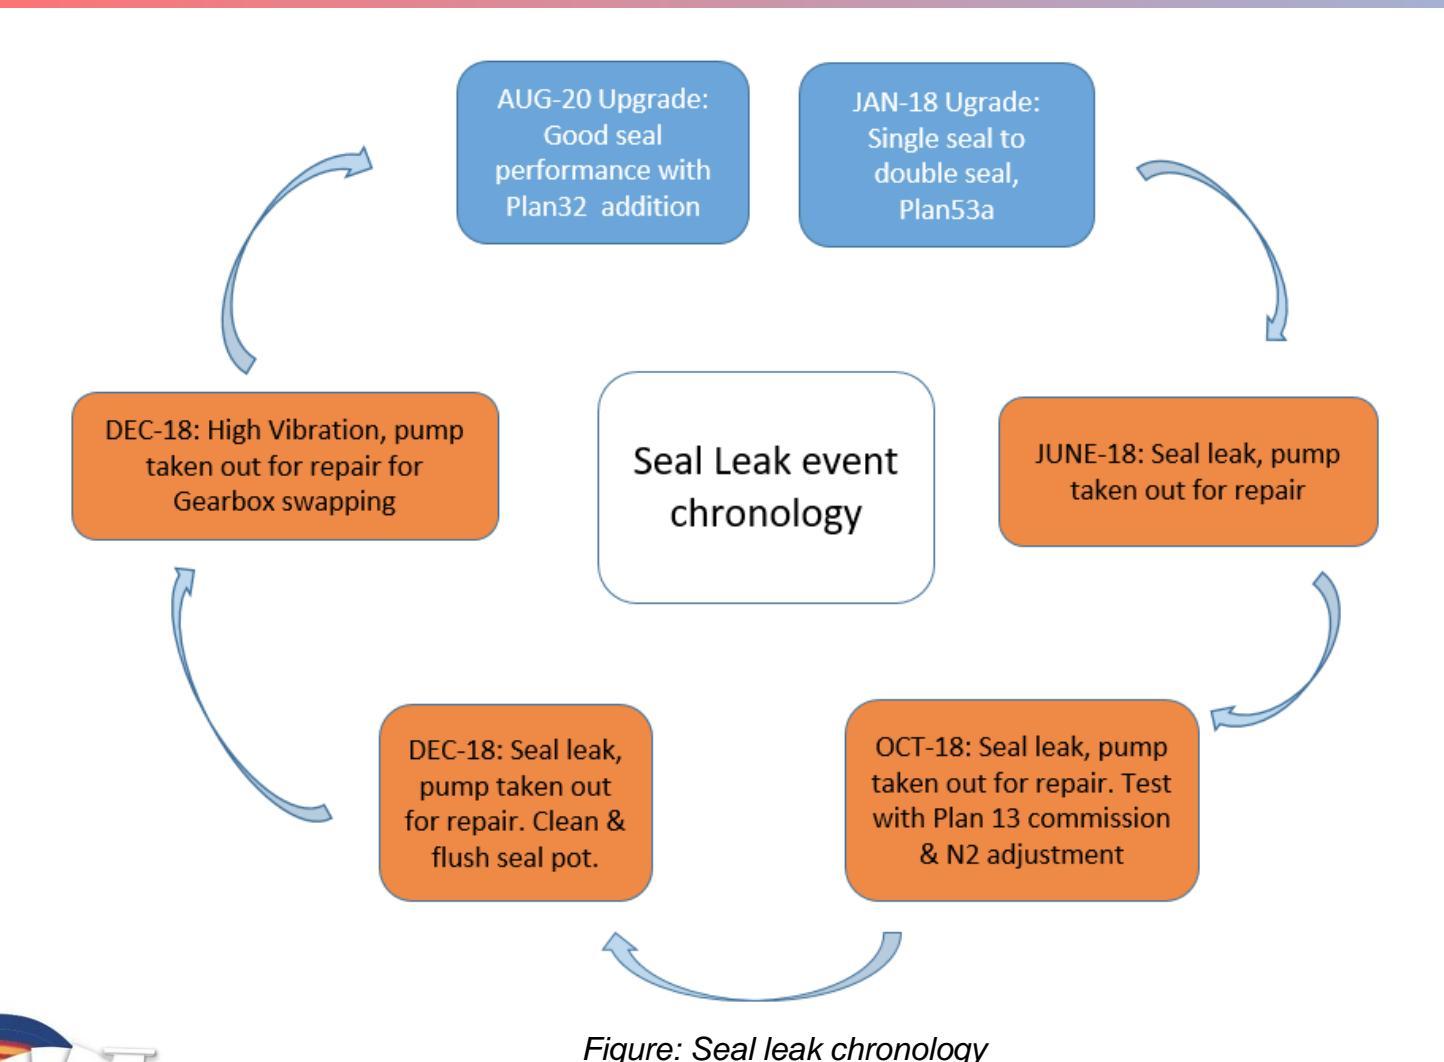
Findings during failure:

- Average life of 0.5 years
- Commission Plan13 and adjusting N2 pressure (not helping much)
- Product reversal to seal pot
