ASIA TURBOMACHINERY & PUMP SYMPOSIUM

SILO EXHAUST FAN – STRUCTURAL VIBRATION ODS AND MA

Kogan Creek Power Station

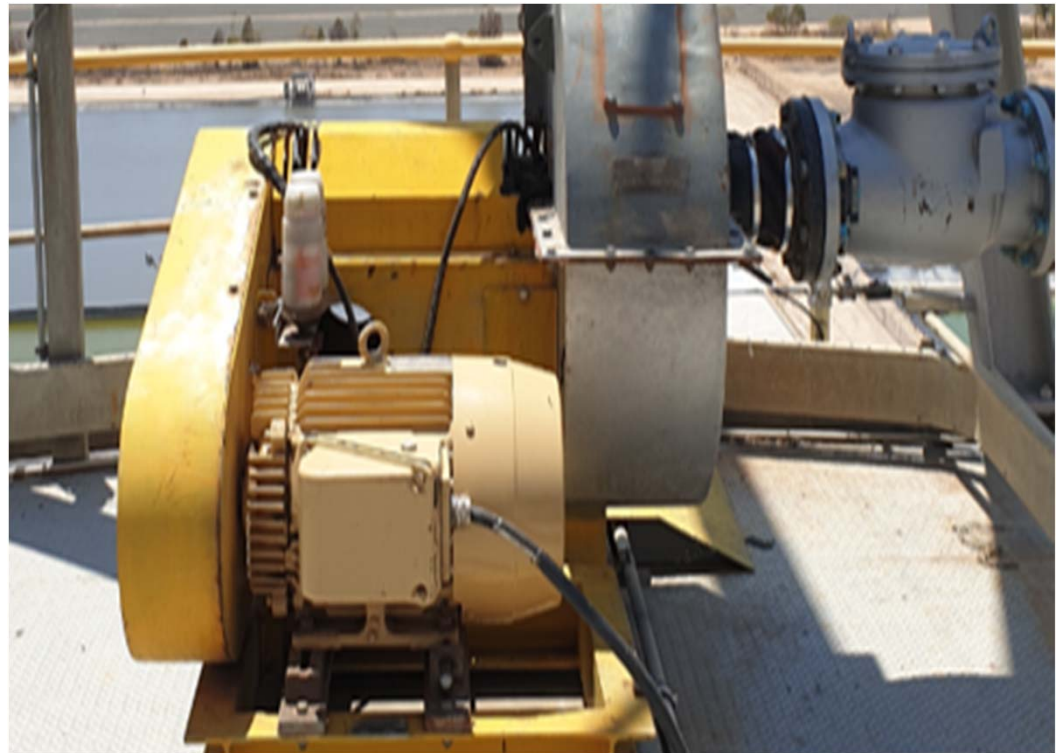
Highly critical belt driven vacuum fan unit on an ash silo to prevent dust leakage to atmosphere

50% loss of production in case of failure

Motor Speed: 2640 RPM

Fan Speed : 2940 RPM
