DIAGNOSIS OF SCREW PUMP FLOW INSTABILITY FROM CASING VIBRATION – A HOLISTIC MACHINERY DIAGNOSTIC APPROACH.

ABSTRACT

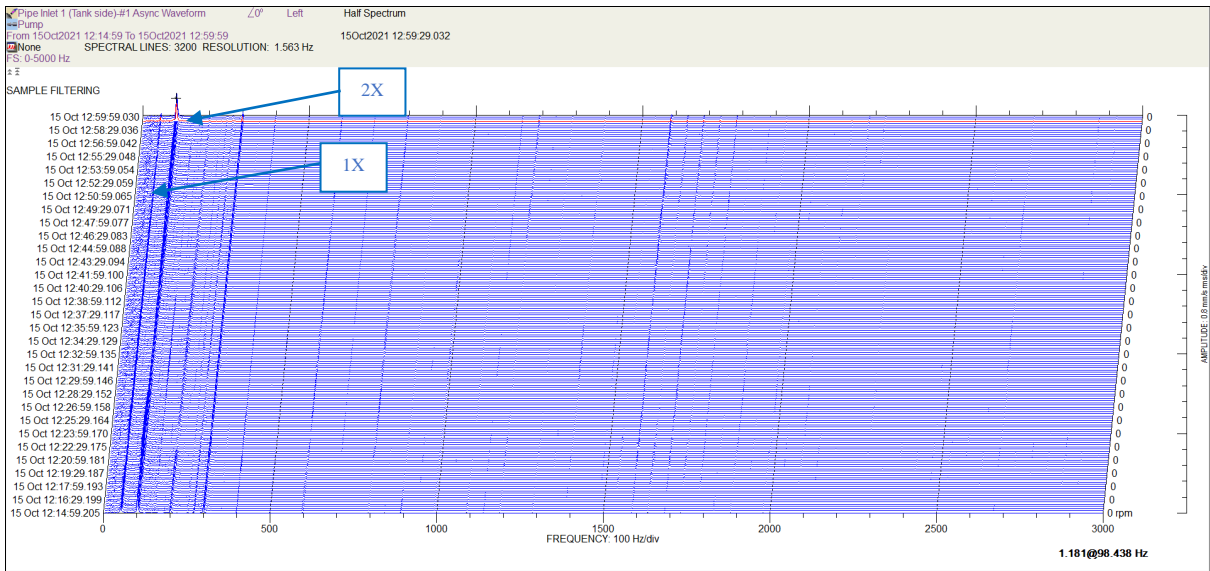
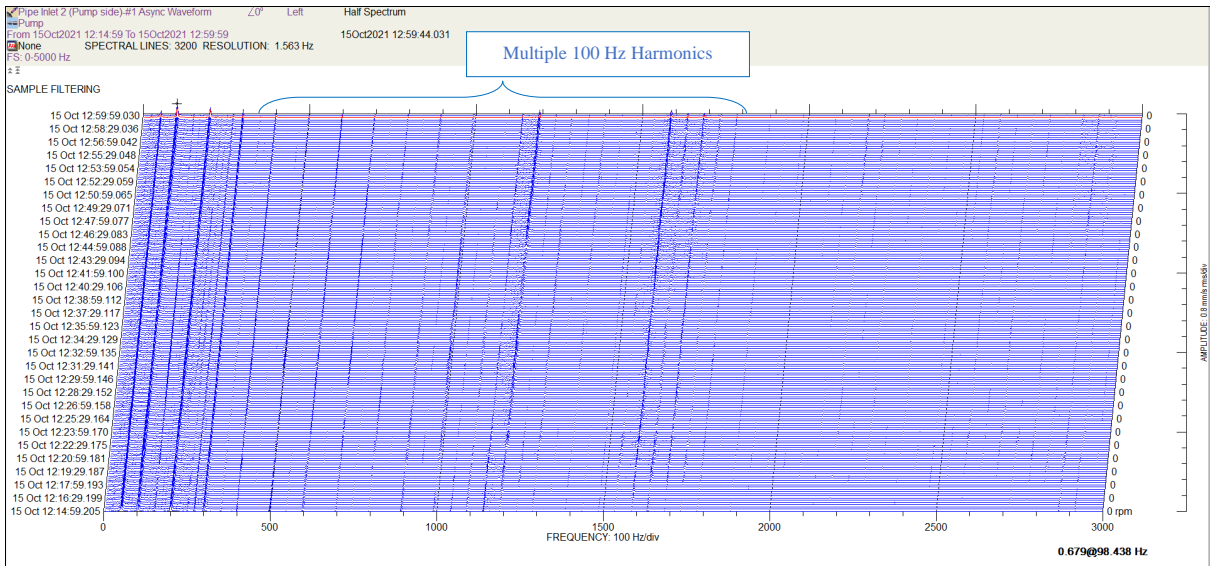
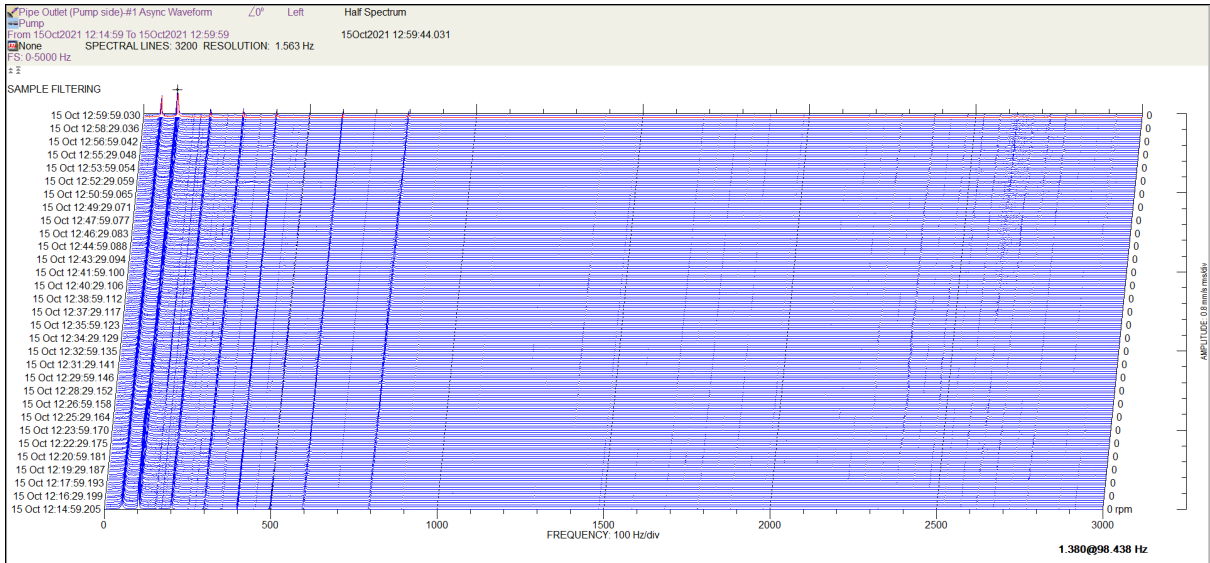
During the test run of LO Pump A, the intermittent low-frequency impulse type noise previously reported was observed. These coincided with low-level spikes in the vibration data (Figure 16). These events were most notable at the Pump NDE axial position then Pump NDE radial positions, and with very low magnitudes in the pipework (Figure 17). At this time, the LO filter DP was reading 0.80 bar on the gauge at the machine skid. Overall, the frequency components for LO PUMP A were comprised of 1X (50 Hz) and harmonics of 1X, with the 2X (100 Hz) the slightly dominant component (Figure 18 to Figure 20). The impulse events were seen to cause very slight increases across multiple harmonics (Figure 21).

Figure 18: LO Pump A, Pipe Inlet 1 (Tank side), Asynchronous Half Spectrum Waterfall, 15th October 2021 12:15 to 13:00.

Figure 19: LO Pump A, Pipe Inlet 2 (Pump side), Asynchronous Half Spectrum Waterfall, 15th October 2021 12:15 to 13:00.

Figure 20: LO Pump A, Pipe Outlet (Pump side), Asynchronous Half Spectrum Waterfall, 15th October 2021 12:15 to 13:00.

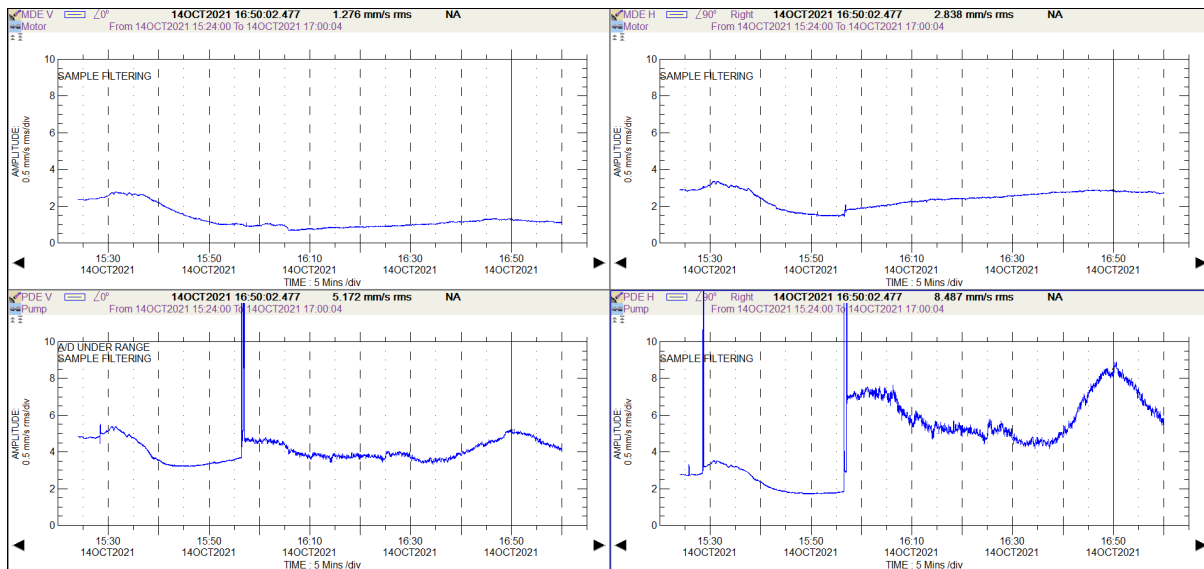
During the test run of LO Pump B, the consistent noise previously reported was observed. Twelve minutes after TEC reaching steady state operation at 11300 rpm the noise developed, increased, and then remained until shutdown at 17:14. This correlated with an increase in vibration measured across the motor DE axial and pipework transducers (Figure 22). After correction of pump measurement locations, similar behavior was observed (Figure 23). Examination of the spectral data showed increased activity in 1X and harmonics of 2X across the pump DE (Figure 24 and Figure 25). These were also detected in the pipework (Figure 26 to Figure 28 and Motor axial spectrums (Figure 29). The behavior measured at LO Pump B indicated an issue with the flow through the pump.

Figure 23: LO Pump B, Motor DE vs. Pump DE, Vertical & Horizontal, Direct Velocity Trends, 14th October 2021. Note spike at 15:56 occurred due to transducer location adjustment.

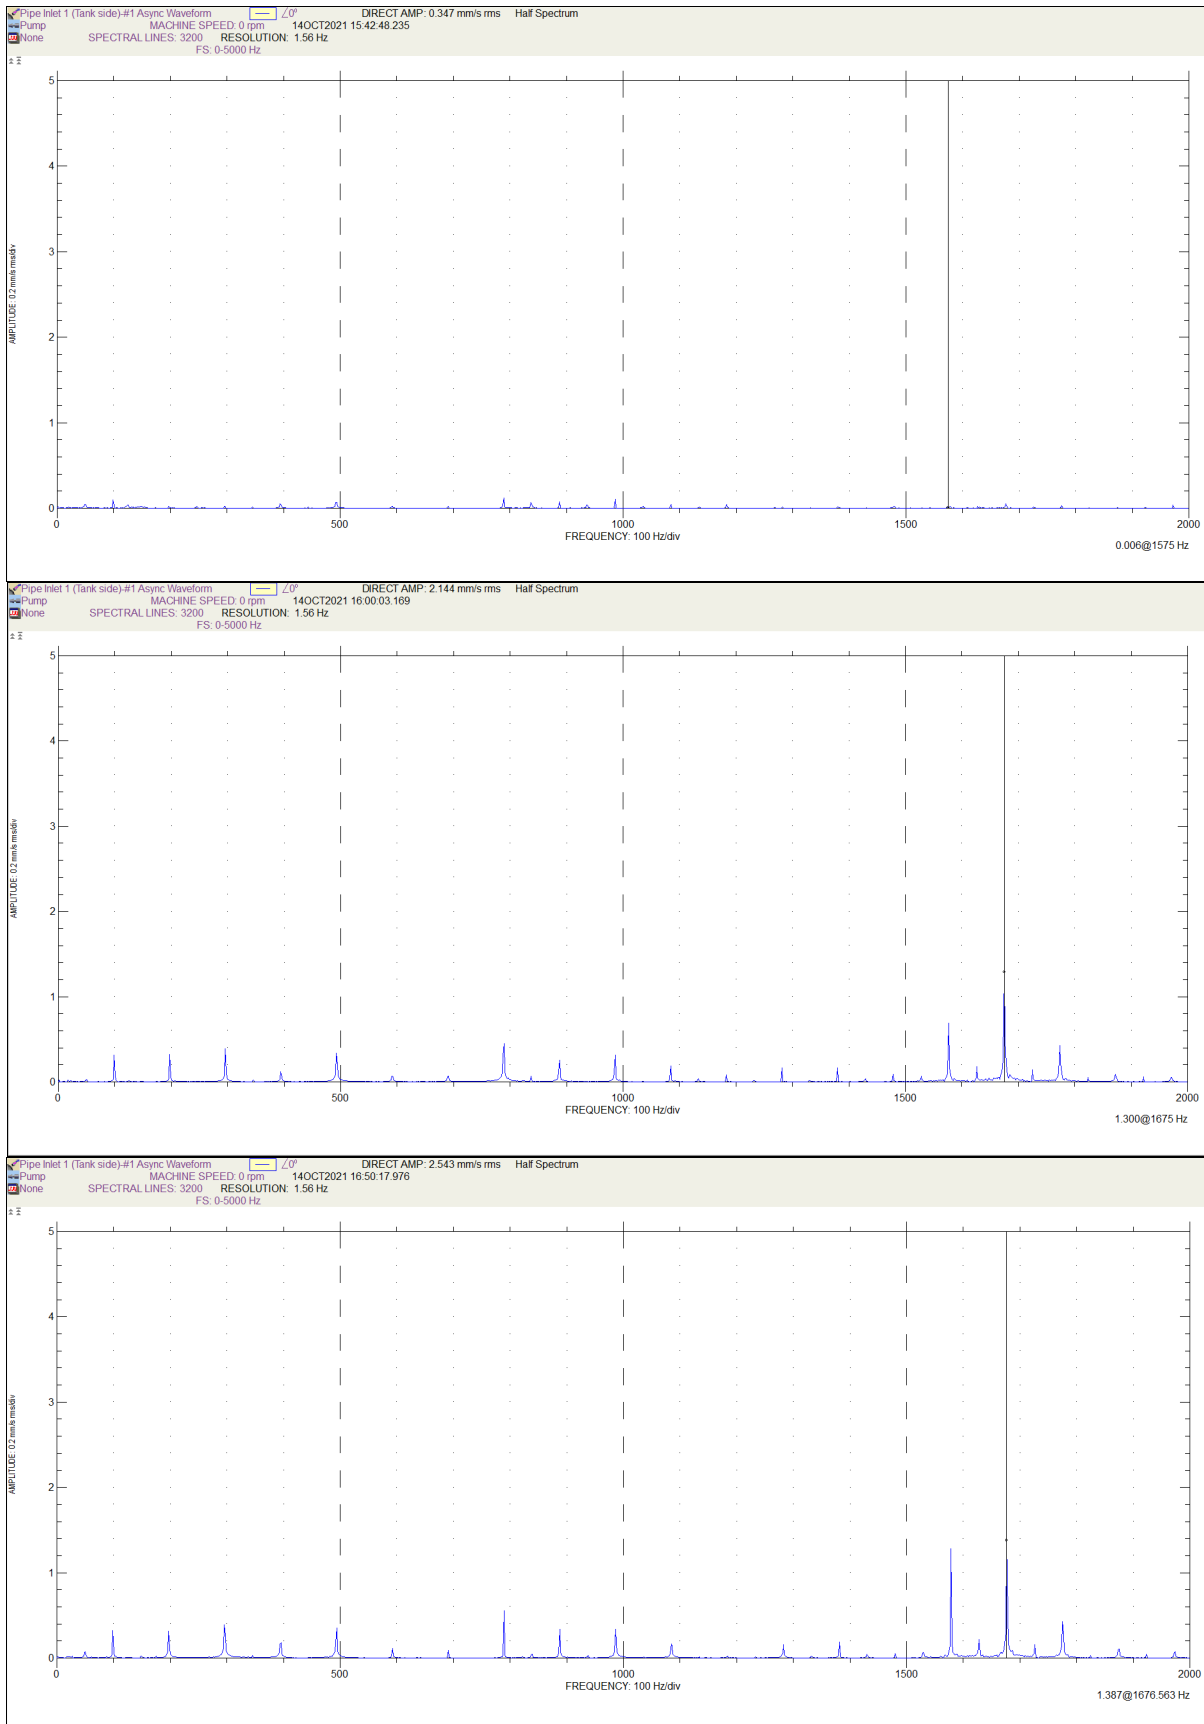
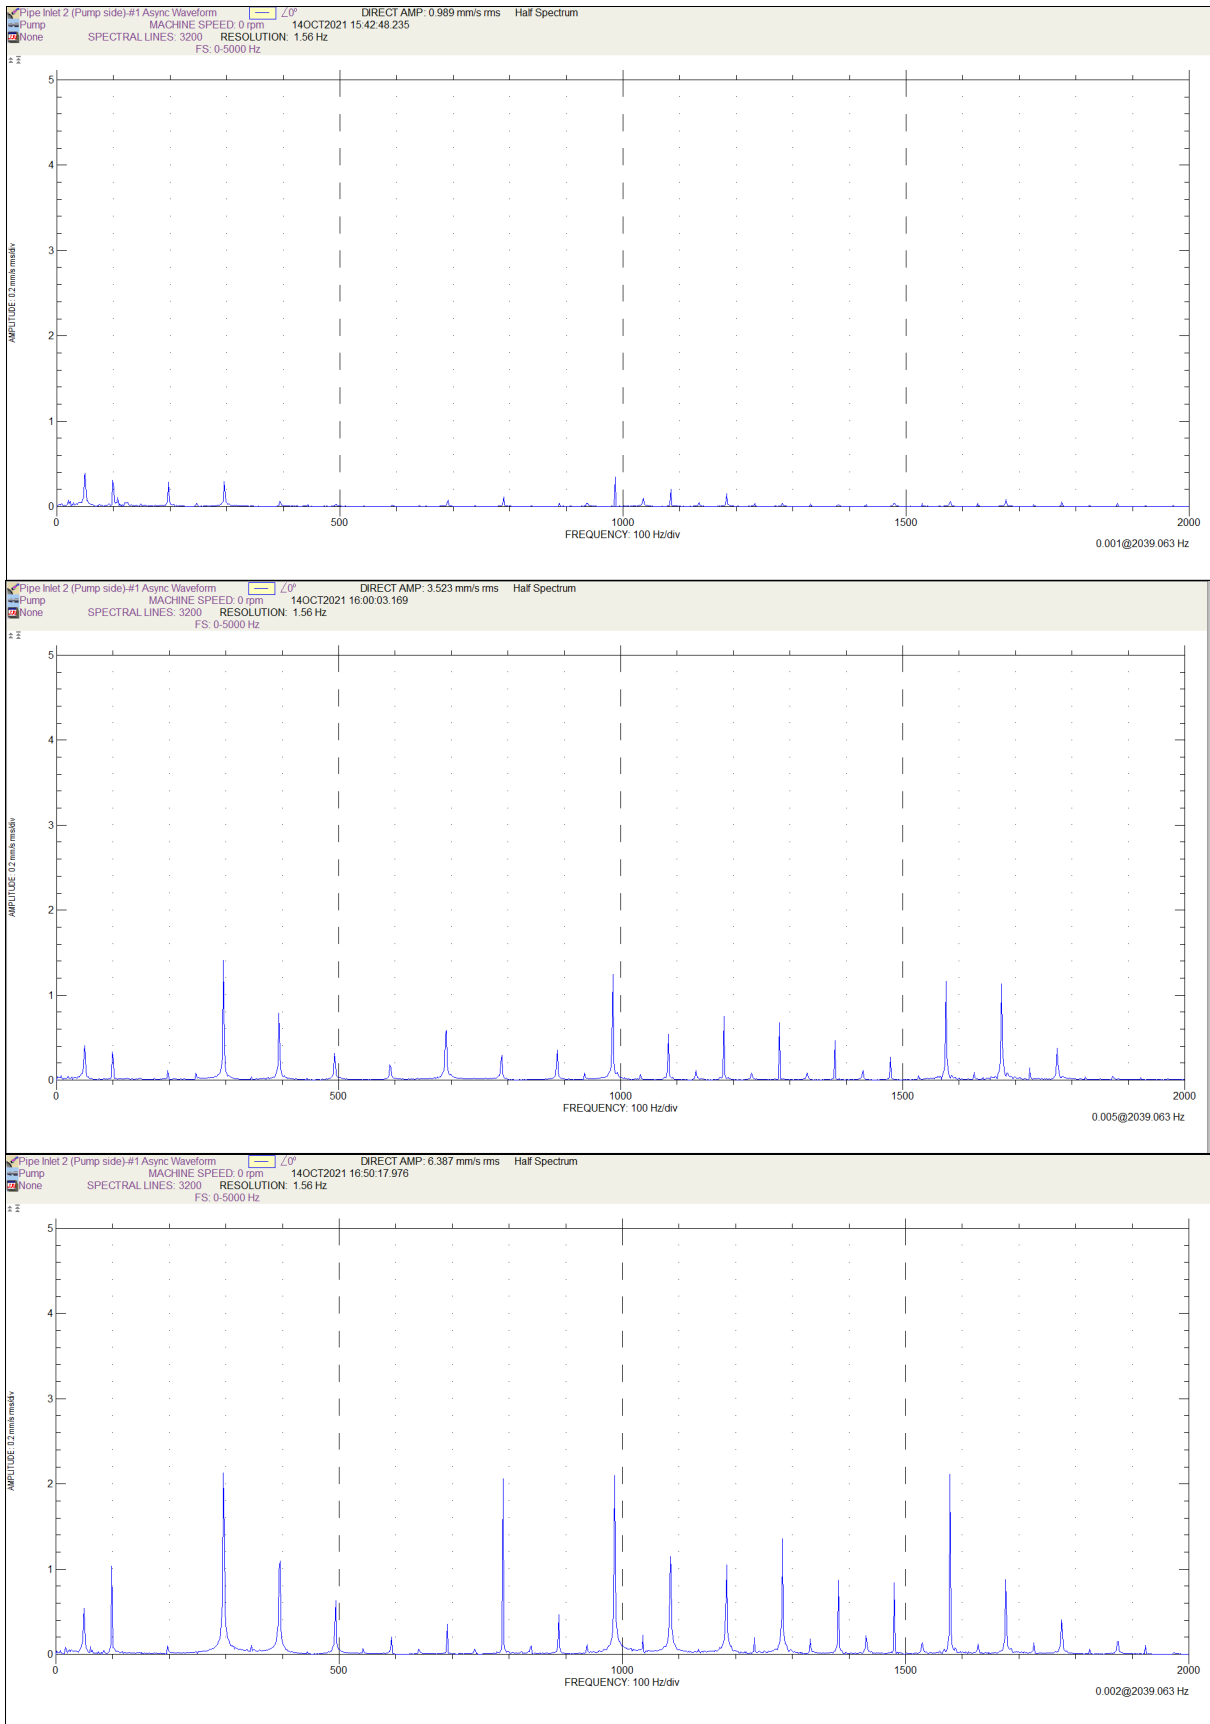
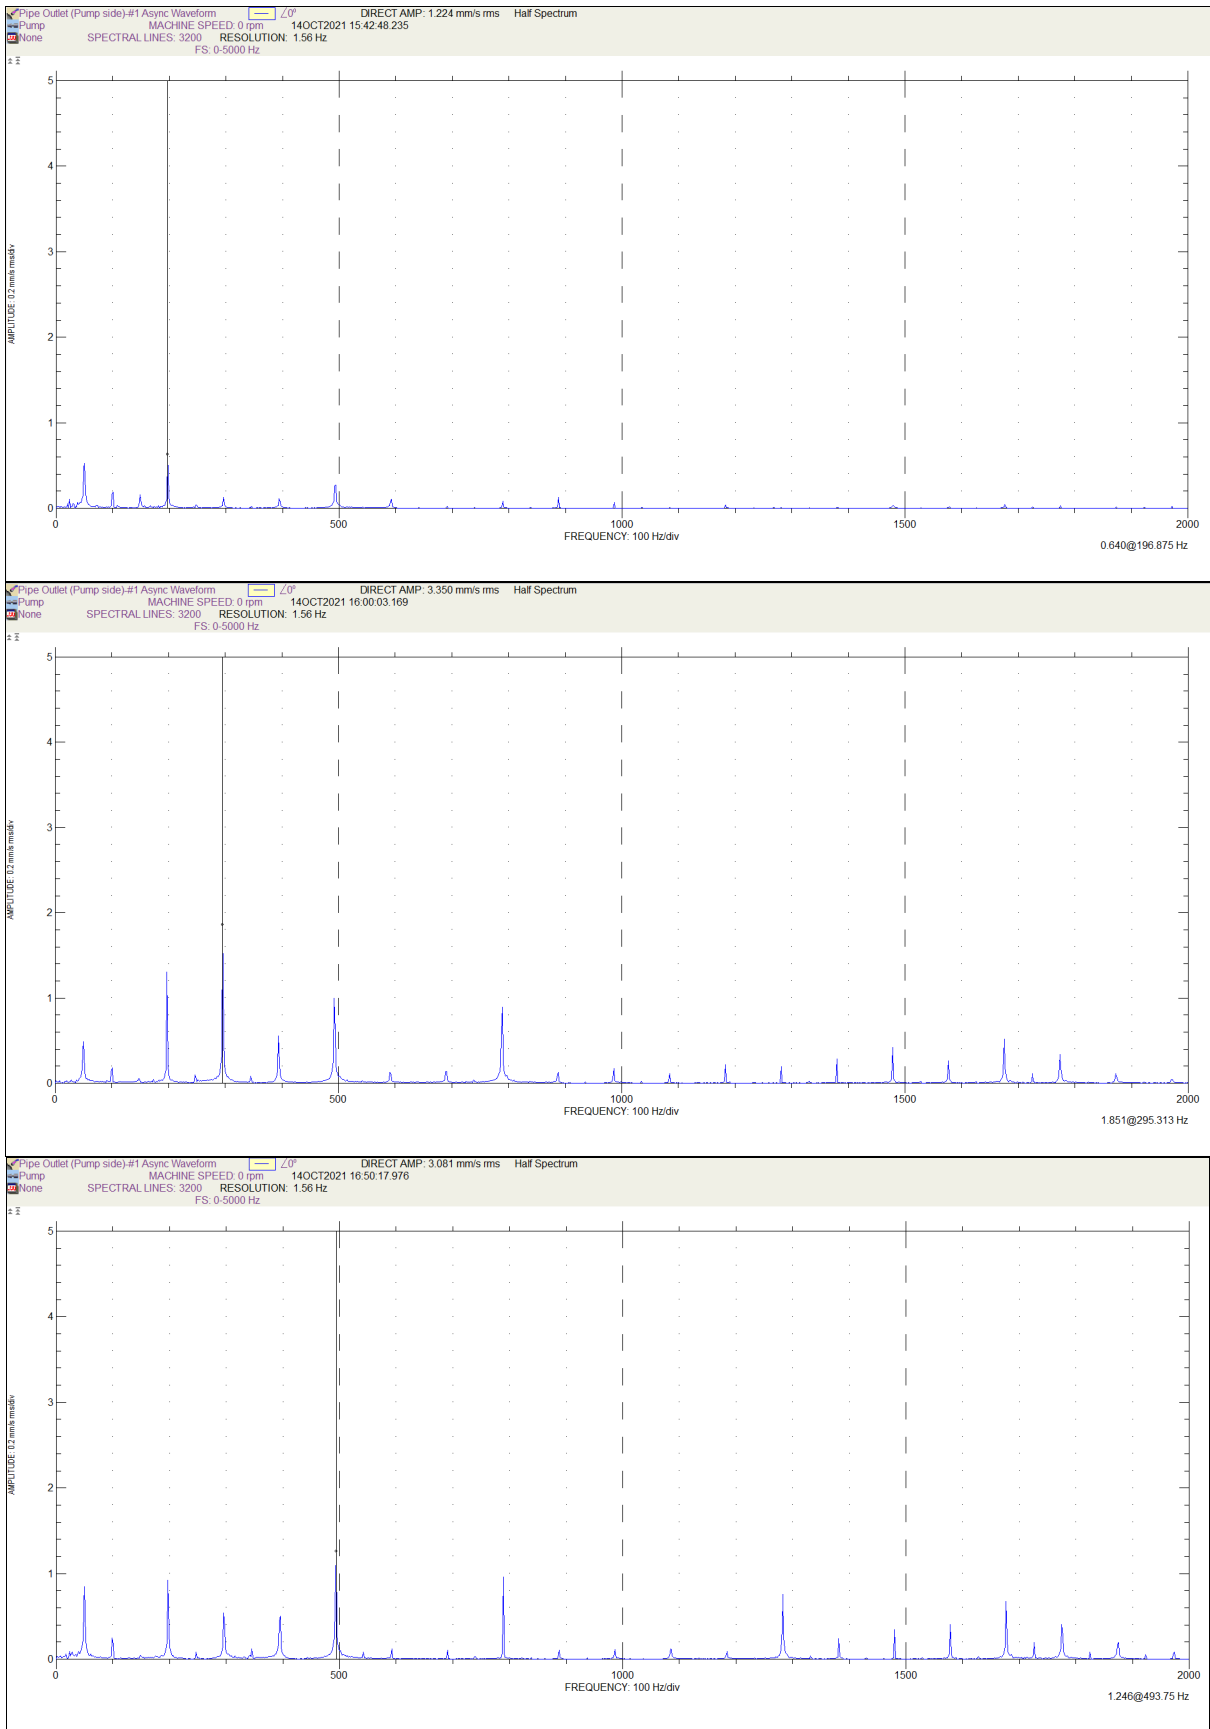
Figure 26: LO Pump B, Pipe Inlet 1 (Pump Side), Asynchronous Half Spectrum, 14th October 2021 15:42:48 (upper spectrum – prior noise) vs. 16:00:03 (middle spectrum – noise plateaued) vs. 16:50:17 (lower spectrum – peak vibration).

Figure 27: LO Pump B, Pipe Inlet 2 (Pump Side), Asynchronous Half Spectrum, 14th October 2021 15:42:48 (upper spectrum – prior noise) vs. 16:00:03 (middle spectrum – noise plateaued) vs. 16:50:17 (lower spectrum – peak vibration).

Figure 28: LO Pump B, Pipe Outlet (Pump Side), Asynchronous Half Spectrum, 14th October 2021 15:42:48 (upper spectrum – prior noise) vs. 16:00:03 (middle spectrum – noise plateaued) vs. 16:50:17 (lower spectrum – peak vibration).

It was recommended to the end-user that the filters were exchanged with those of the original design.
