**Investigation of PVC Pipe Failure at Terrell State Hospital  
- Final Report**

**Terrell State Hospital  
Texas Department of Mental Health and Mental Retardation  
(MHMR)**

**Energy Systems Laboratory  
Texas A&M University  
College Station, TX 77843**

**May 2000**

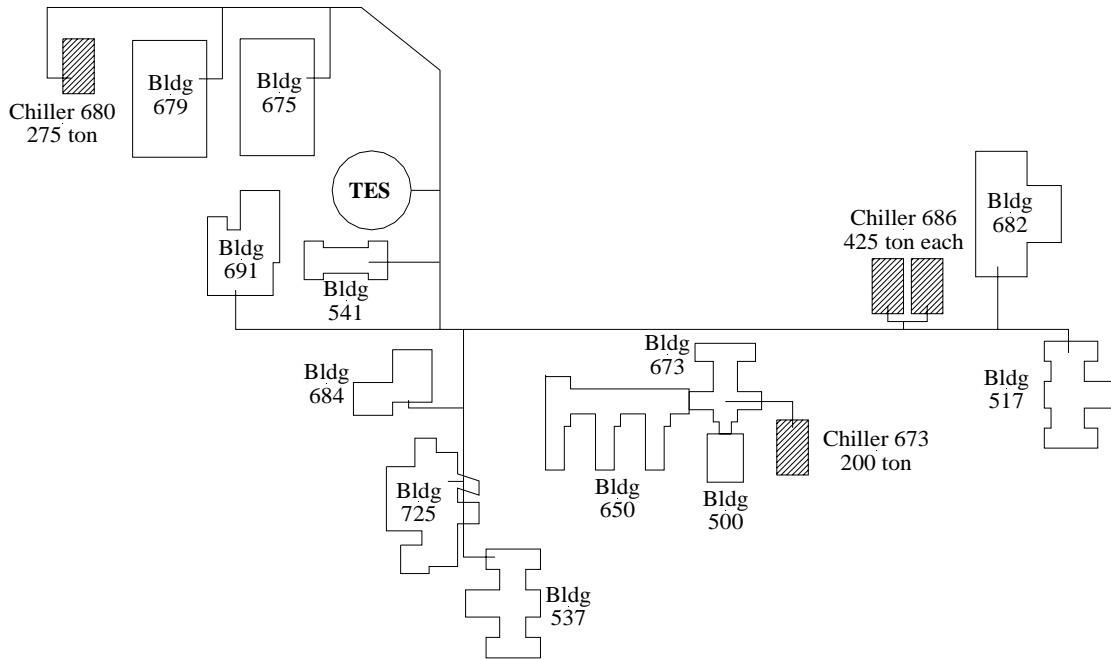
Figure 1. Schematic of the campus chilled water loop.

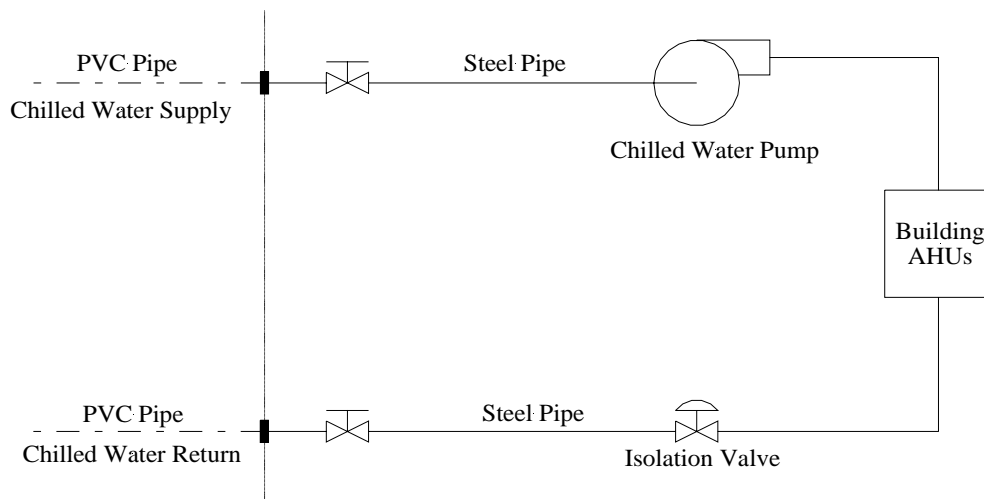
Refer to the schematic of the piping in Figure 1. Chilled water is delivered to Building 691 by direct buried PVC pipes. The PVC pipes come out of the ground and joint the building pipes, see Figure 2. The building pipe is made of steel. There is one building chilled water pump that is equipped with a variable frequency drive for the motor. An isolation valve is installed in the return pipe inside the building.

Figure 2. Schematic of the chilled water loop at Building 691.
