SHORT-TERM MONITORING TO DIAGNOSE COMFORT PROBLEMS IN A RESIDENCE IN CENTRAL TEXAS

V. Kootin-Sanwu¹, A. Sreshthaputra², J.S. Haberl³

ABSTRACT

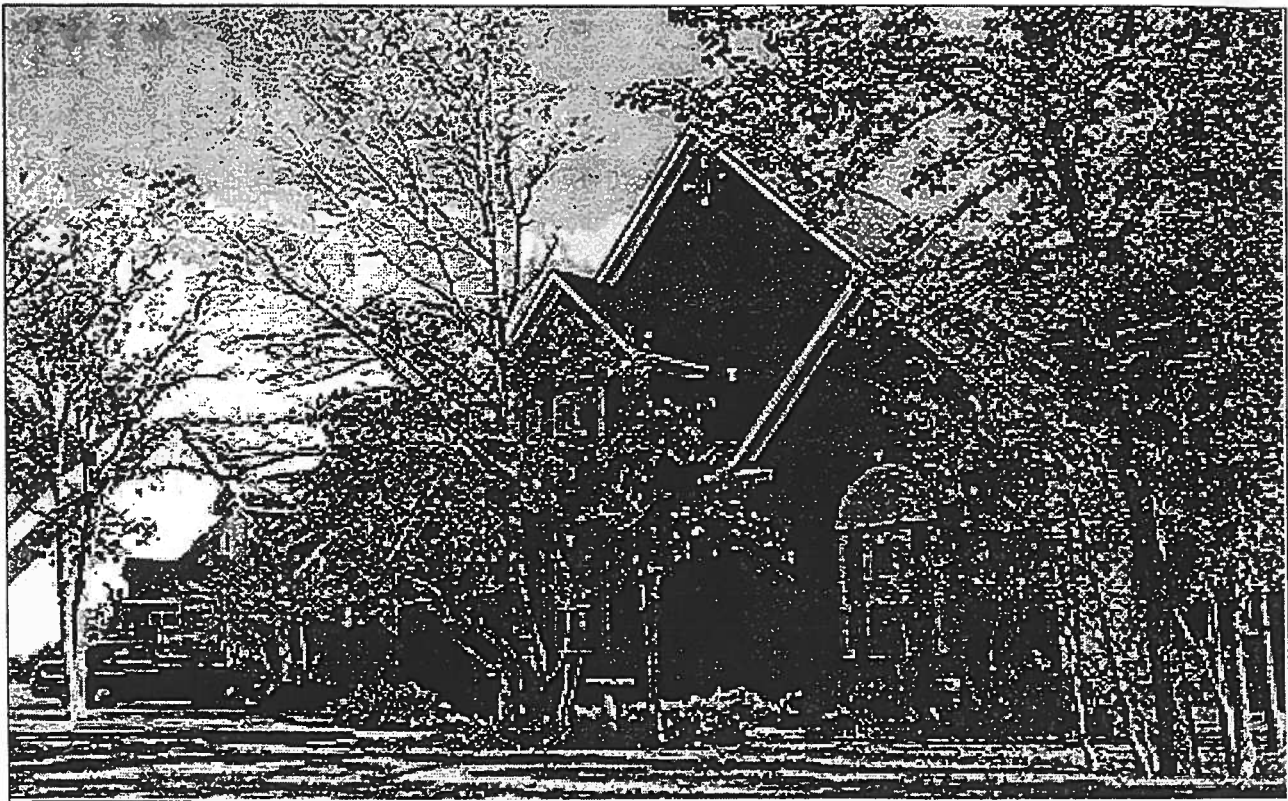
Figure 1. Front Elevation of the case study house

The house examined in this paper is a 3,400 sq.ft. two-story residence located in Bryan, Texas. The house is a four-bedroom dwelling with a cathedral ceiling and an 18-foot high ceiling in the entrance hall. The first floor consists of a living room, dining room and kitchen, a study, one bedroom and a bathroom. A laundry room, attached double car garage and external patio are also on the first floor. The second floor has three bedrooms and a sitting area. Two people presently occupy the house. Figure 1 is a photo of the case study house.

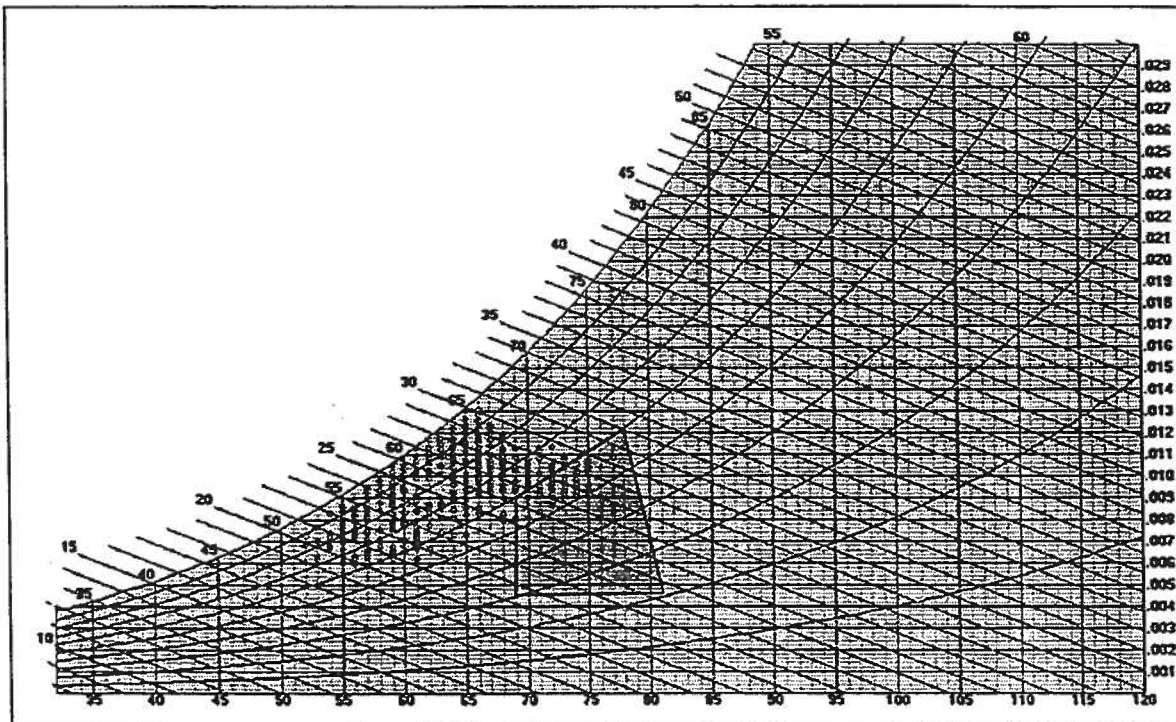
These same data are presented on a psychrometric plot in Figures 7-9. Figure 7 shows the first floor temperature and humidity as measured at the thermostat. The ASHRAE comfort zone is also shown on the psychrometric chart (i.e., 60 % RH upper humidity bounds, 68-78 °F effective temperature, and 36 °F dewpoint lower humidity bounds). From Figure 7, it is clear that the first floor was colder and more humid than recommended ASHRAE conditions. Figure 8 shows the conditions of the supply air for the same period. In a similar fashion to Figure 5, Figure 8 indicates that the supply air to the first floor was not being cooled enough for adequate moisture removal. Figure 9 shows the outdoor temperature and humidity for the same period. This figure shows the significant variation in the outdoor conditions during the pre-retrofit period. This is quite a contrast to the very tightly controlled indoor condition for the first floor (Figure 7).

Figure 8. Supply air temperature and relative humidity for the first floor of the house for the pre-retrofit period of 11/17/98 to 12/1/98.

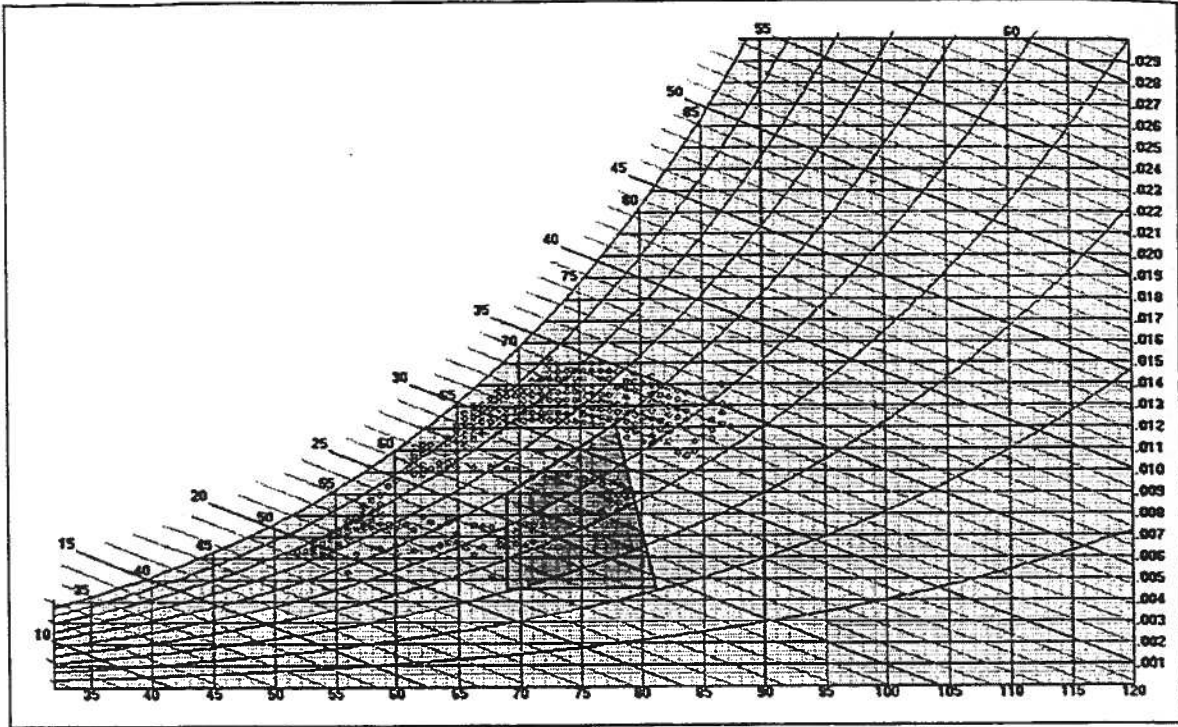
Figure 9. Outdoor air temperature and relative humidity for the period of 11/17/98 to 12/1/98.

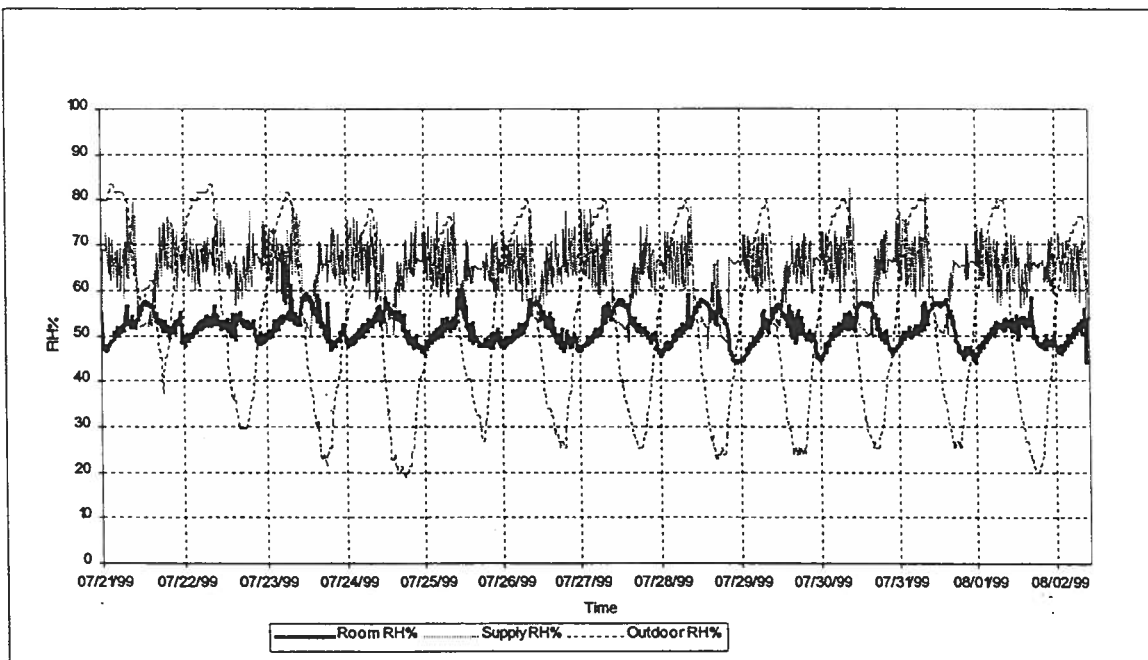
Post-retrofit Measurements. Measurements were then repeated to confirm the success of the retrofits as shown in Figures 11 – 14. Although, these measurements were taken during a much hotter period of the year they still show a marked improvement in the comfort conditions. In Figure 11, supply temperatures dropped to the 57-60°F range. Relative humidity dropped well below 60% as shown in Figure 12. The homeowner appears to have increased the set point as well (possibly in response to the drier conditions). Figure 13 also confirms the post-retrofit conditions are well within the recommended ASHRAE comfort range. Figure 14 indicates an improvement of the supply-return temperature difference as well.

Figure 12 Room, supply, and outdoor air relative humidity (%) for the first floor of the house for the post-retrofit period of Jul 21 - Aug 2, 1999.

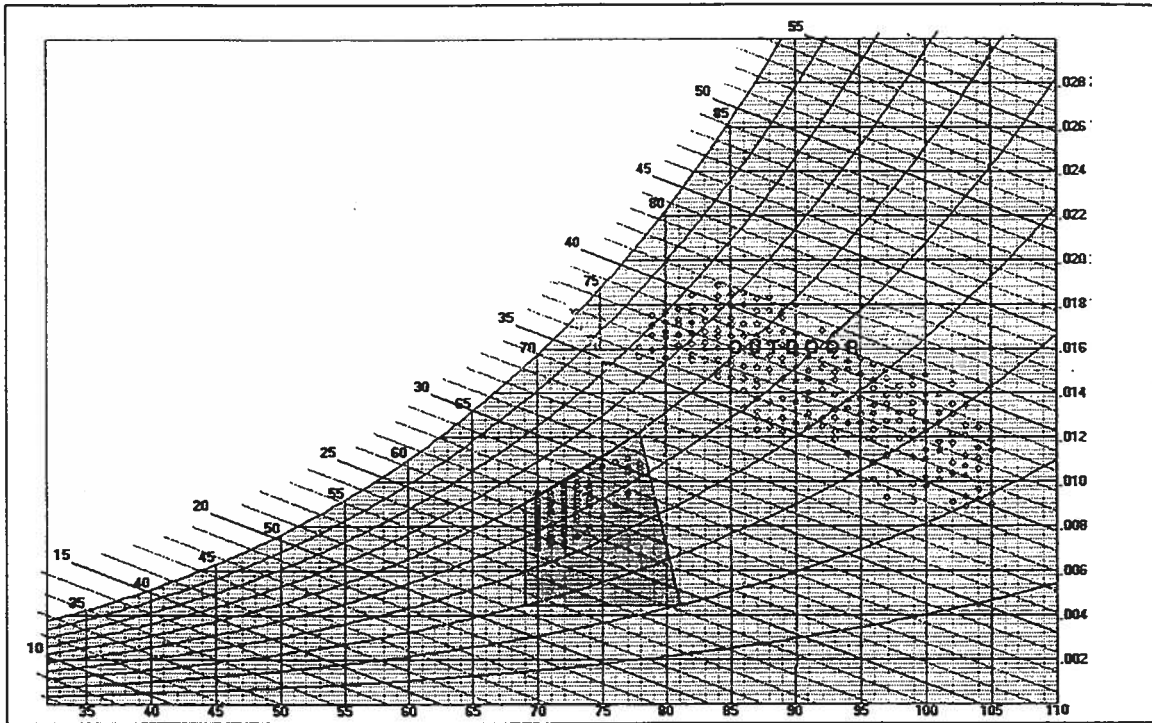
Figure 13 Room and outdoor air conditions for the post-retrofit period of Jul 20 - Aug 2, 1999.

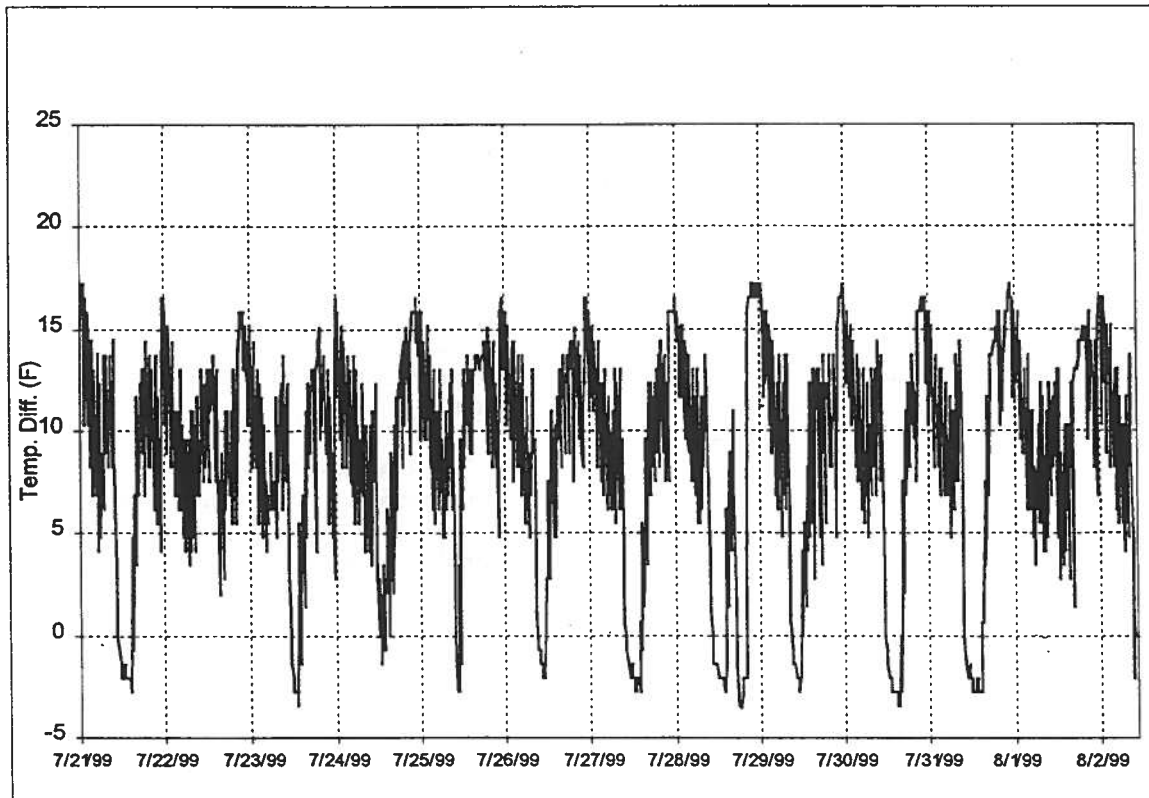
Figure 14 The first floor difference in temperature between the return air and supply air at the case study house for the post-retrofit period.
