ENGINEERING GEOLOGIC ASSESSMENT OF RISK TO VISITORS:  
CANYON LAKE GORGE, TEXAS

A Thesis

MASTER OF SCIENCE

May 2010

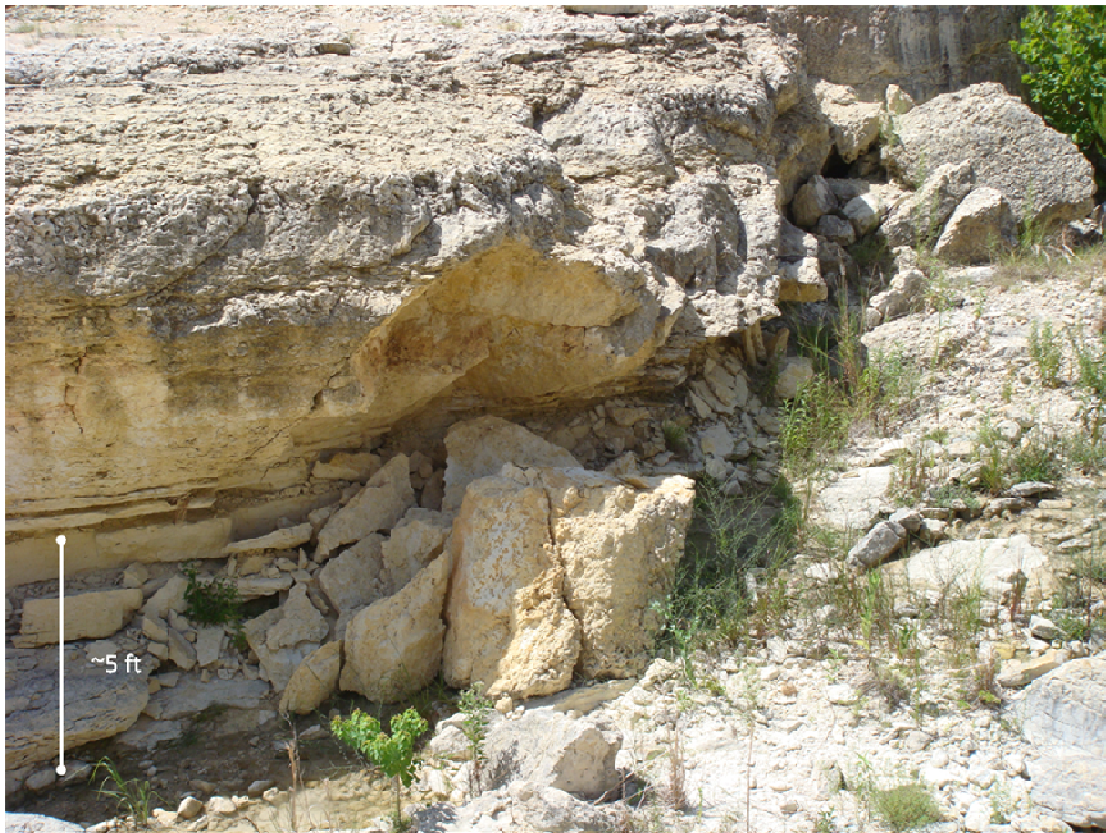
Figure 7. Rock fall process.

Rock falls and toppling of rock blocks were indicated by large blocks of rock strewn at the base of ledges and small cliffs. The aforementioned unstable masses of rock can

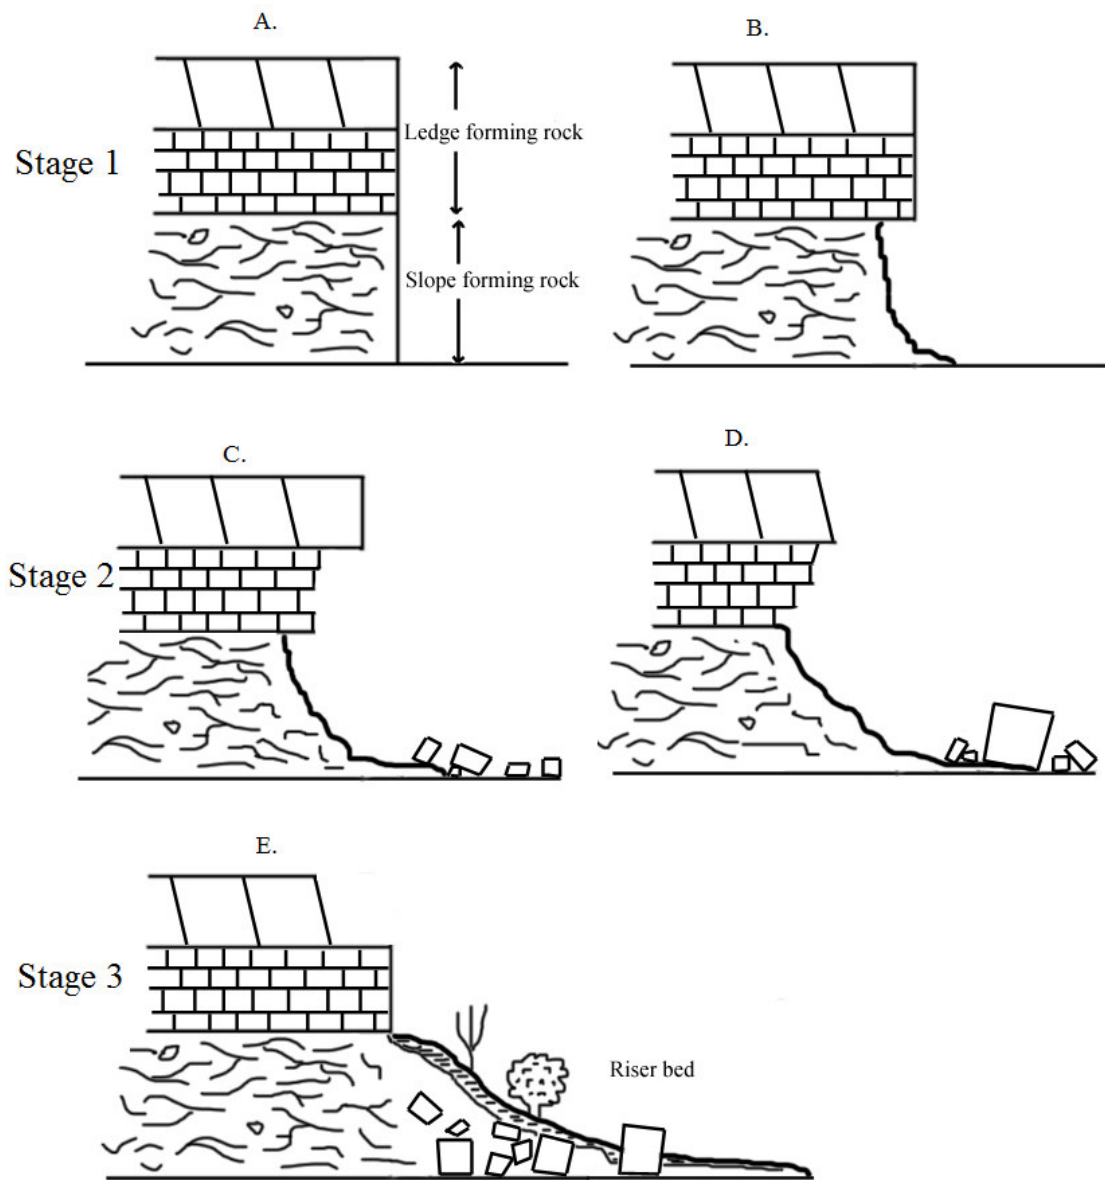
Stage 2 – This is the current stage of the gorge. Differential weathering has led to undercut rock ledges throughout the gorge. Constant rock fall events occur as rock ledges fail. Vegetation has started to enter the gorge.

Figure 13. Erosion progression diagram. Diagram predicts an erosion model that leads to rock falls and eventual formation of a riser bed. (A) is equivalent to a fresh road cut. (B) represents a sequence in the gorge immediately after the 2002 flood. (C) represents the current state of many areas in the gorge. (D) shows progression of erosion and blocks of rock accumulating at the base of the ledge. (E) is the final stage where the landscape has reached a relative equilibrium, when erosion proceeds much slower.

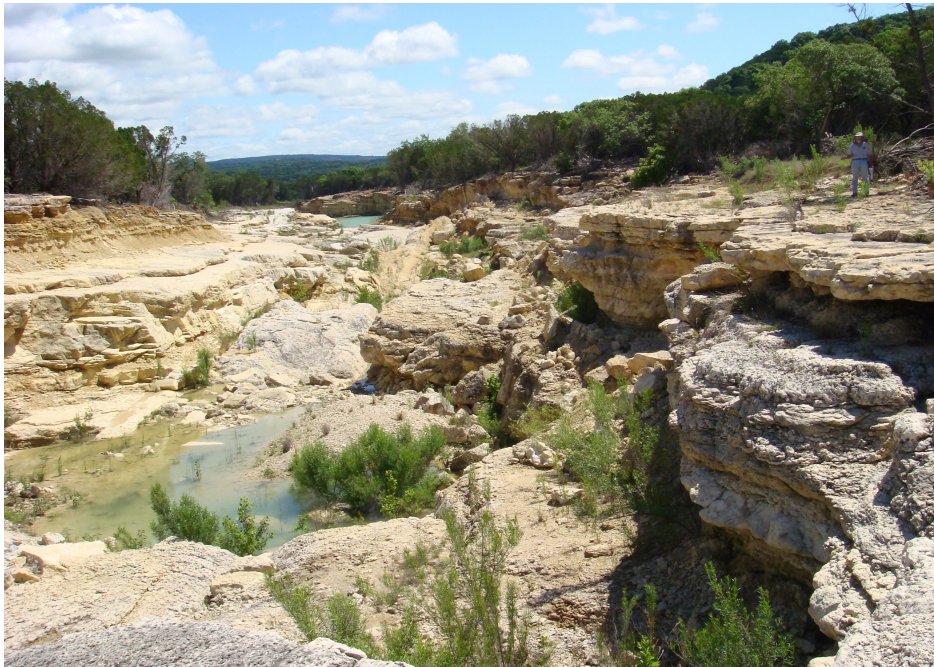
The methodology of this study was designed to gather information pertaining to potentially hazardous unstable masses of the gorge adjacent to a pathway used for guided tours. On the pathway, undercut rock ledges were the unstable masses of interest, as failure of these ledges has the possibility of causing injury to the visiting public and guides (Figure 14).

Figure 14. Photo of Canyon Lake Gorge in July 2008. Person on right side of photo for scale. View is from the western end of the gorge towards the east, down the flow of water.

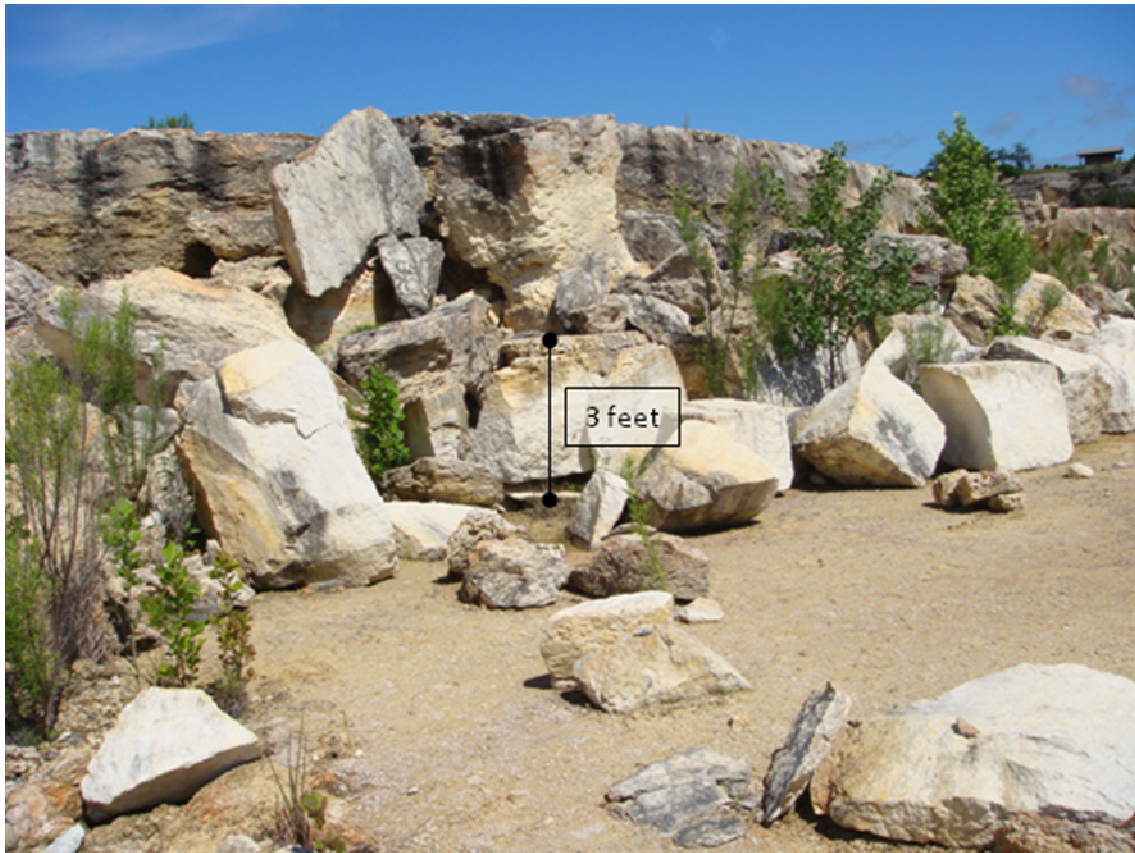
A sudden change in gradient in a stream or spillway profile is termed a Knickpoint (May, 1988). Photos taken during the flood appear to support a theory of the erosional progression of knickpoints “stepping up” the gorge toward the lake (Figure 5, page 7). Knickpoint erosion requires a flow of water over a steep gradient or vertical face, creating an unvented pocket of air behind the falling water (May, 1988). Water flow can then be drawn into that unoccupied space, scouring the rock or even causing sufficient pressure to uplift large blocks of rock and transport them with the prevailing flow of water. Large boulders measuring greater than five ft (1.52 m) are positioned in areas far from the parent bedrock (Figure 18). Post-flood discontinuity orientations mapped in this study indicate that in-situ fractures would have aided a knickpoint erosional progression model that could have created the current gorge geomorphology. Knickpoints would have been prone to form at the junction of vertical and horizontal discontinuities. The two main surface discontinuity orientation sets observed in this study can be considered important remnants of factors that played large in the formation of the gorge. When the flood waters scoured out the emergency spillway while flowing toward the river to the north-east, any north-western oriented discontinuities would have

effectively divided the bedrock into blocks easily excavated by the immense amount of flood water flow.

Figure 18. Canyon Lake Gorge. Large boulders scoured from the bedrock were moved during the 2002 flood

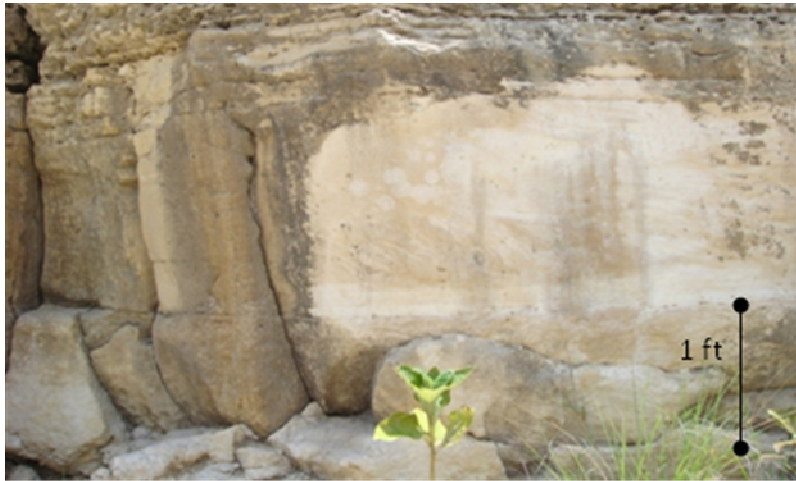
Lying overtop unit 1-1 are a layer of packstone and grainstone (Figure 22, Figure 23). Unit 1-2 is a very homogenous packstone, and unit 1-3 is distinguished by its pervasive vuggy porosity. Unlike wackestone, units 1-2 and 1-3 are very resistant to weathering. Vertical fractures run sparsely through the thickness of unit 2-1 before terminating in adjacent units.

Figure 22. Rock unit 1-2. Unit 1-2 is a homogeneous packstone that is 1.34 m (4.4 ft) thick.

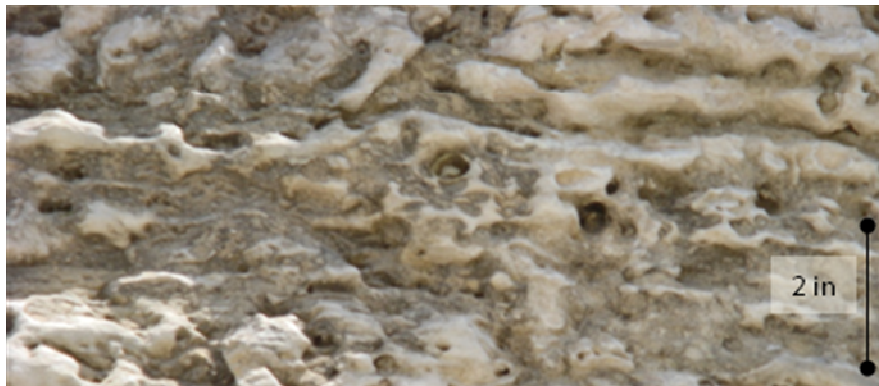
Figure 23. Rock unit 1-3. Unit 1-3 is a grainstone that is 0.94 m (3.1 ft) thick.

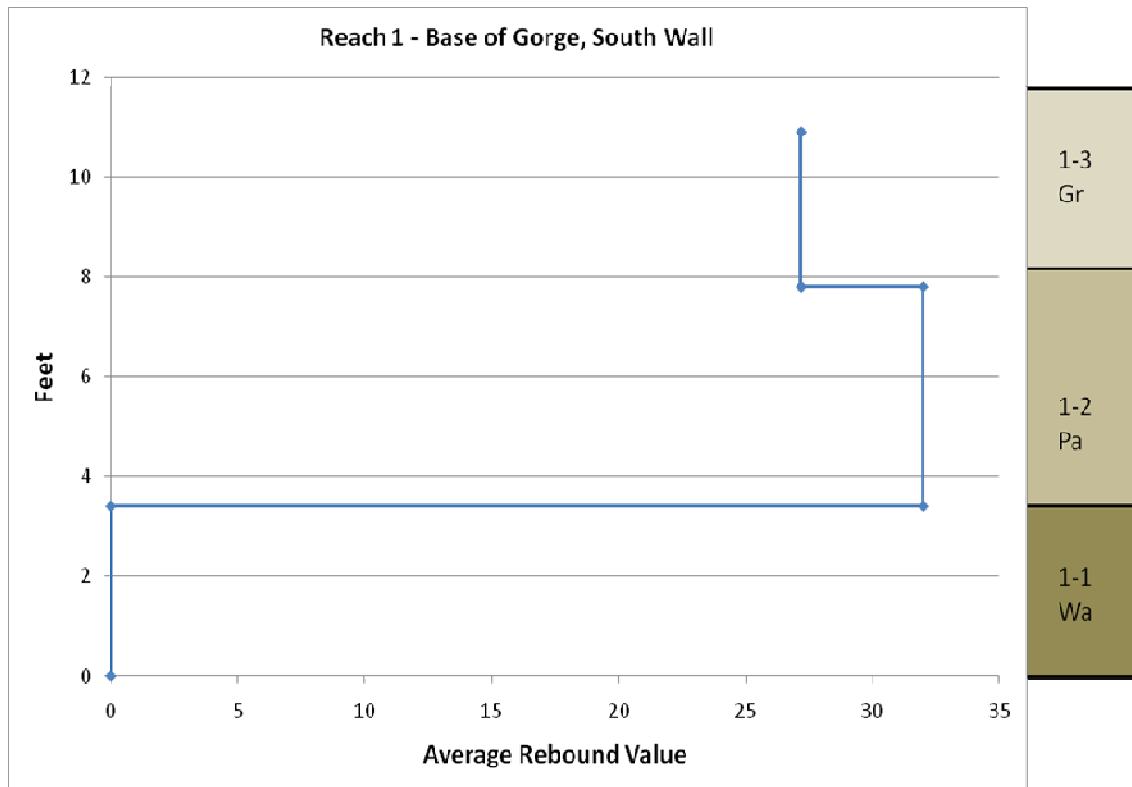
The impact test hammer results of Reach One revealed results that correlated high values with the ledge forming rock, and low values with the wackestone base unit (Figure 24 Table 1). Ten impact test hammer measurements were taken of each unit, resulting in an average rebound value of 32.1 (3,990 psi) for unit 1-2 and rebound value of 27.2 (3,020 psi) for Unit 1-3. The wackestone measured readings of zero, whereas the

more competent packstone and grainstone had many measurements exceeding 30 (2900 psi).

Figure 24. Reach One Graph, average rebound vs. thickness. The thickness is of the lithologic unit. Wa (wackestone), Pa (packstone), Gr (grainstone).

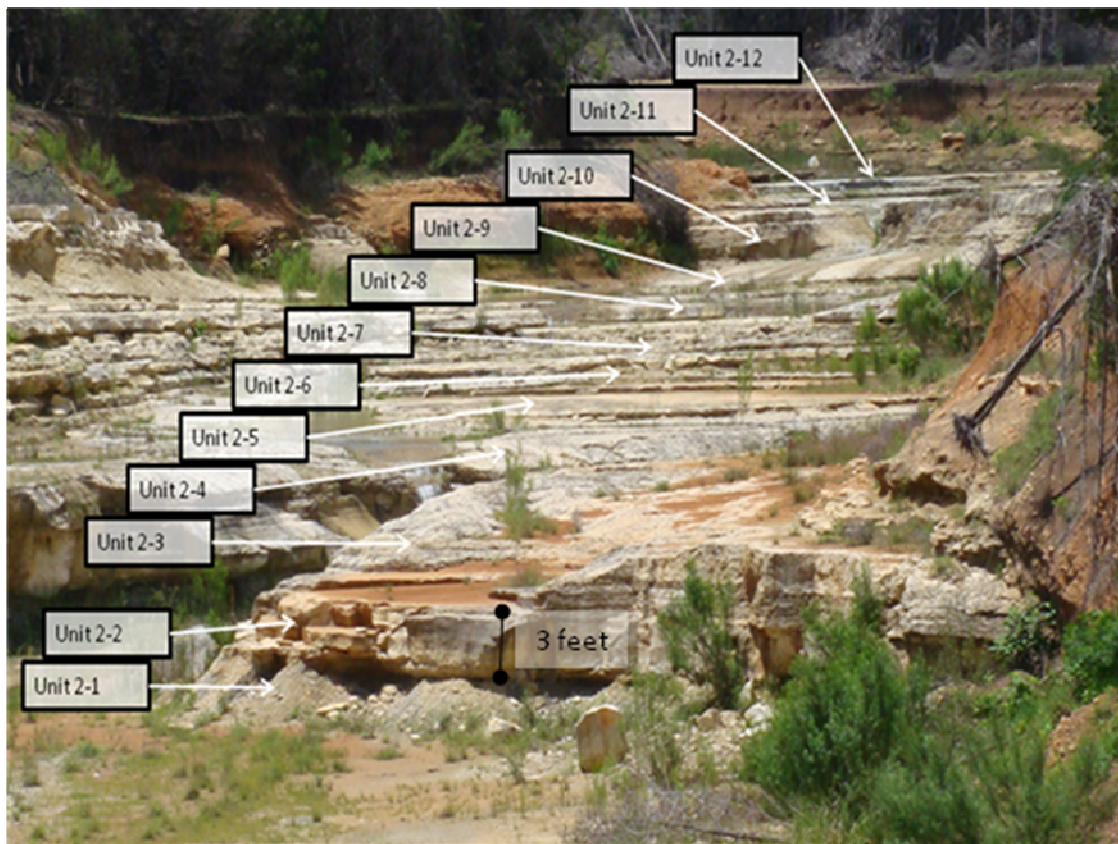
Figure 25. Reach Two Stratigraphy. Reach Two is a sequence of twelve units of rock. This reach displays the variety of carbonate rock that can be found in the Glen Rose Formation.

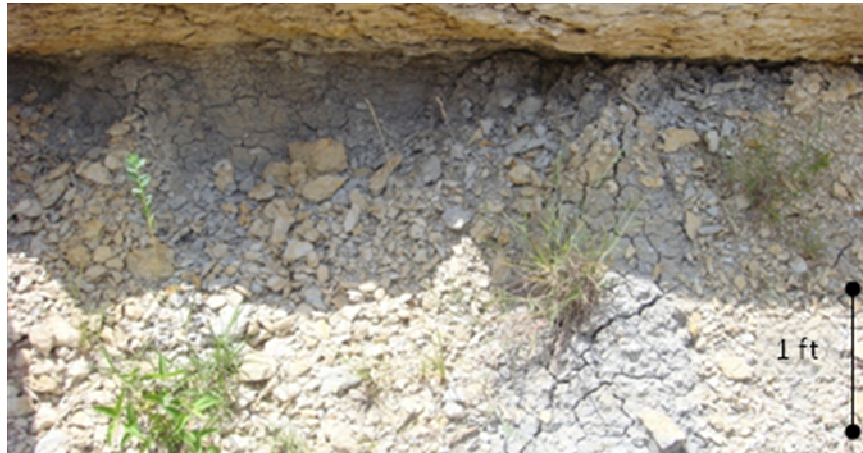
Units 2-1 and 2-2 create a noteworthy sequence (Figure 26, Figure 27). Unit 2-1 is a very friable wackestone unit, and Unit 2-2 is a ledge forming packstone. Located

directly in the path used to traverse the gorge, the undercut ledge of unit 2-2 over unit 2-1 form a sloped feature that is unavoidable to hikers. The weathered slope of unit 2-1 rises up 1.28 m (4.2 ft) to a competent layer of packstone (unit 2-2), undercutting the layer of packstone. The wackestone is very friable, consequently the impact test hammer failed to read any measurement above zero, whereas the packstone has an average value of 38. Additionally, unit 2-2 has obvious fractures running through undercut portions of the ledge, adding to the danger of ledge failure underfoot of a hiker.

Figure 26. Rock unit 2-1. Unit 2-1 is a wackestone and is 1.28 m (4.2 ft) 1.28 m thick.

Reach Two has two major wackestone beds in units 2-1 and 2-10, and both are seen undercutting the overlying packstone. Both of the wackestone-packstone junctions are unavoidable obstacles in a hike through the gorge. Collapse of a rock ledge under the weight of a person is a hazard to any visitors traversing these two geologic structures. Injury resulting from a small fall is possible in such a situation, but can be avoided by picking a careful path over the wackestone-packstone intersects. If a tourist or guide attempts to travel up the gorge using a route other than the marked path, the risk of falling or destabilizing a rock slope is high.

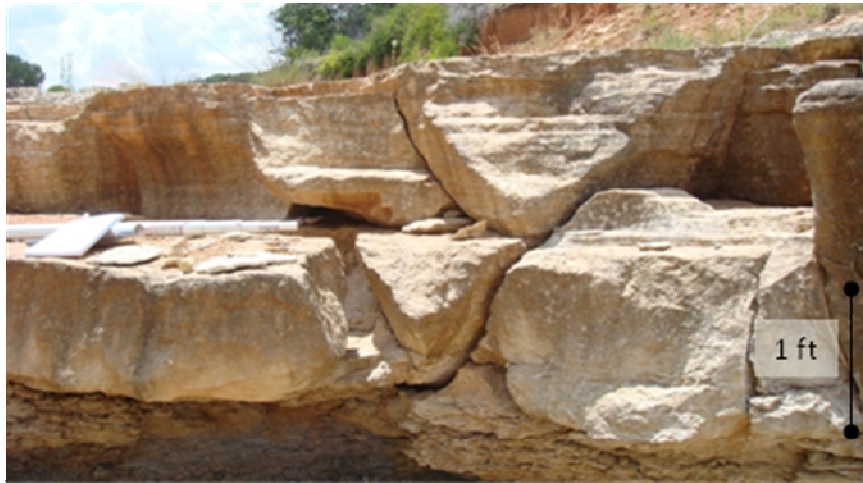
Figure 27. Rock unit 2-2. Unit 2-2 is a packstone that is 0.91 m (3.0 ft) thick. The impact test hammer averaged a rebound value of 38.43 ( $367.7 \text{ Kg/cm}^2$ , 5230 psi) in seven successful measurements.

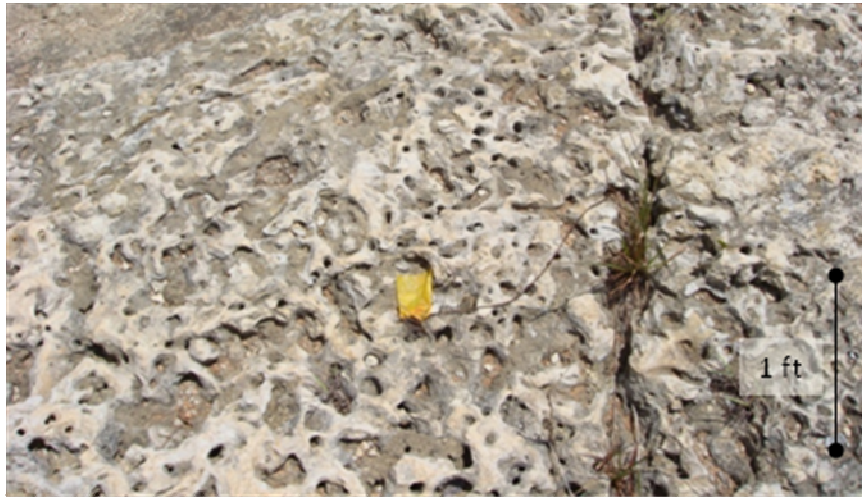
Figure 28. Rock unit 2-3. Unit 2-3 is a grainstone that is 0.85 m (2.8 ft) thick. Fracture density is low; at least seven ft (2.13 m) separate the larger surface fractures.

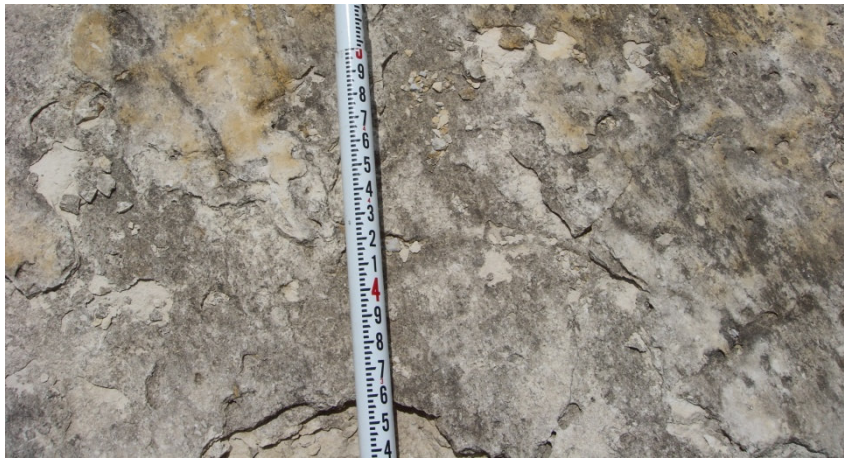
Figure 29. Rock unit 2-4. Unit 2-4 is a packstone that is 0.55 m (1.8 ft) thick. Weathering of the surface causes the rock to break into laminar sheets.

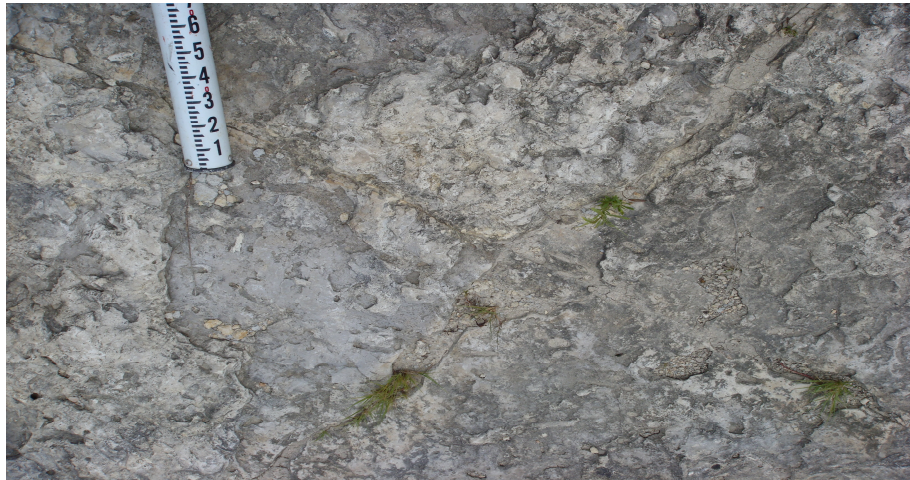
Figure 30. Rock unit 2-5. Unit 2-5 is a grainstone or a grain dominated packstone that is 0.18 m (0.6 ft) thick.

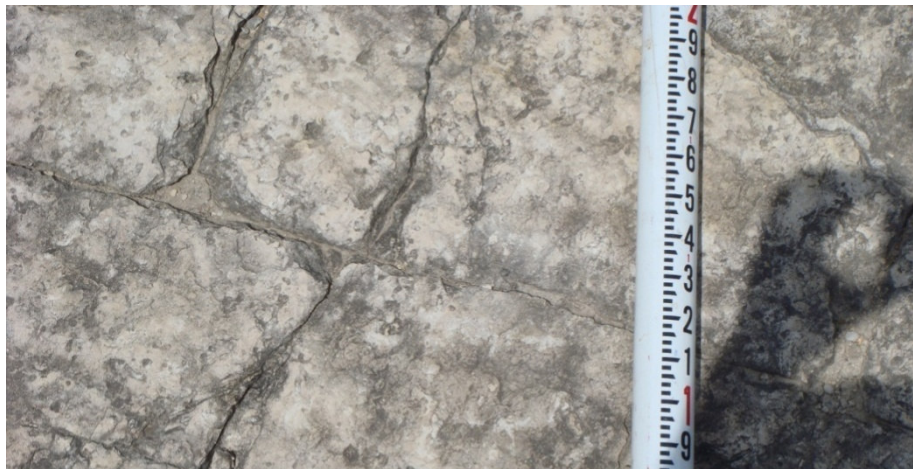
Figure 31. Rock unit 2-6. Unit 2-6 is a packstone that is 0.52 m (1.7 ft) thick. Fracture spacing is approximately 0.5 ft (0.15 m) and a very distinct rectangular pattern is displayed.

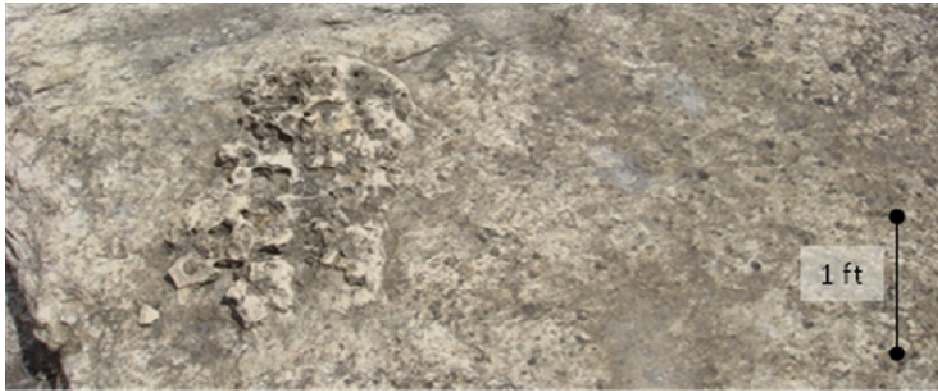
Figure 32. Rock unit 2-7. Unit 2-7 is a packstone that is 0.67 m (2.2 ft) thick.

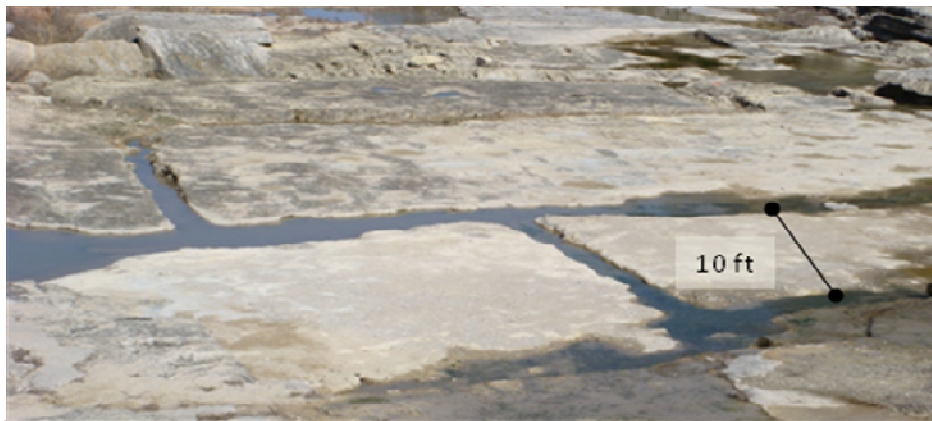
Figure 33. Rock unit 2-8. Unit 2-8 is a wackestone that is 0.3 m (1.0 ft) thick. Large channels run through the surface of the rock.

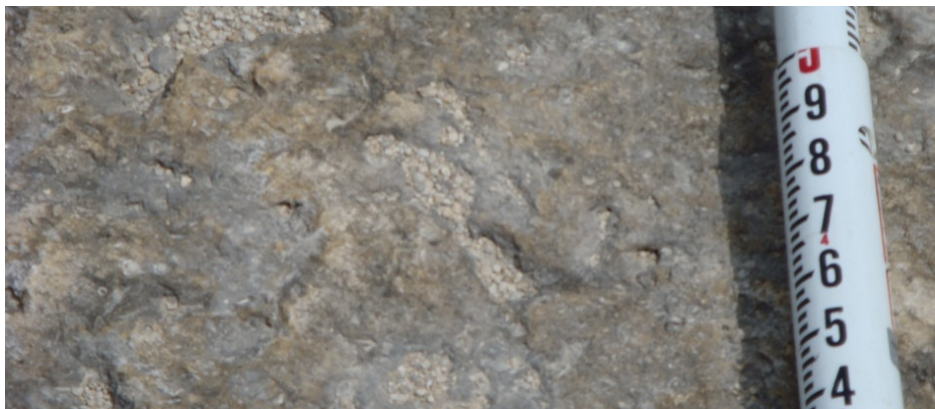
Figure 34. Rock unit 2-9. Unit 2-9 is a homogenous grainstone that is 0.61 m (2.0 ft) thick. This is a very competent unit, and displays vuggy porosity.

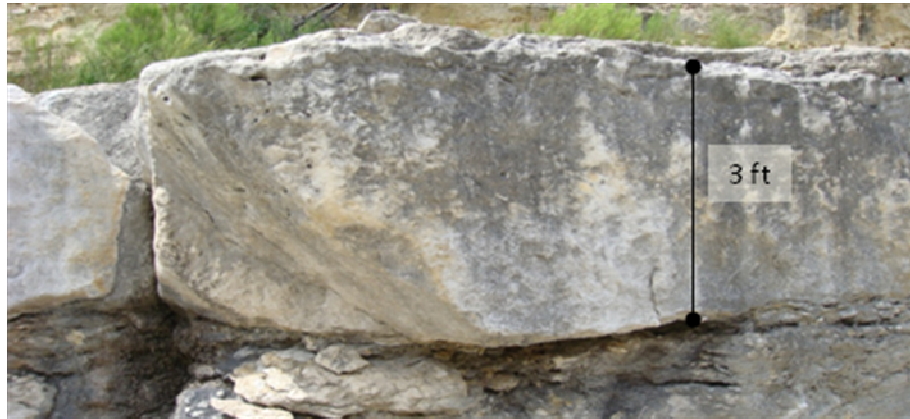
Overlying unit 2-9 is a wackestone and packstone bed (Figure 35, Figure 36). This is a similar sequence to that of the unit 2-1 and unit 2-2 wackestone packstone sequence. In an expected pattern, the wackestone unit 2-9 undercuts the overlying competent packstone, forming an undercut rock ledge. The undercut rock ledge present at the junction of 2-10 and 2-11 is an obstacle to visitors of the gorge. The wackestone layer 2-10 is 7.2 ft (2.2 m) thick, and at some points presents a vertical face not easily climbed.

Figure 36. Rock unit 2-11. Unit 2-11 is a homogenous packstone that is 0.95 m (3.1 ft) thick. This unit is a ledge former that is very consolidated and indurated, with sparse vuggy porosity.

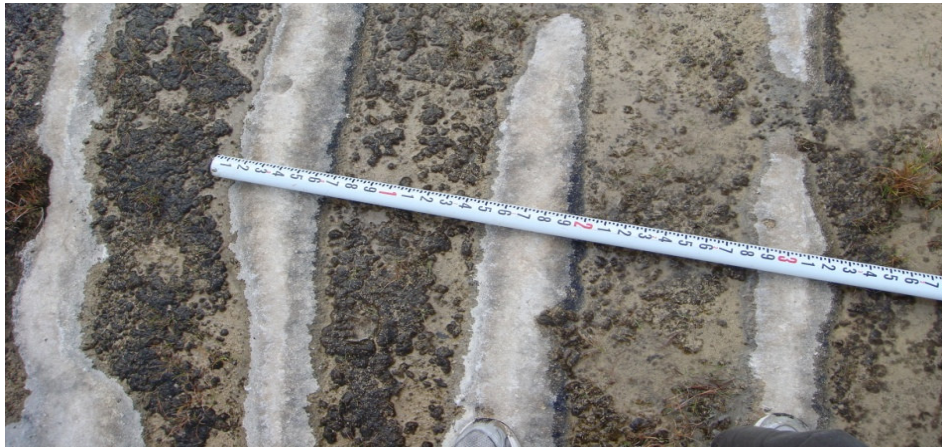
The final lithologic unit surveyed in Reach Two was a grainstone with an average impact test hammer measurement of 43 (Figure 37). The surface of the rock presents a unique display of large surface ripples

Figure 37. Rock unit 2-12. Unit 2-12 is a grainstone that is 1.07 m (3.5 ft) thick. Ripples are prominent on the surface.

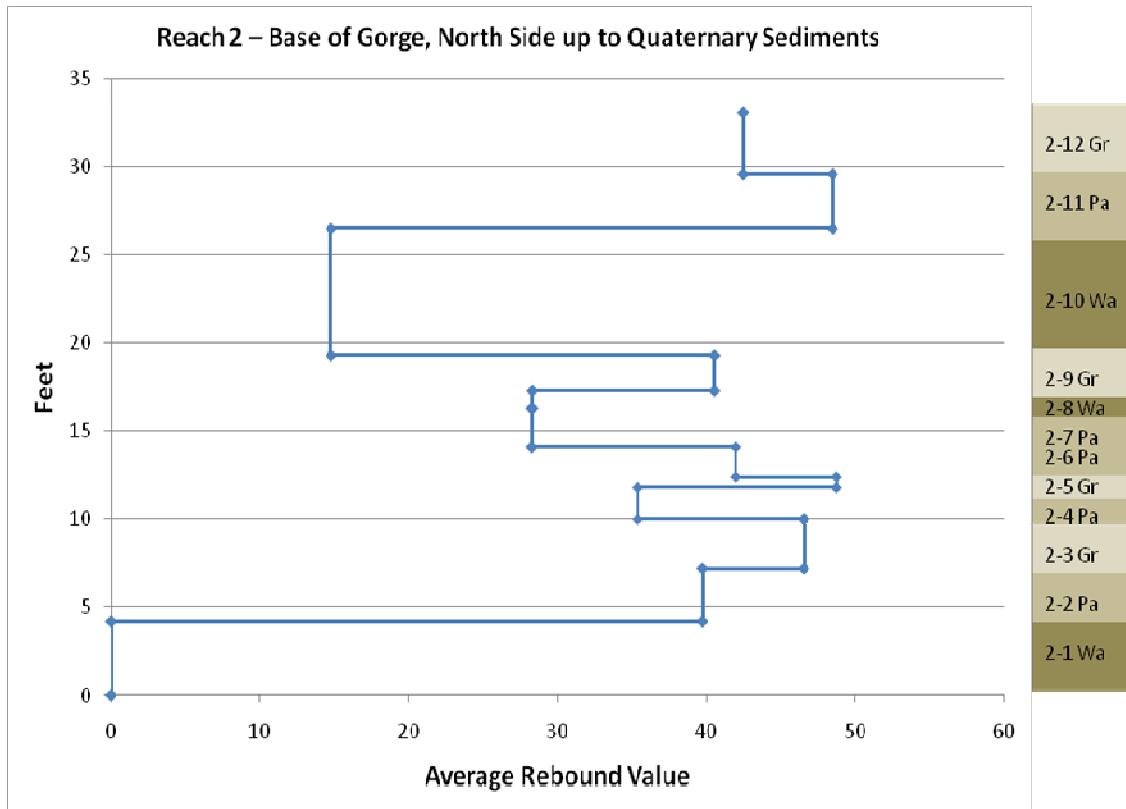
The lithologic units of Reach Two own some of the highest rock strengths measured in this survey (Figure 38, Table 2). In particular, the packstone units 2-3 and 2-11 and the grainstone unit 2-5 measured high average values on the impact test hammer.

Figure 38. Two Graph, Average Rebound vs. Thickness. Graph of average rebound value vs. thickness of lithologic unit. Wa (wackestone), Pa (packstone), Gr (grainstone).

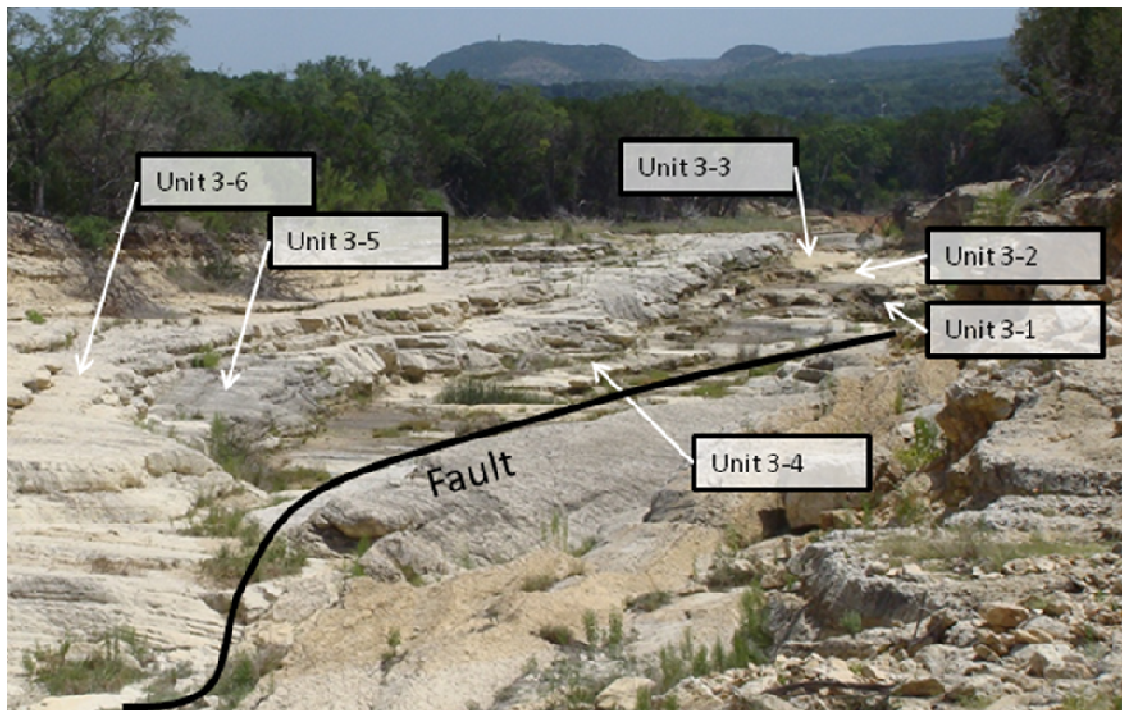
Reach three is a sequence of six units of rock, consisting of four packstone units, one wackestone, and one grainstone (Figure 39). The pathway used to traverse the gorge is on the north side of a large fault that runs through the center of the gorge. There are no notable structures that would present a high risk in this reach of stratigraphy. Only small risks are present in reach three.

Figure 39. Reach three stratigraphy. Picture showing rock units of reach three, and the fault running through the gorge.

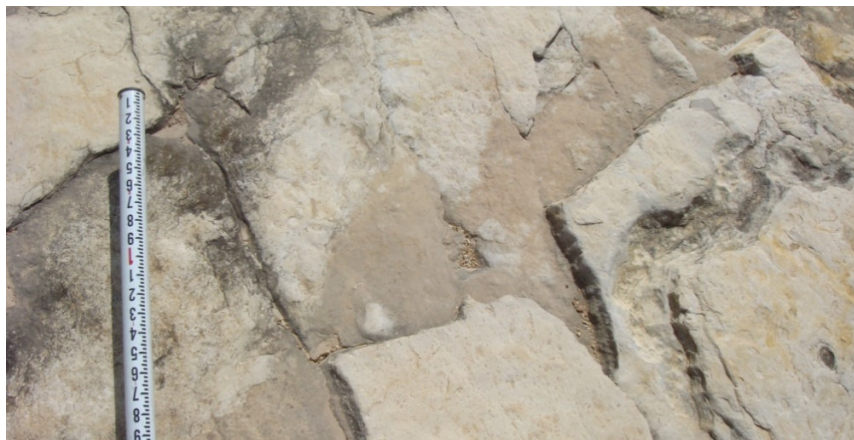
Reach three is the highest in elevation of the three reaches, and is consequently composed of strata younger than that seen in Reach Two. The first two units of reach three are packstones (Figure 40, Figure 41). Unit 2-1 is a more homogenous packstone and measured a higher rock strength than unit 2-2. The lower average impact hammer results of unit 2-2 appear to be accounted for by a slightly higher clay content.

Figure 40. Rock unit 3-1. Unit 3-1 is a packstone that is 0.67 m (2.2 ft) thick. It is consolidated and relatively homogenous in appearance.

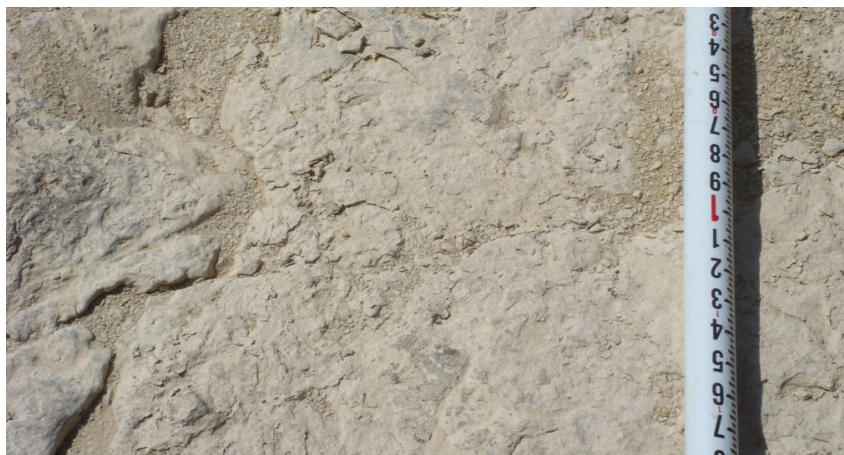
Figure 41. Rock unit 3-2. Unit 3-2 is a packstone that is 0.55 m (1.8 ft) thick. Clay content appears greater than other packstones.

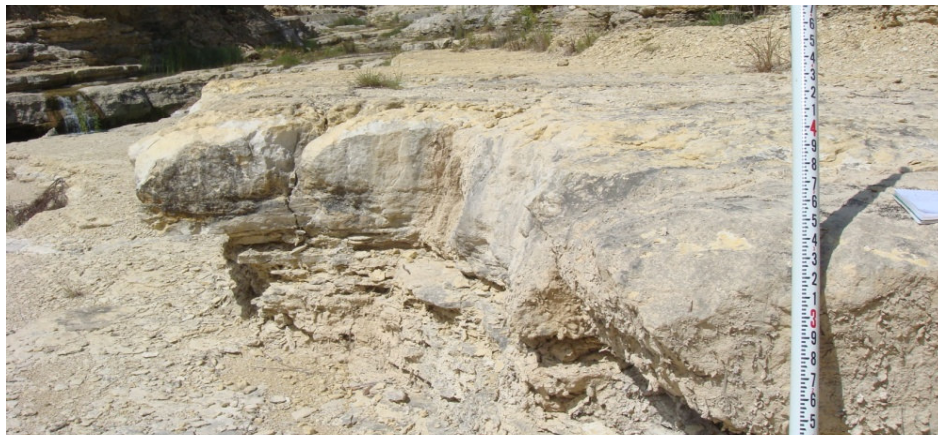
Unit 3-3 marks the first occurrence of wackestone in reach three (Figure 42). Unit 3-3 is a wackestone that undercuts the packstone of unit 3-4, but the thickness of unit 3-3 (1.5 ft (0.46 m)) makes any rock ledge failure a low risk of injury (Figure 43).

Figure 43. Rock unit 3-4. Unit 3-4 is a packstone that is 0.46 m (1.5 ft) thick. This unit is a consolidated, ledge forming rock.

The area encompassed by reach three contains low risk situations where a minor fall is possible. The junction of unit 3-3 and 3-4 has a potential fall hazard, although any fall is unlikely to cause serious injury because the thickness of unit 3-3 is small. Units 3-5 and 3-6 can be difficult to climb to continue on the path up the gorge, and thus represent a potential fall hazard. In summary, tourists and guides are at very low risk of injury when traversing this reach of the gorge.

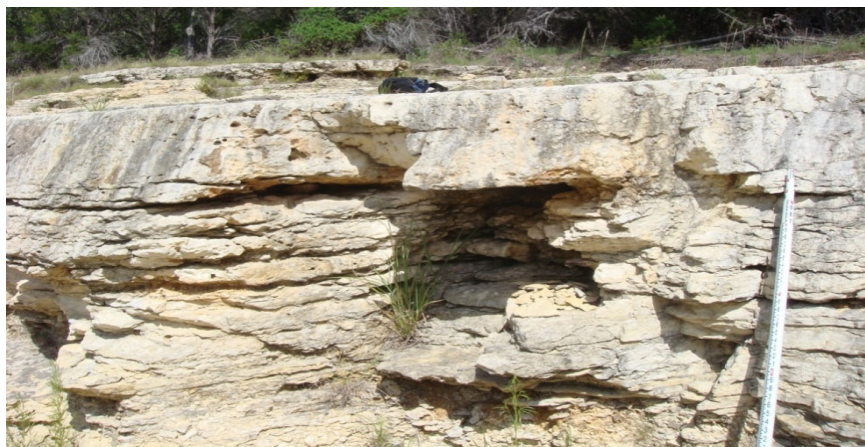
consolidated and provides solid footing for visitors (Figure 44, Figure 45). The near vertical slopes found traversing units 3-5 5.0 ft (1.52 m) and 3-6 (6.4 ft (1.95 m)) can be a minor risk if a visitor is not guided up the proper pathways.

Figure 45. Rock unit 3-6. Unit 3-6 is a grain dominated packstone that is 1.95 m (6.4 ft) thick.

1. Unit 3-5 creates a 1.5 m (5 ft) high slope that is easily climbed. This unit is highly weathered, and could break away underfoot.
2. Unit 3-6 creates a 1.95 m (6.4 ft) high slope that is easily climbed. This unit is highly fractured, and could break away underfoot.

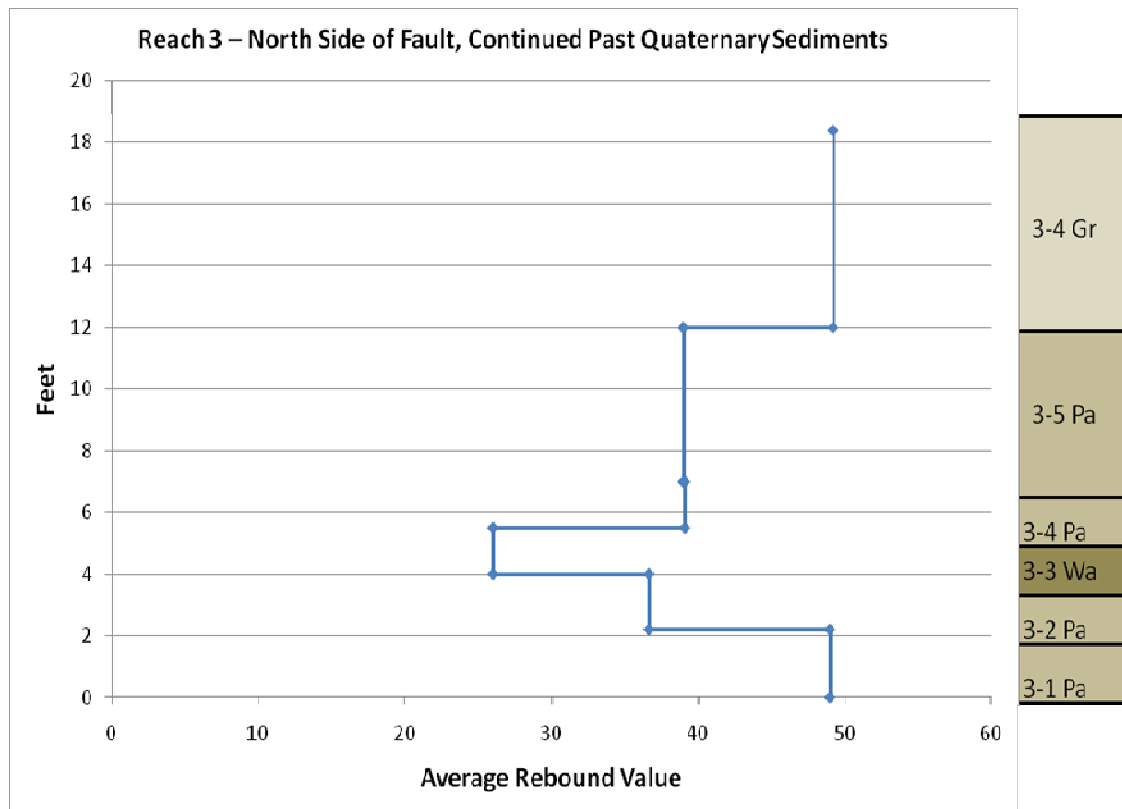
The lithologic units of reach three possessed very high rock strength values (Figure 46, Table 3). With the exception of unit 3-3, a wackestone, all the units of reach three averaged 40 (351 Kg/cm<sup>2</sup>, 5,000 psi) or higher in the impact test hammer tests.

Figure 46. Reach Three Graph, Average Rebound vs. Thickness . Thickness is of the lithologic unit. Wa (wackestone), Pa (packstone), Gr (grainstone).

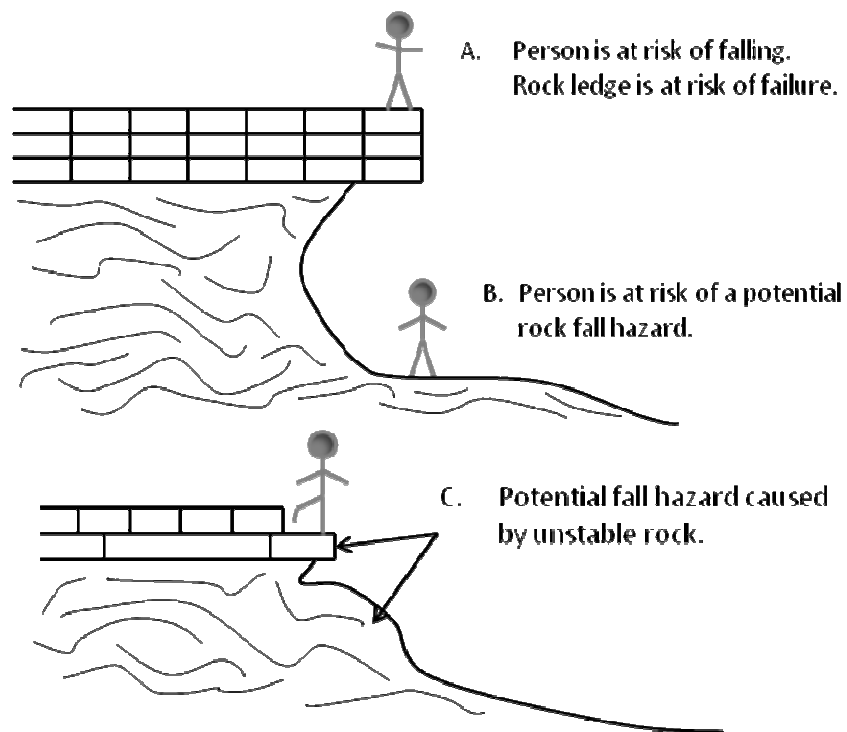
1. Visitors should be educated on the dangers of Canyon Lake Gorge before entering. Visitors of the gorge should avoid walking along the edges of ledge drop offs, and avoid walking underneath overhanging rock (Figure 50). The two high risk situations present in the gorge are potential rock fall hazards and potential fall hazards. Potential rock fall

hazards are most commonly present in the gorge as an undercut ledge of competent packstone or grainstone, where a visitor may rest underneath the ledge. Potential fall hazards are present in the gorge as undercut ledges and unstable slopes of rock. This is especially true after any periods of rainfall, when unstable masses are wet and more likely to fail.

Figure 50. Illustrations of the potential hazards present in the gorge.

2. Unavoidable dangerous areas should be evaluated for possible ways to mitigate the risk of injury to visitors. It is possible that some areas will become more hazardous as erosion and weathering proceeds. In that case, it is recommended that a qualified professional be employed to evaluate risk in the gorge. The professional should be able to offer some options on how to mitigate danger in Canyon Lake Gorge.
