45<sup>TH</sup> TURBOMACHINERY & 32<sup>ND</sup> PUMP SYMPOSIA  
HOUSTON, TEXAS | SEPTEMBER 12 – 15, 2016  
GEORGE R. BROWN CONVENTION CENTER

## TORSIONAL INSTABILITY OF COOLING TOWER FAN DURING INDUCTION MOTOR STARTUP

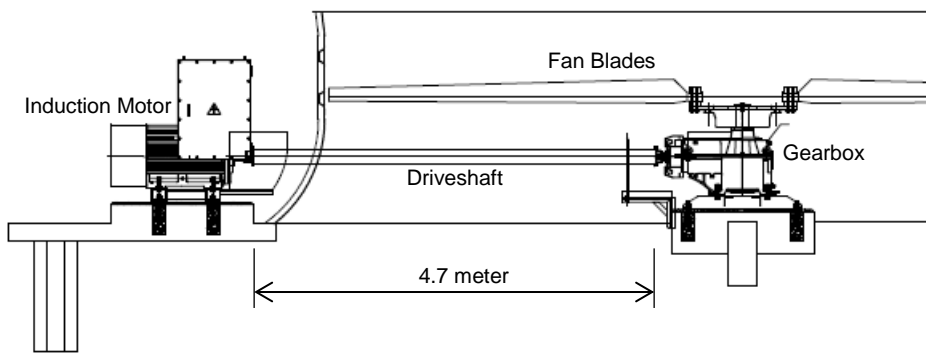
Figure 1. Outline of Cooling Tower Fan Train

An open circuit, counter flow cooling tower is equipped with a total of 16 fan trains (of which two trains are stand-by) to provide mechanical draft of cooling air. A three phase, four pole, 50 Hz induction motor with nominal output power of 295 hp (220 kW) drives each fan train. The induction motor is started direct on line without a soft starter. Nominal operating speeds are 1490 rpm for the motor, and 119 rpm for the fan. A two stage speed reduction gearbox (first stage = bevel, second stage = helical) is applied, on which the fan blades (which are made of composite material) are mounted on the hub plate installed at the output shaft. The induction motor and the gearbox are connected by a long coupling, which is termed a driveshaft in this application. The driveshaft spacer is made of carbon fiber reinforced composite material, and is approximately 15 ft (4.7 meter) in length. The induction motor and the gearbox are mounted on concrete foundations, see Figure 1.

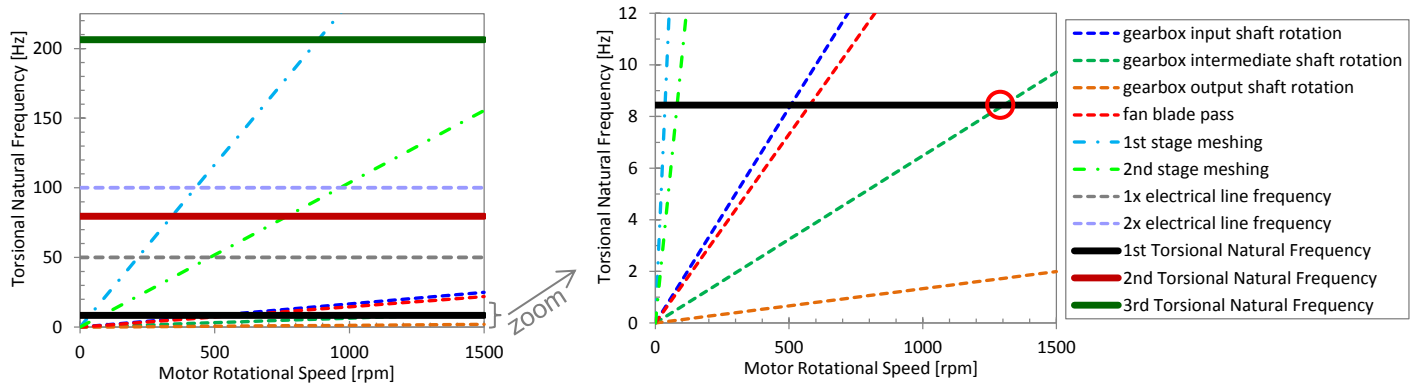
Figure 7. Campbell Diagram of Torsional Natural Frequencies

Campbell diagram of the calculated torsional natural frequencies is shown in Figure 7. As shown in this figure, the calculated torsional natural frequencies have sufficient separation margins from the potential excitation sources during the steady state operation (i.e. at 1490 rpm of motor speed). Note that, although it may appear in Figure 7 that the diverging torsional vibration during motor acceleration (as observed in Figure 3) is caused by resonance of the gearbox intermediate shaft rotational speed with the first torsional natural frequency of 8.4 Hz at around 1300 rpm of motor speed, as will be shown in the subsequent sections, the diverging torsional vibration during motor acceleration is actually caused by instability, not resonance. This case demonstrates that, although a Campbell diagram is a useful tool in identifying potential resonance, it cannot predict the possibility of instability.

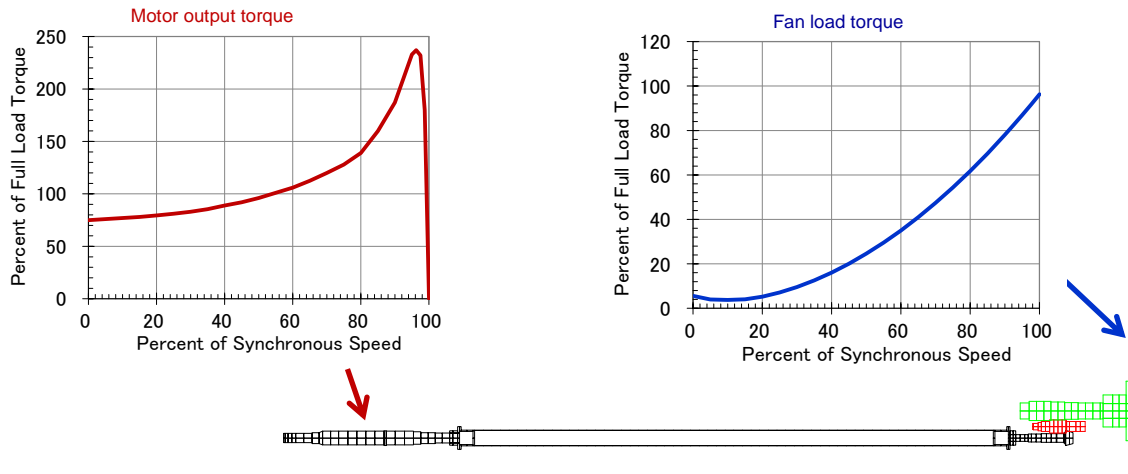
Figure 8. Transient Torsional Analysis Model

Transient torsional analysis was carried out by applying motor output torque at the motor core and fan load torque at the fan hub plate as functions of rotational speed, and by calculating a full transient solution from standstill to steady state rotational speed. The model uses speed-torque curves. Figure 8 shows plots of torque versus speed provided by the motor and fan manufacturers. In addition to this pair of speed dependent torques, a 1.3 percent modal damping ratio for the 8.4 Hz mode was implemented as a stiffness proportional damping matrix.

Reexamining the torque curve of this induction motor (Figure 8), it has a small locked rotor torque (75 percent of full load torque at 0 rpm), no corresponding pull-up torque (because the locked rotor torque is the minimum torque), and a considerably greater breakdown torque than the locked rotor torque (240 percent of full load torque, which is more than three times greater than the locked

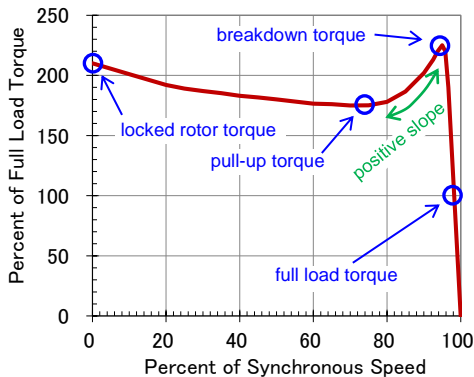
Figure 10. Typical Speed-Torque Curve (Motor)

During acceleration of an induction motor, the driving torque developed by the motor varies as a function of motor speed. Typical speed - torque characteristics curve of a generic induction motor is shown in Figure 10. As shown in this figure, the locked rotor torque, also sometimes referred to as starting torque, is the torque delivered by a motor at 0 rpm, while pull-up torque and breakdown torque are the minimum and maximum torques that can be developed, and full load torque is the torque required to produce the rated power at full speed (NEMA 2014).

As such, before reaching breakdown torque, negative effective damping is generated by an induction motor’s positive slope of its speed-torque curve, and the degree of negative damping is larger with a steeper slope.

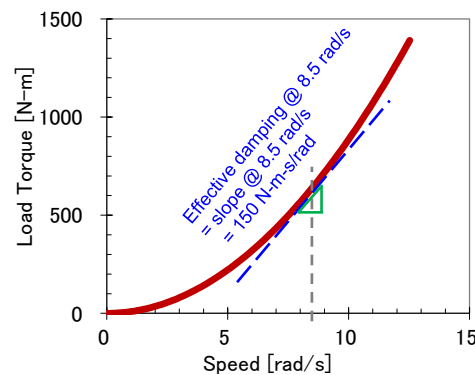
Figure 11. Effective Damping of Load Torque (Fan)

In this manner, small perturbations in torque and rotational speed become amplified by the positive slope of motor’s output torque curve. In other words, positive slope of motor torque curve can be regarded as negative damping. Conversely, negative slope of motor torque curve results in positive damping (induction motor’s speed-torque curve usually has very steep negative slope when nearing rated speed. Torsionally stabilizing effect by the slip of induction motor when at or near rated speed is attributable to this damping mechanism). On the other hand, positive slope of a load torque (i.e. the fan) is equivalent to positive damping. It can be shown that the effective damping of load torque is equal to the slope of that load torque curve (Vance 1987). For example, effective damping of the example load torque curve of Figure 11 is 1328 in-lbf-s/rad (150 N-m-s/rad) at the angular rotational speed of 8.5 rad/s (81 rpm).

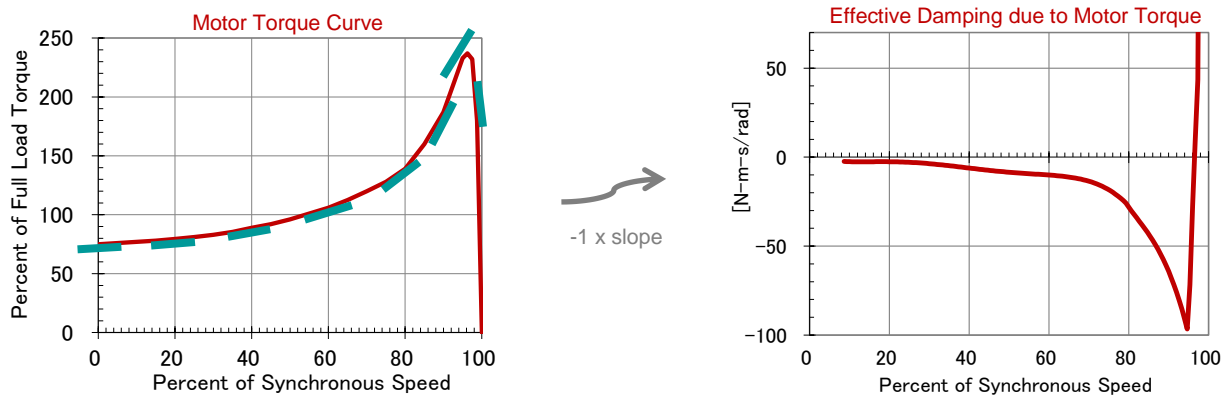
Figure 16. Derivation of Effective Damping from Slope of Motor Torque Curve

Torsional stability of a rotor system can be evaluated in essentially the same manner as lateral stability. As shown in Figure 11, effective damping of a load torque is equivalent to the slope of the load torque curve, and the effective damping of a motor torque is equivalent to the slope of the motor torque curve multiplied by -1 (because it is opposite of load torque). Hence, effective damping due to fan and motor torque curves can be derived by calculating the slope of torque curves at incremental values of rotational speed (Figure 16 & Figure 17). By applying these speed dependent damping coefficients at the locations of motor core and fan hub plate, the damping ratio for the first torsional natural frequency can be calculated at each rotational speed by damped torsional eigenvalue analysis.

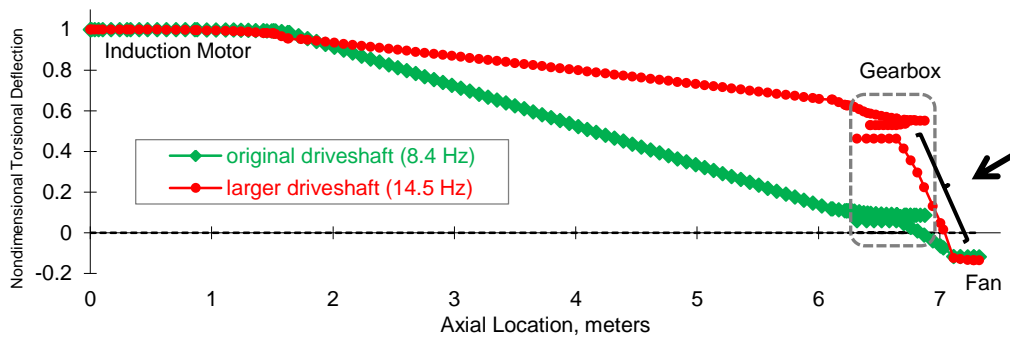
**Figure 19.** Comparison of Mode Shapes (green: original, red: countermeasure)

Figure 18 is a plot of the torsional damping ratio. With the original driveshaft, the damping ratio  $\zeta$  becomes negative (i.e. unstable) above 600 rpm motor speed, and peaks at 1420 rpm with a damping ratio of -0.17. In contrast, with the stiffer driveshaft the rotor system is stable up to 1150 rpm, and its peak negative value is down to -0.07. From this torsional stability analysis, it is clearly shown that the larger diameter driveshaft indeed contributes to stabilize the rotor system against torsional vibration. Greater stability by the stiffer driveshaft is essentially attributable to the increased elastic twist throughout the drive train instead of being concentrated in the driveshaft (i.e. other parts of the rotor system also participate to dissipate the energy in case of the stiffer driveshaft via the 1.3% proportional damping matrix described earlier). Dissipation by fan load torque was found to be negligible. See Figure 19 for the comparison of the mode shapes.

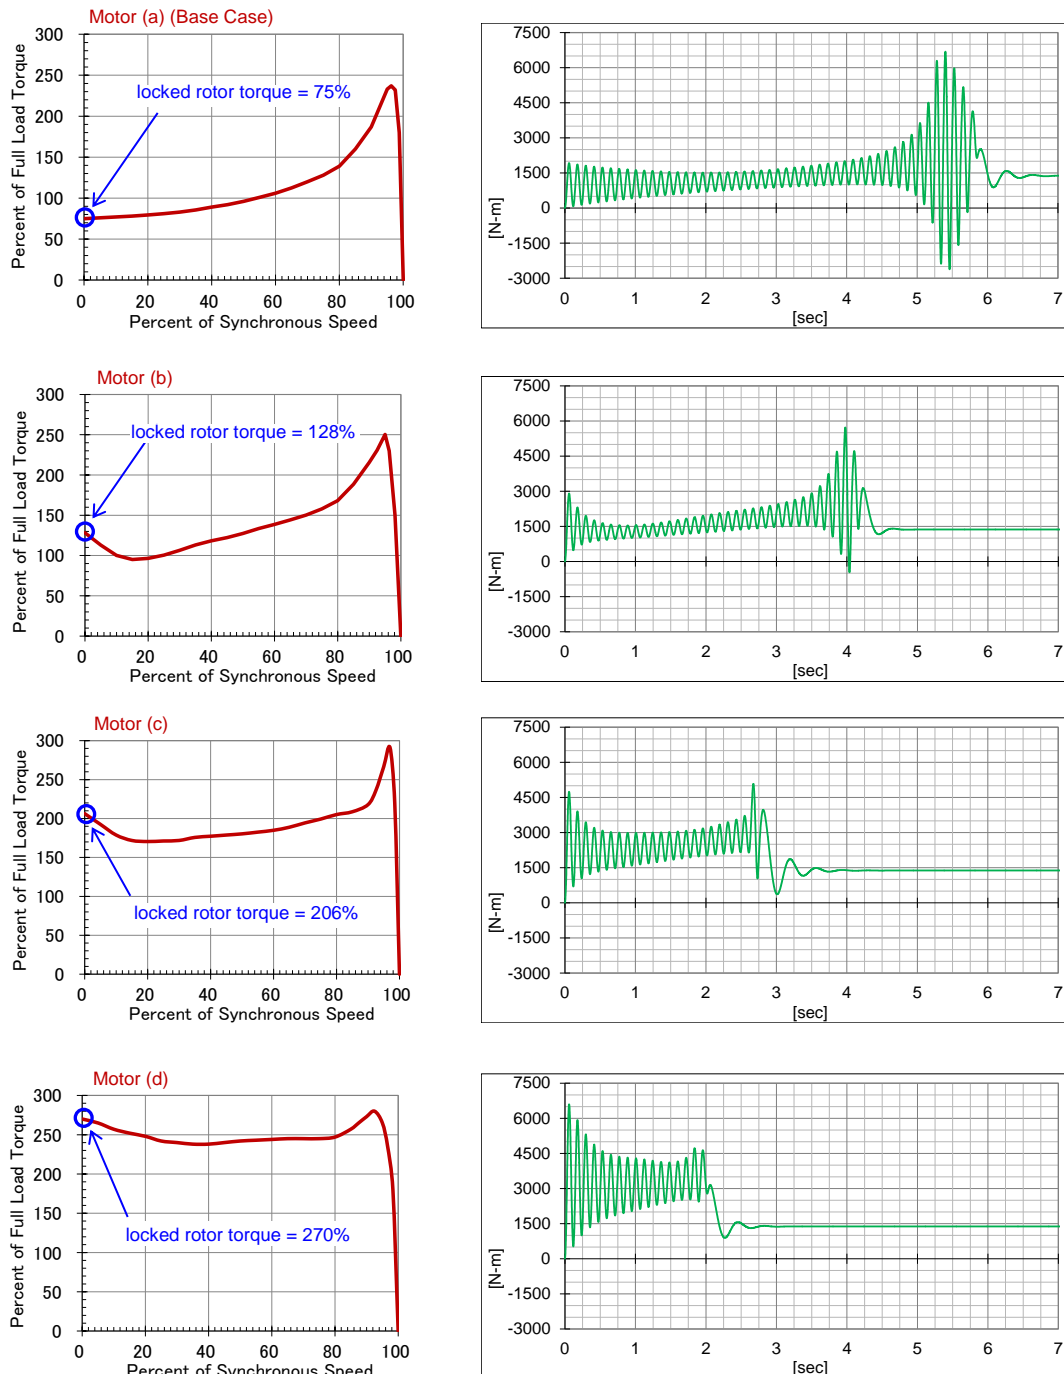
Figure 20. Various Motor Torque Curves (left) and Calculated Transmitted Torque Predictions (right)

Figure 20 is the result of this case study. When the locked rotor torque is increased to 128 percent of full load torque (Motor (b)) from 75 percent in the Base Case, the instability occurrence becomes milder, because of milder slope of the torque curve. When it is increased to 206 percent (Motor (c)), the instability is almost completely suppressed. On the other hand, because of a bigger locked

Note that, as the locked rotor torque increases, the time required to reach the rated speed reduces because of the quicker acceleration due to more output torque of the motor (e.g. it takes three seconds by Motor (d) to reach the rated speed as opposed to 6.5 sec by Motor (a)). Consequently, a larger number of cycles is experienced during motor acceleration with Base Case (Motor (a)).

It is therefore proposed that, for the cooling tower fan application, aiming to select a motor with locked rotor torque around 200 percent of the full load torque might be recommendable from the standpoint of limiting the peak torque during motor acceleration.
