Investigation of process gas compressor shaft vibration phenomena

Investigation for Process Gas HP Compressor (PGC) Shaft Vibration Phenomena

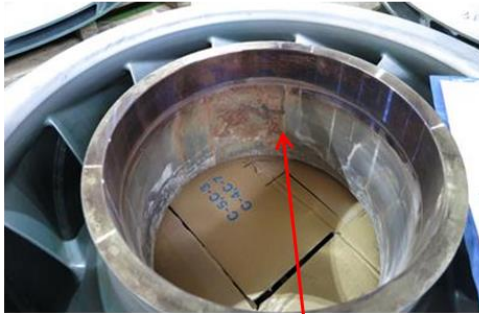
- **Heavy rust** observed around HP section (4th to 8th impeller) mainly. (Stage 1-3 is Stainless steel. Stage 4-8 is Carbon steel.)

Rotor as-found condition after disassemble 4th Impeller and shaft

Under 4th impeller

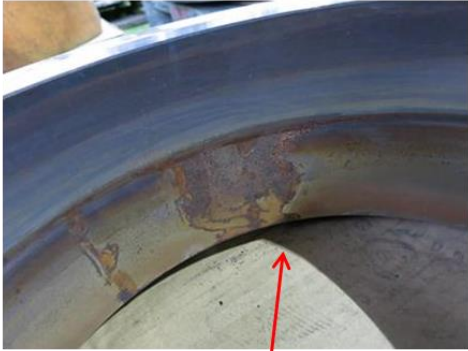
Rotor as-found condition after disassemble
8th Impeller and shaft

Under 8th impeller

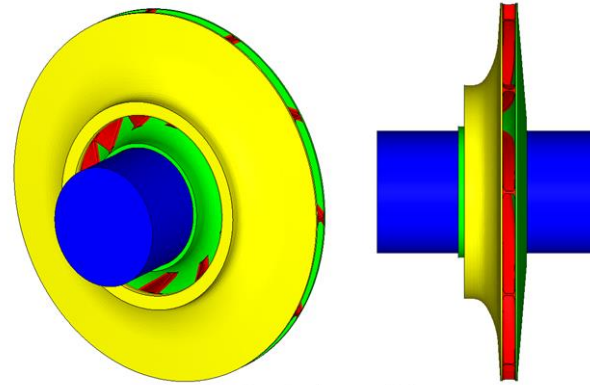
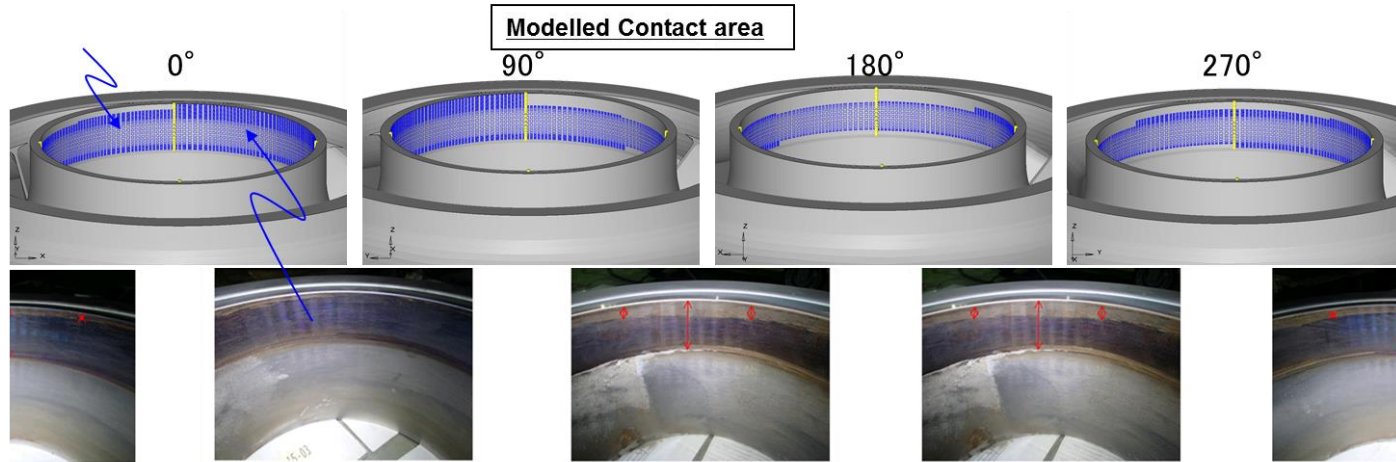
Analysis model

As found condition of contact area

- Contact area did not change with impeller centrifugal deformation.
- Contact area did not change with impeller deformation due to gas pressure too.
- Enough gripping force against gas thrust force confirmed by FEM analysis.
- The impeller did not shift during operation.

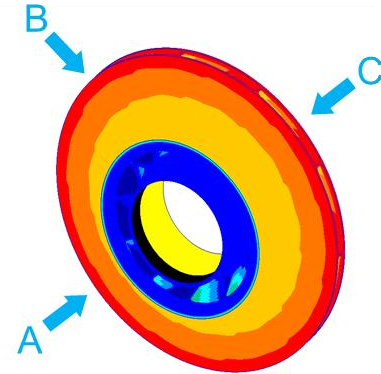
Boundary condition for pressure distribution

- 0.0005mm of deformation at impeller inside edge was caused by gas pressure.
- The impeller deformation by gas pressure was very small comparing to the deformation by centrifugal force.

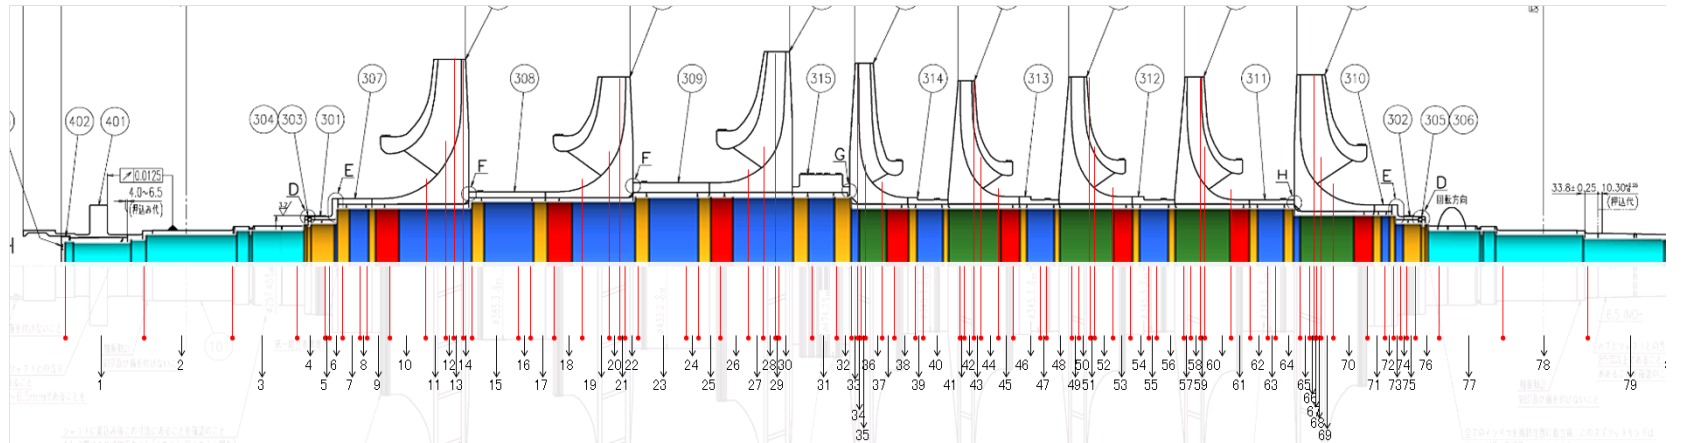
Thermal boundary condition

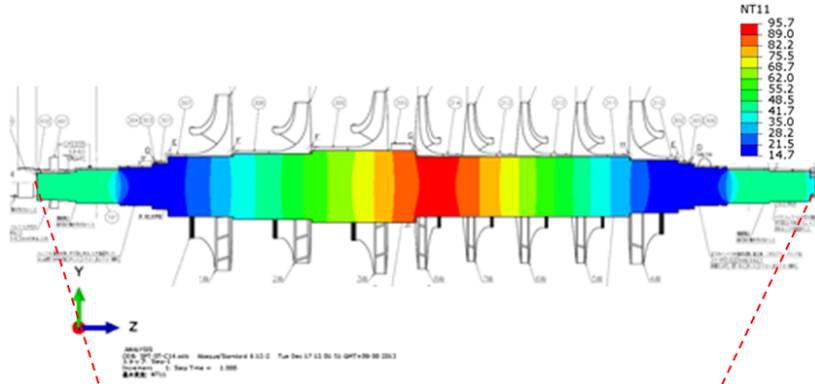
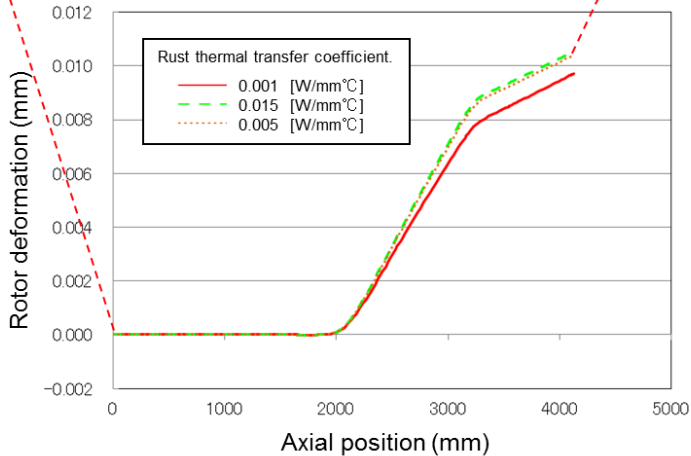
Thermal bending of the rotor could be caused by the rust, due to the uneven heat transfer from impeller.

Temperature distribution of rotor

Rotor thermal bending analysis was performed based on N2 operating condition.

Effect of thermal transfer coefficient difference was confirmed by the analysis.
