# TURBINE FAILURE AND RECONSTRUCTION

**Charles. R. Rutan**

**Lyondell Chemical Company**

## ABSTRACT

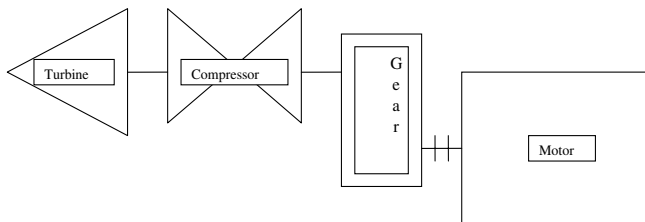
Figure 1. Compressor Platform Layout Plan View.

The operation of the compressor train is somewhat unique for a chemical plant. The turbine is started and once it reaches 6000 rpm, the motor is started and the compressor train comes up to 8676 rpm. Figures 1 and 2 show the layout of the compressor platform.

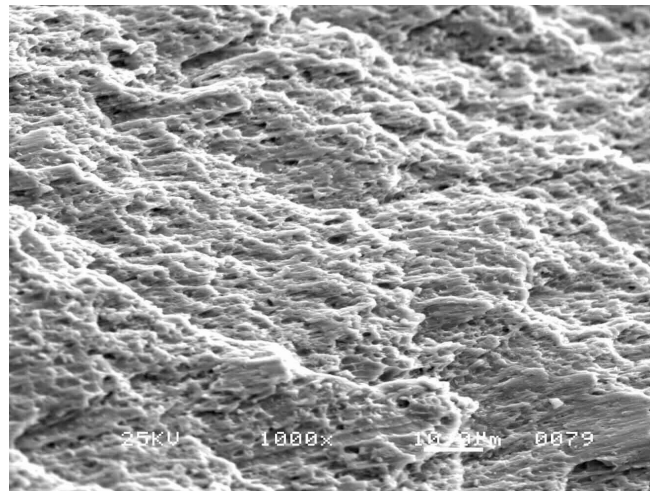
Figure 32. Elongation of Microvoids.

On one end of the fracture, there was clear sign of final ductile overload fracture (Figure 31). Also known as microvoid coalescence (MVC). Another final fracture area is found about 90 degrees to the first one. Here the microvoids appeared to be distorted or elongated (Figure 32), which indicates the fracture is at a different orientation. Efforts to locate the crack initiation site by tracing back from the final fracture areas to the opposite end of the fracture surface were not successful, as the area was too damaged to be recognizable (Figure 33).
