47<sup>TH</sup> TURBOMACHINERY & 34<sup>TH</sup> PUMP SYMPOSIA  
HOUSTON, TEXAS | SEPTEMBER 17-20, 2018  
GEORGE R. BROWN CONVENTION CENTER

# Resolving High Vibration On a Vertical Pump

Baker Hughes, a GE Company

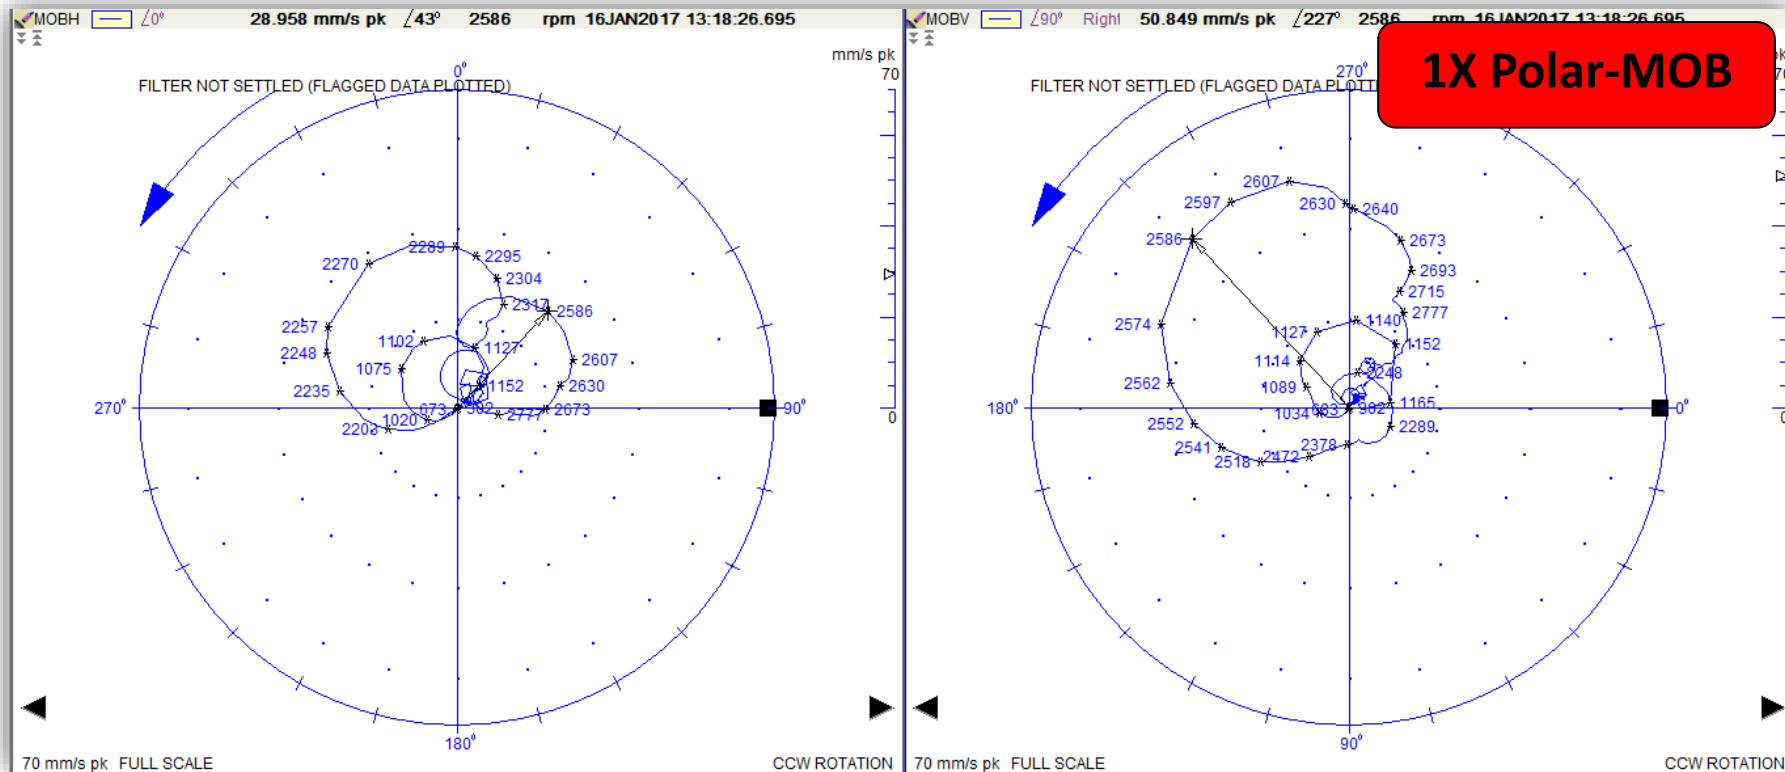
# Data Analysis— Coupled Run “cont’d”

- High overall vibration levels with 1X motor dominant frequency
- Transient Start-Up / Shut-Down data showed that the unit is running well above the 2nd critical speed
- **The highest amplitude while passing the 2<sup>nd</sup> critical frequency (2.7 in/sec Peak)**

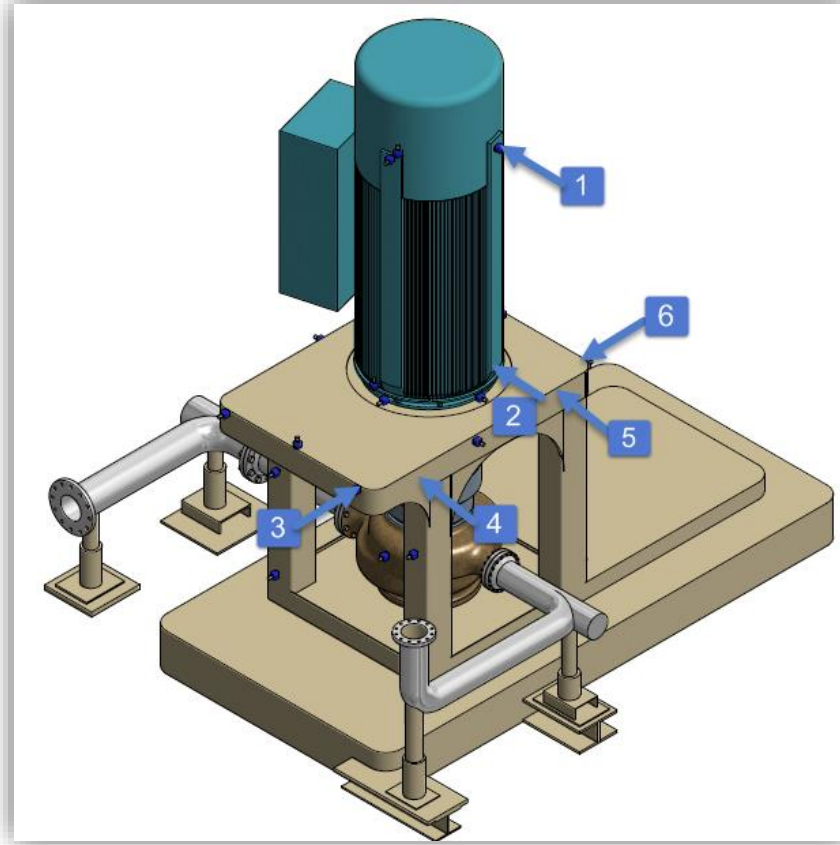
# Data Analysis-Impact Test

- High vibration levels on the motor, pump and structure for more than 2 years (0.43 in/sec Peak at steady state)
  - 1X motor dominant vibration component.
- Bump test showed natural frequency at 43Hz
- Many trials were done by the End User to reduce the high vibration:
  - Total mass of 220lbs were added to the structure
  - Additional supporting braces
- Vibration levels remained as high as the original measurements

Point#5 Showed Natural Frequency Close to The Running Speed

Other Points Showed Natural Frequency BUT Away from The Forcing Frequencies
