SHELBURNE SHIPYARD STEAMBOAT GRAVEYARD: ARCHAEOLOGICAL  
INVESTIGATION OF FOUR STEAMBOAT WRECKS

A Thesis

August 2015

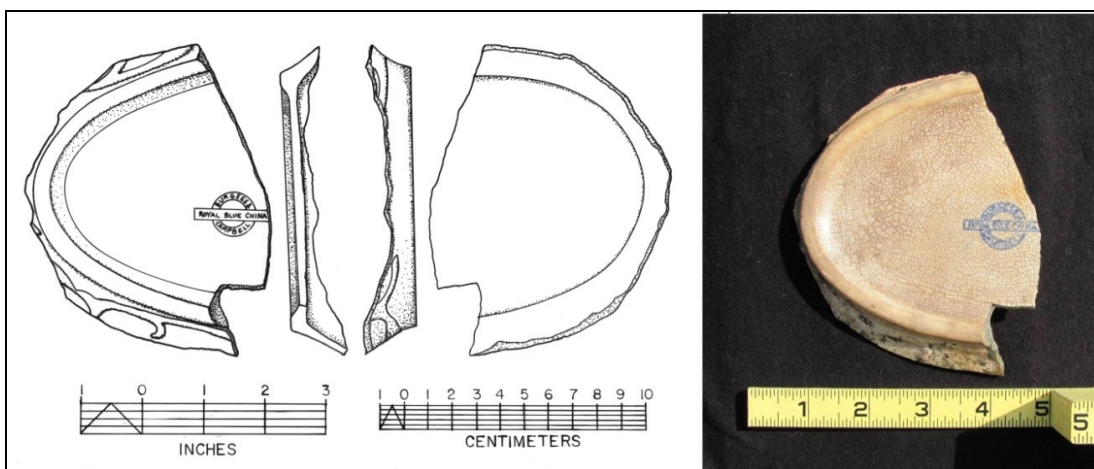
Prior to identification, Wreck 1 was observed to have the most engine bed timbers by far of all of the wrecks, separating it from the other wrecks. Furthermore, within the first week a diver recovered a ceramic plate fragment from Wreck 1 with the maker's mark 'Burgess & Campbell' on the underside (Figure 11). Research revealed that this British company operated between the years 1879 and 1895.<sup>37</sup> Finally, LCMM Director Emeritus Arthur Cohn discovered a photograph dating to the mid-1890s portraying a stripped-down steamboat hull floating directly over where Wreck 1 was sunk, that was hand-labeled '*A. Williams*' (Figure 12). These combined clues strongly suggested that Wreck 1 was indeed the 1870-built steamer *A. Williams* (Figure 13).

Figure 11. Ceramic plate or serving-platter fragment with maker's mark 'Burgess & Campbell'. This plate helped date and identify Wreck 1. (Drawing and photo by Nathan Gallagher.)

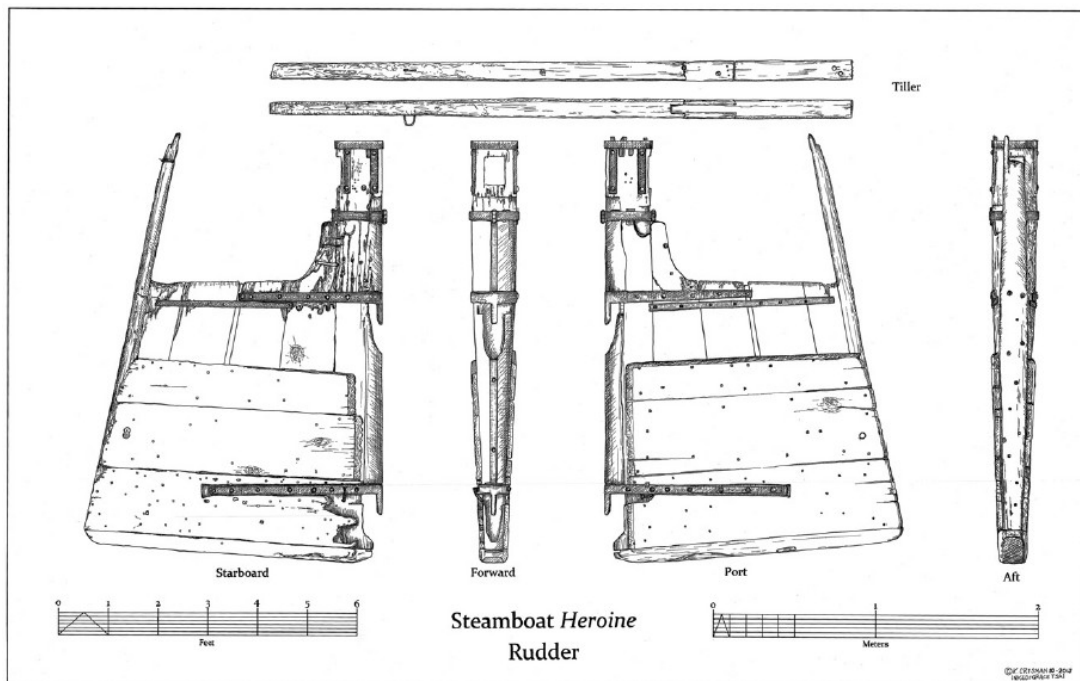
This symmetrical rudder was typical to steamboats in North America's inland waters. For example, a similar configuration was found on the rudder of *Heroine*, an 1832 western river steamboat.<sup>52</sup> On this steamboat the furthest aft timber is made much narrower than the other rudder timbers, and was as tall as the rudder post (Figure 20). Wreck 1's final rudder timber was made taller, like *Heroine*, but unlike *Heroine*'s aft-most timber, Wreck 1's was substantial. This upward projection was attached to the steering mechanism with block and tackle to allow for better control over the entire rudder. By attaching lines to the outer extremity of the rudder, the need for long tillers was eliminated and wheels could be substituted, freeing up space on the deck.<sup>53</sup> Also, being longer and shorter than most rudders, steamboat rudders may have been somewhat difficult to turn, needing more direct leverage.

Figure 20. *Heroine*'s "barn-door" shaped rudder. (Crisman, 2013: 146.)

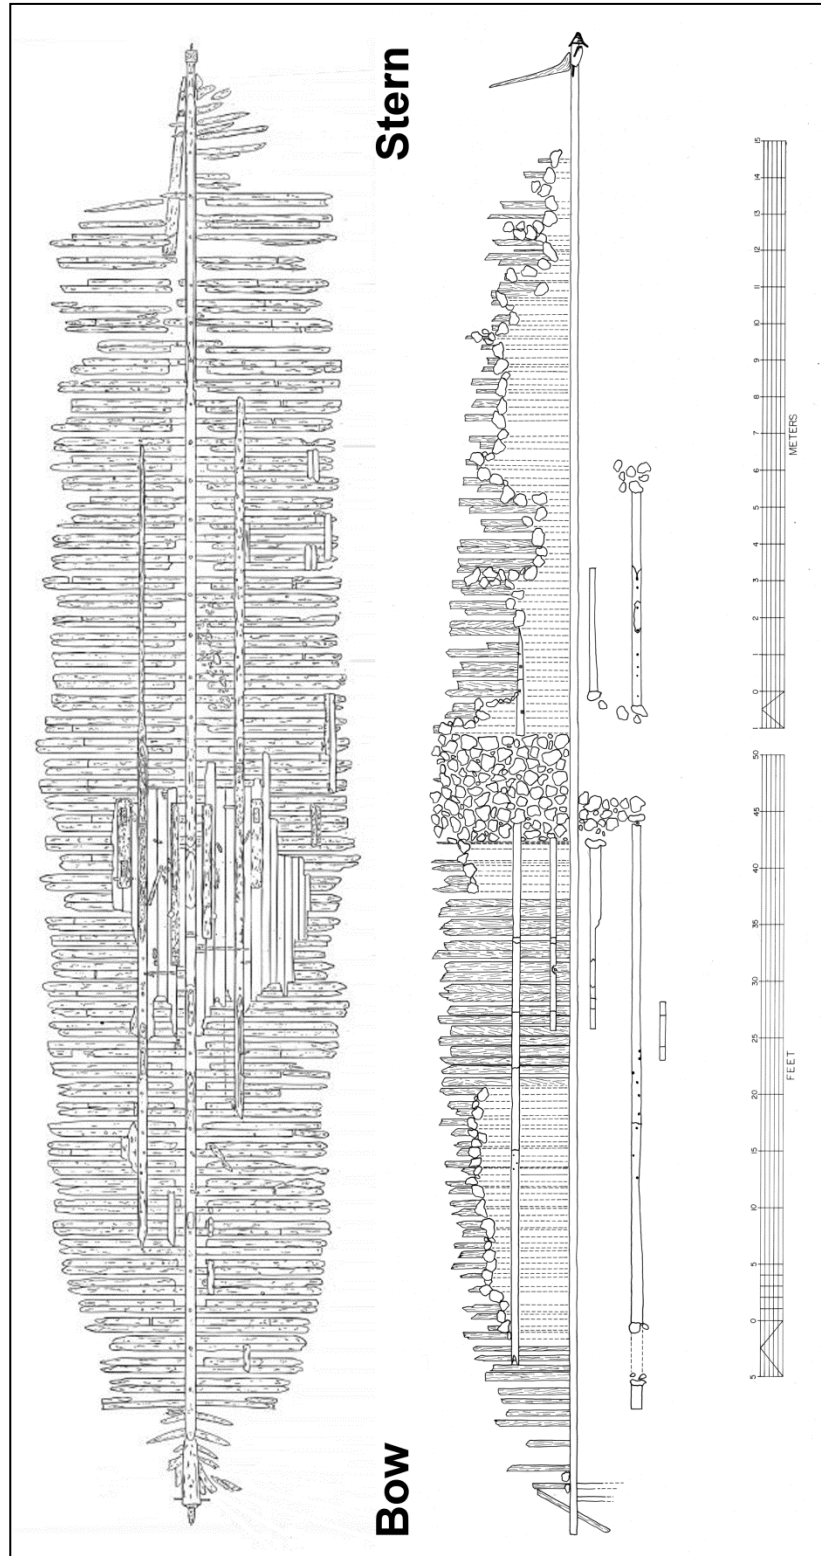
The construction of this steamboat is reminiscent of the construction of the 17-year earlier steamboat *Phoenix* of 1815 (Figure 23). *Winooski*'s frames, like those of *Phoenix*, were heavy and closely-spaced. The average sided dimension of the frames was 9 in. (22.9 cm) and molded dimension of 9 in. (22.9 cm), with spaces between frame pairs ranging from 4 in. (10.2 cm) to 9 in. (22.9 cm) (therefore giving them an average of 22 in. [55.9 cm] between frame centers). Since most of the frame measurements were taken considerably outboard of the keelson, it was difficult to identify which timbers were floors and which were futtocks.

Figure 23. Wreck site plans of *Phoenix* and Wreck 2, scaled and aligned at stemposts. (*Phoenix* site plan Schwarz, 2012: 129.)

The engine bed timbers on Wreck 2 were similarly sized and placed as those on *Phoenix* (see Figure 23). Two pairs of bed timbers on each side of the hull were recorded and labeled Starboard 1 and 2 (S1 and S2) and Port 1 and 2 (P1 and P2). S1 and P1 were the shorter, inboard timbers, and S2 and P2 were much longer and further outboard. S2, running parallel to the keelson at a distance of 4 ft. 6 in. (1.4 m) from the starboard side of the keelson, was broken forward of 16 ft. 1 in. (4.9 m) MBL, but continued as far aft as 64 ft. 4 in. (19.6 m) MBL, where it was broken by the rocks piled here. From 64 ft. 4 in. to 72 ft. (19.6 m to 21.9 m) MBL, S2 is completely covered by rocks. Aft the rock pile, S2 extended from 72 ft. to 81 ft. 7 in. (21.9 m to 24.9 m)

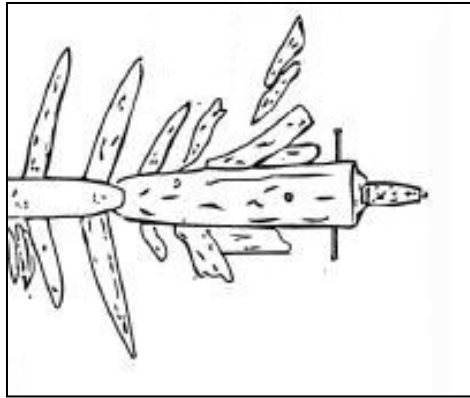
At the top of the lower stem section, a horizontal iron bolt ran perpendicular to the axis of the keel. The 22 in. (55.9 cm) long fastener extended horizontally across the broken upper face of the stem, extending out 7 in. (17.8 cm) on the port side and 6 in. (15.2 cm) on the starboard side. A similar fastener was present on the stem of *Phoenix* (Figure 24). The purpose of the bolt is unknown; however, it may have been used for securing the hood ends of the planking. Another iron bolt extended downward approximately 1 ft. (30.5 cm) from the forward face of the stem.

Figure 24. A large iron bolt protrudes from either side of Phoenix's bow. A similar feature was found on Wreck 2's bow.
