45<sup>TH</sup> **TURBOMACHINERY** & 32<sup>ND</sup> **PUMP SYMPOSIA**  
HOUSTON, TEXAS | SEPTEMBER 12 – 15, 2016  
GEORGE R. BROWN CONVENTION CENTER

Potassium Carbonate Pump Failure – High Axial Movement due to Uncontrolled (unbalanced) forces.

Ibrahim AbdAl-Wahab  
Ammonia Sector Head  
Misr Fertilizer Production Company

Hatem AbdelRahman  
Machinery Section Head  
Misr Fertilizer Production Company

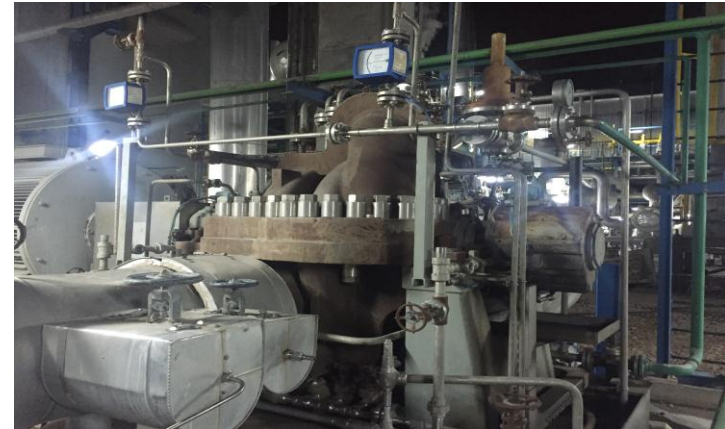
Rotor assembly and balancing , check casing wear rings and throat bushings clearances measuring

- The rotor parts were assembled and balanced
- The new impeller wear ring of first stage impeller was machined in work shop to get the optimum clearance and size

- All new casing wear rings machined in our work shop to get the optimum size
- The pump casing was deformed in lower and upper parts in two locations. Some machining activity was done for the new DE throat bushing also for inner casing wear ring for first stage impeller. Some lapping was done to get the optimum surfaces established for these items with casing and shaft to get the optimum clearance

- Assembling the rotor complete with all parts with measuring all clearances , it was all after machining according to standard
- Assembly a new mechanical seal for both DE and NDE according to optimum dimensions

- Assemble a new hydrodynamic bearing with the optimum clearance
- Assemble a new thrust bearing with the optimum clearance
- Assemble the pump casing
