# Thermal Load Effect on Vibration on a Reactor Feed Water Pump (FWP)

Nine Mile Point Nuclear Station (NMPNS) Unit 2 – 1150 MW (Oswego, NY)

Application:	Reactor Feed Water Pump (FWP)
Type:	20x20x22 – 2 Stage (barrel type radial split)
Capacity:	8,000 gpm (min flow) to 22,870 gpm (max flow) Normal operation steady slightly above BEP
Suction Press.:	550 psig
Discharge Press.:	1,200 psig
Speed:	3,339 rpm (55.7 Hz)
Temperature:	382 °F
Normal Load:	10,500 to 11,500 BHP
Driver:	Induction Motor (16,500 HP @ 1785 rpm (29.8 Hz))
Gearbox:	Speed Increaser (Gear ratio 1:1.87)

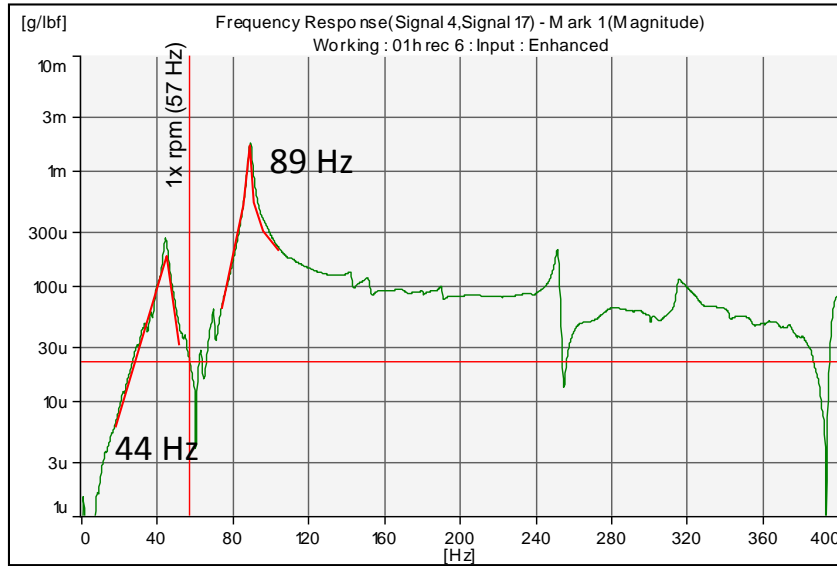
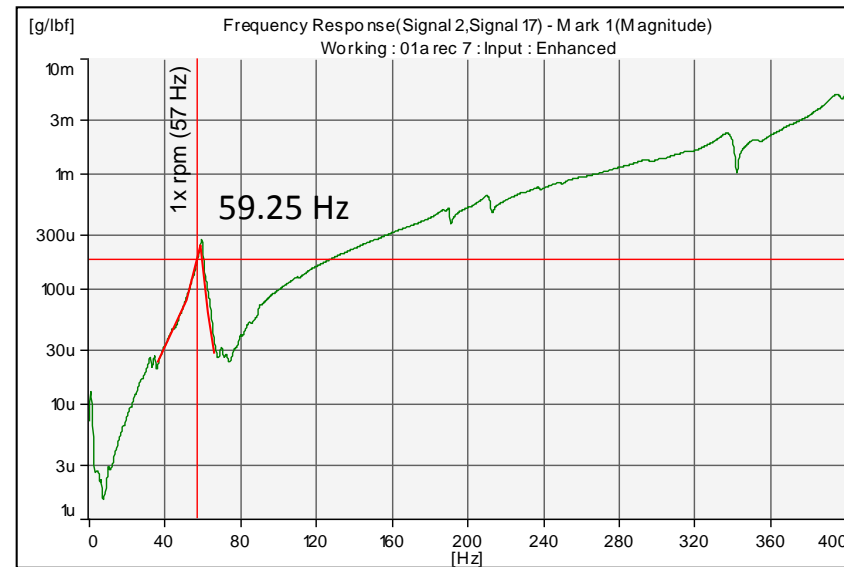
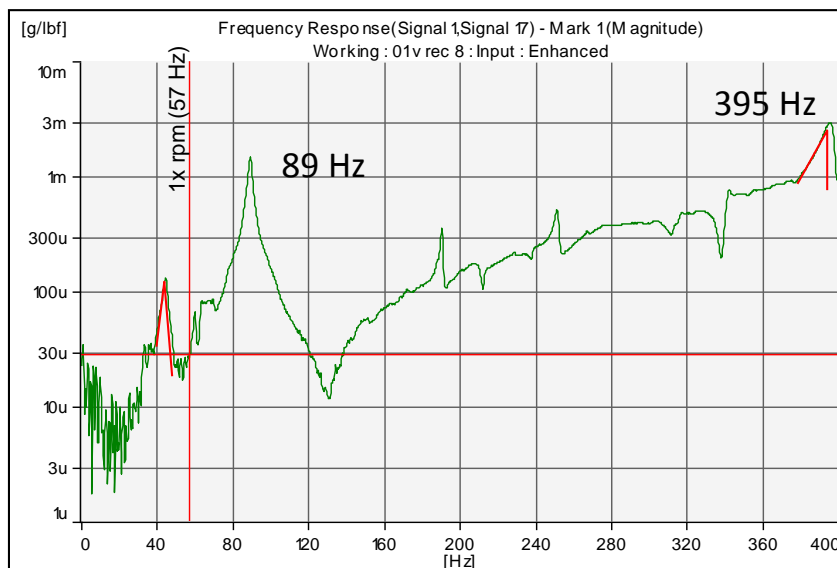
## 2FWS-P1A Pump Typical FRF Plots

Horizontal Direction

Axial Direction

Vertical Direction

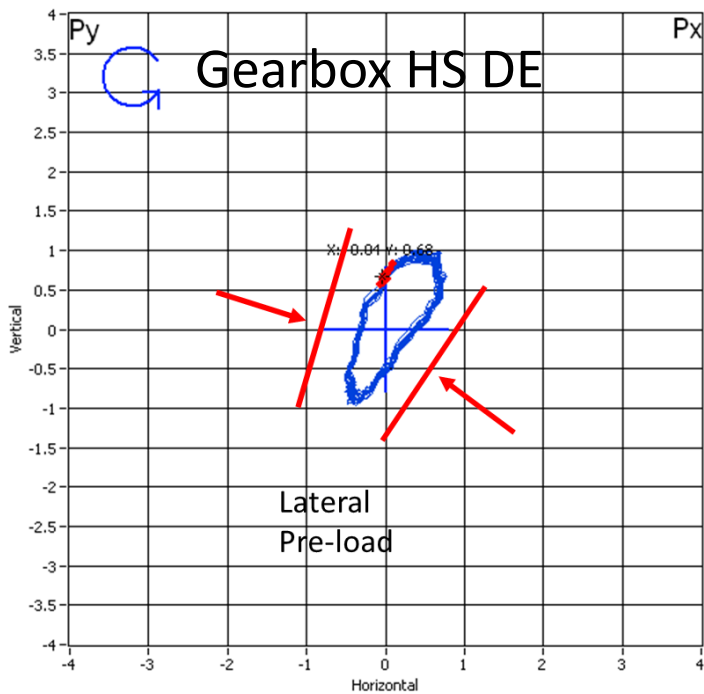
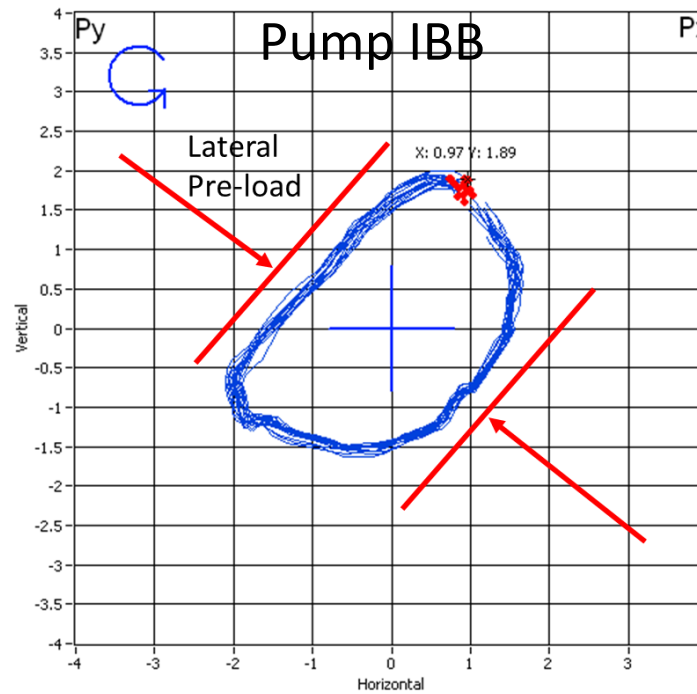
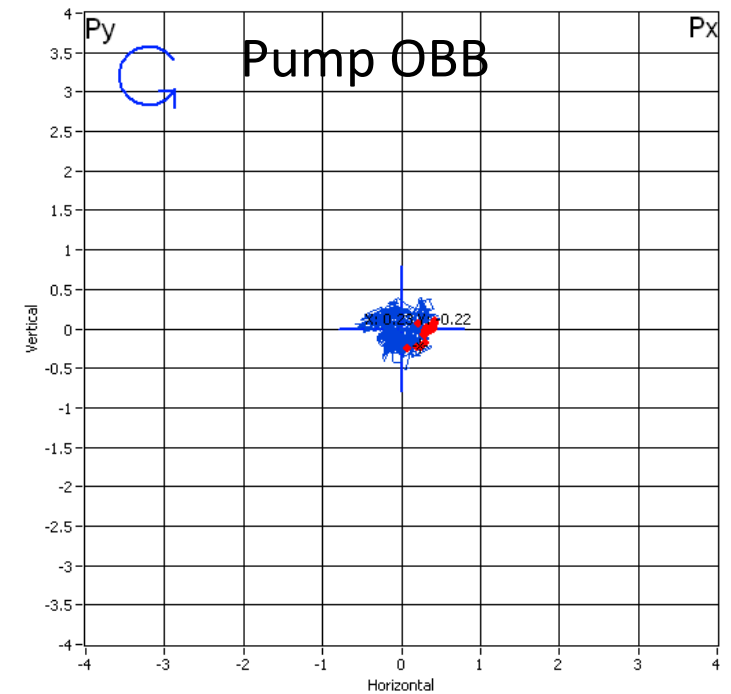
# Orbit Plots 20,000 GPM @ 3:56, 6-13-2010

June 2010: High synchronous vibration was detected only at the IB end of the pump shaft (over 4.2 mils pk-pk).

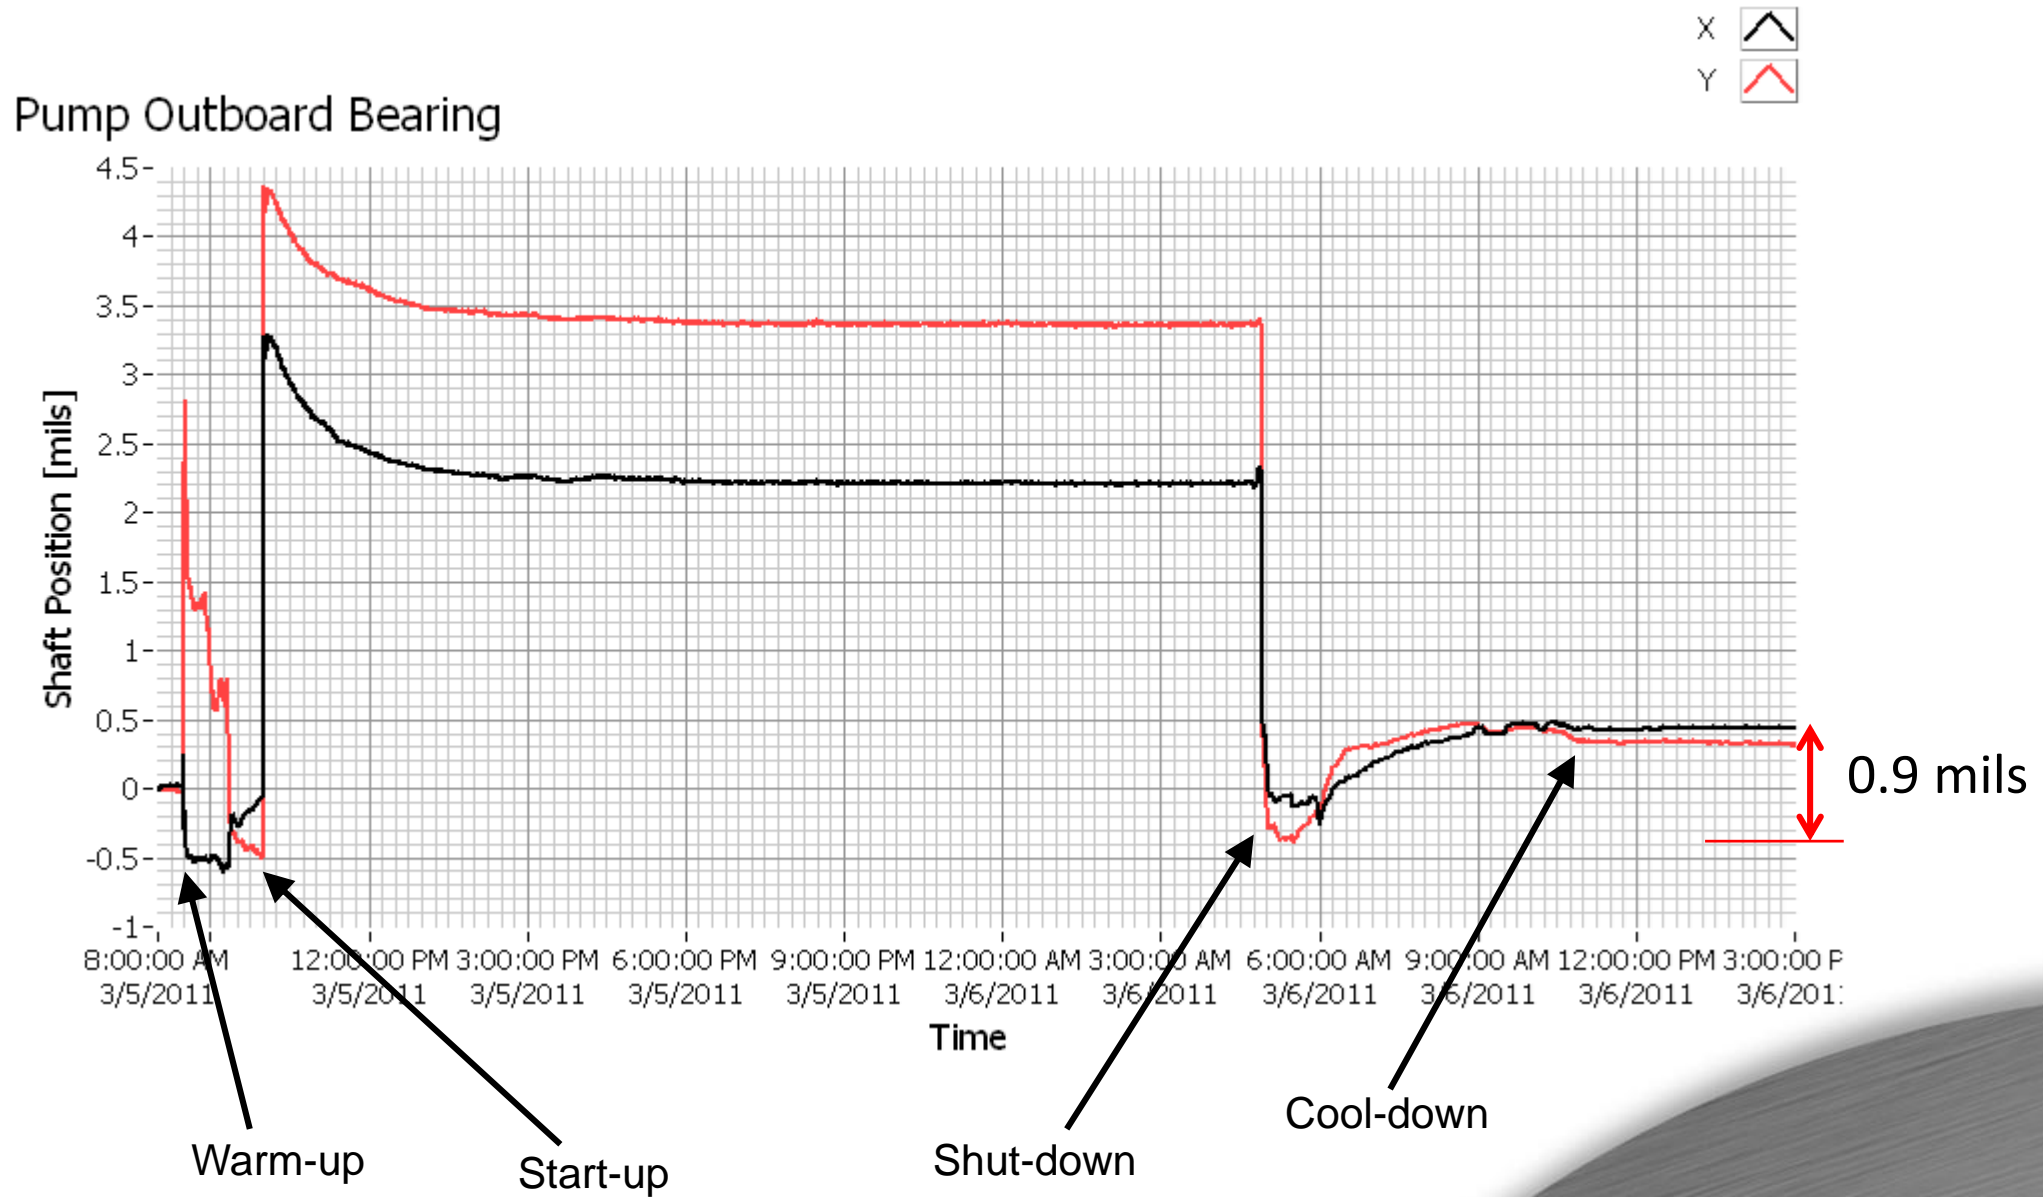
# Pump OBB - Shaft Movement

1<sup>st</sup> stage flow path did not allow uniform thermal expansion of the pump casing at the IB end cover. Former seal injection design allowed accumulation of condensate seal water at the bottom of the pump casing with lower temperature than the reactor feed water. This was causing distortion of the inboard cover plate and therefore internal misalignment at the IBB.

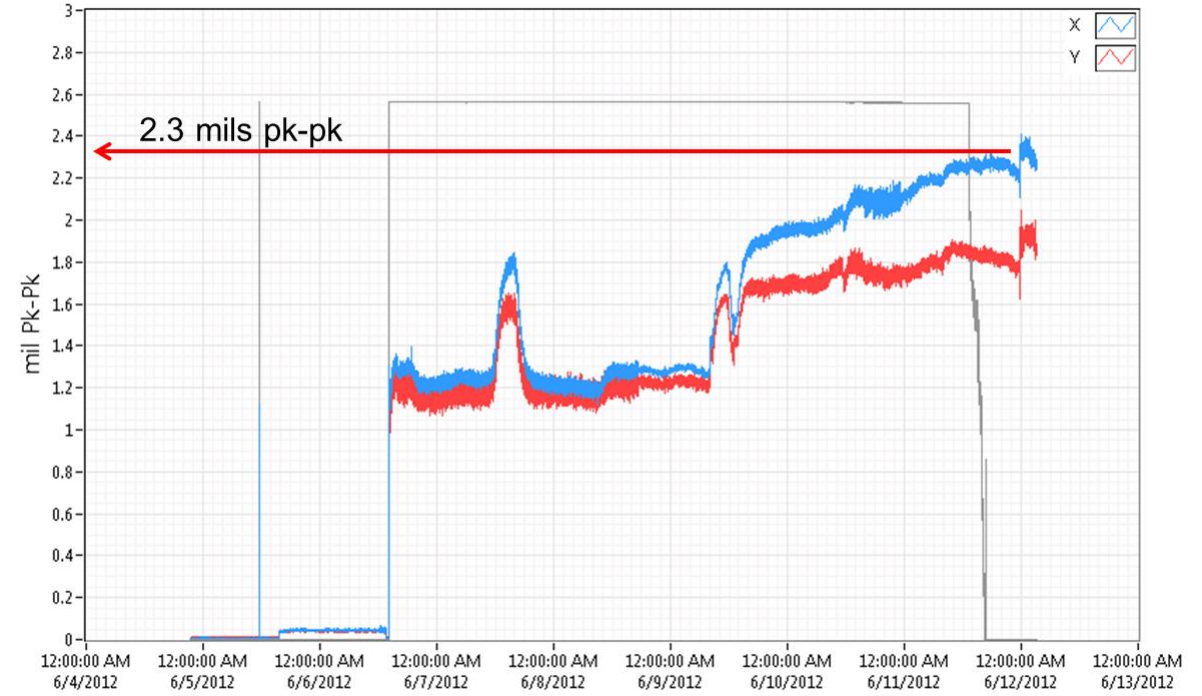
Pump Shaft Vibration - Inboard

1. Modifications implemented on these pumps during the outage (i.e. seal injection API plan 23) eliminated the thermal distortion effect that was causing deformation of the inboard end cover of the pump.
2. Previous seal injection design allowed accumulation of condensate seal water at the bottom of the pump casing with lower temperature than the reactor feed water. This was causing distortion of the inboard cover plate and therefore internal misalignment at the IBB.
3. The shaft vibration at the IBB used to be approximately 4.5 mils pk-pk, while the vibration at the OBB was approximately 1.0 mil pk-pk. Vibration data gathered after the outage indicated significant improvement at the IBB (2x reduction).
4. Radial proximity probe GAP voltage readings were not changing over time during the warm-up or cool-down processes, versus such changes that had been identified in previous tests.
