45TH **TURBOMACHINERY** & 32ND **PUMP SYMPOSIA**
HOUSTON, TEXAS | SEPTEMBER 12 – 15, 2016
GEORGE R. BROWN CONVENTION CENTER

Sub-Synchronous Vibration on Centrifugal Compressor with Tilt-Pad Bearings

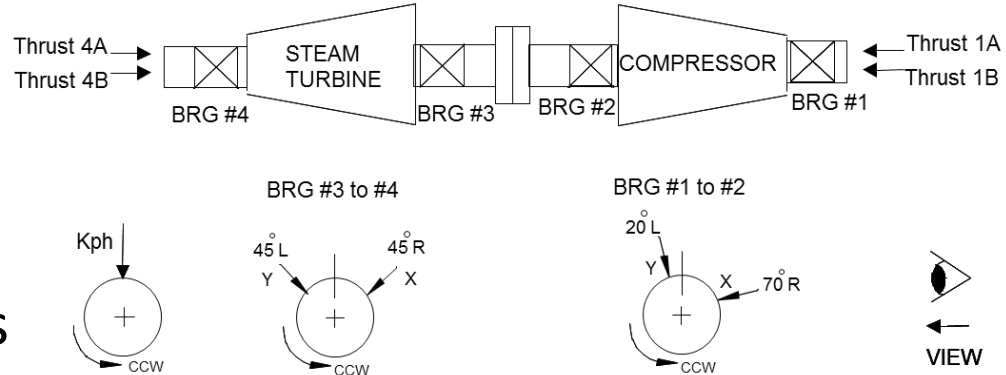
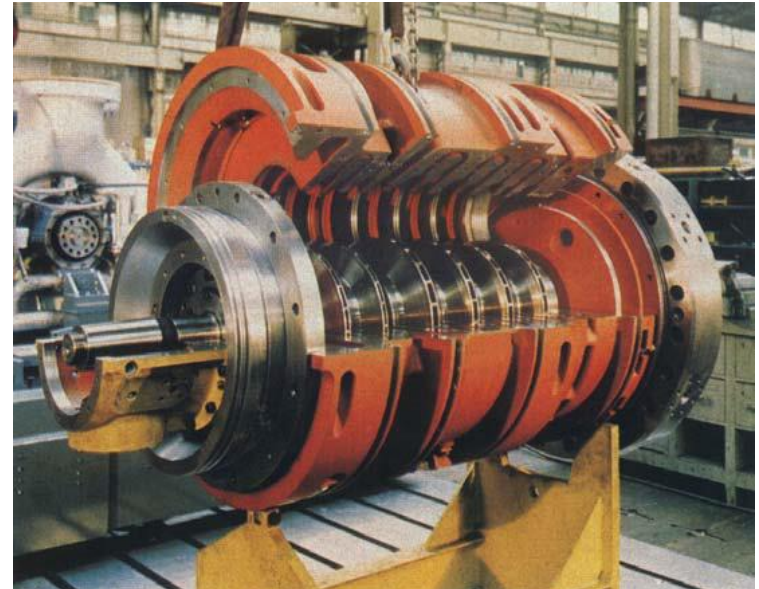
1. Introduction

- 5-stage hydrogen recycle centrifugal compressor
- Supported by 5-pad tilt bearings with LBP arrangement
- Maximum speed ~ 8600 rpm
- Vibration monitored by X-Y pairs of proximity probes at all bearings, with site convention of looking from outboard to inboard of the compressor.
