ASIA TURBOMACHINERY & PUMP SYMPOSIUM  
SINGAPORE | 22 - 25 FEBRUARY 2016  
M A R I N A B A Y S A N D S

# Steam Turbine Vibration Resonance of Pedestal, Vibration Investigation with Countermeasures in Singapore

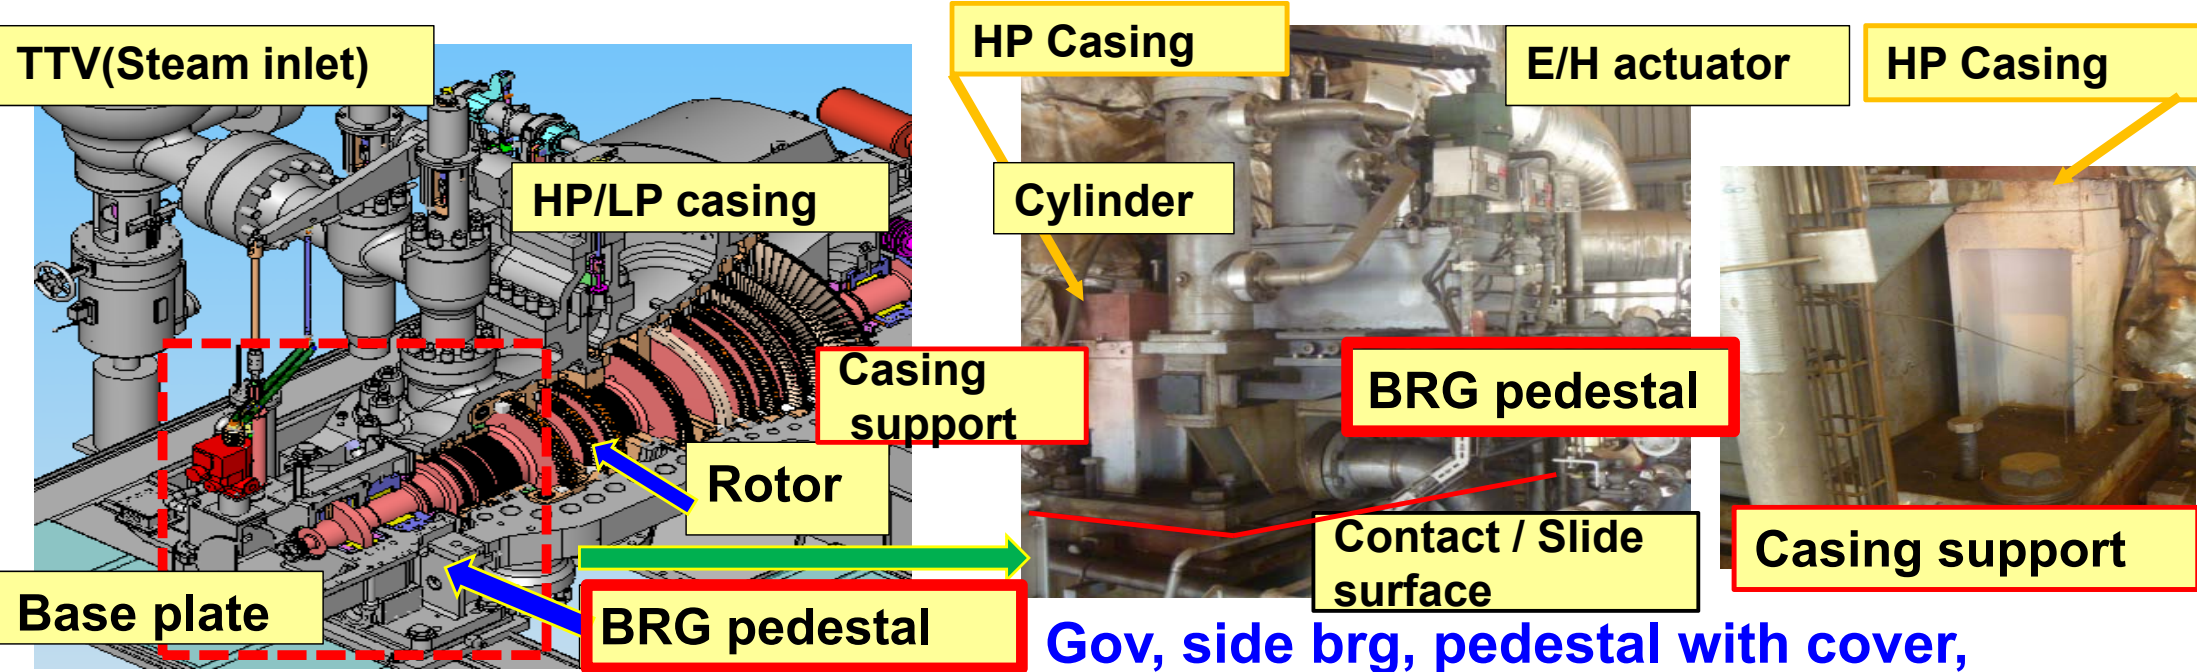
**Section drawing of turbine**

## **Turbine specification ;**

Max, power ; 44MW

Speed ; 3451 – 4263rpm

Plant start ; from 2000

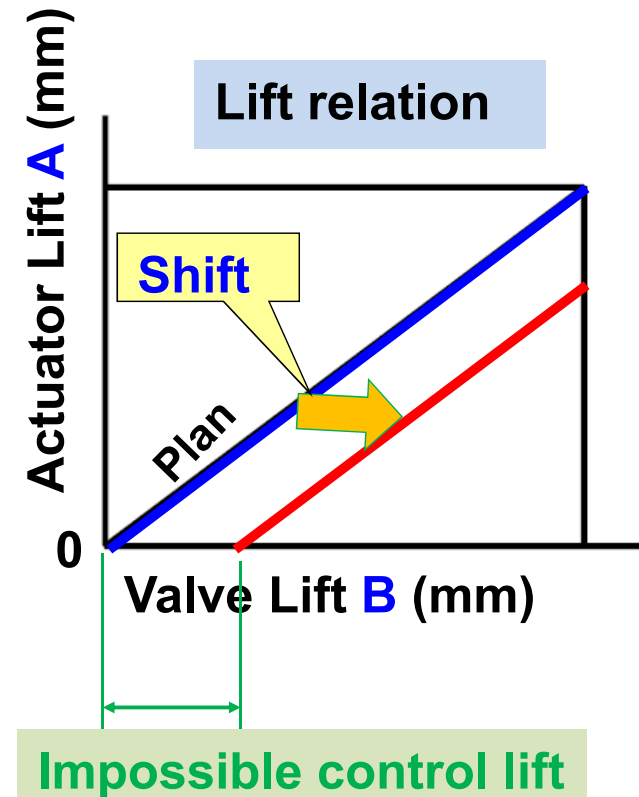
F-B LEVER moved  
from center, and  
heavily worn

It was shifted actual inlet steam flow with valve lift B  
against E/H actuator lift A.

Also, Impossible control area occurred.

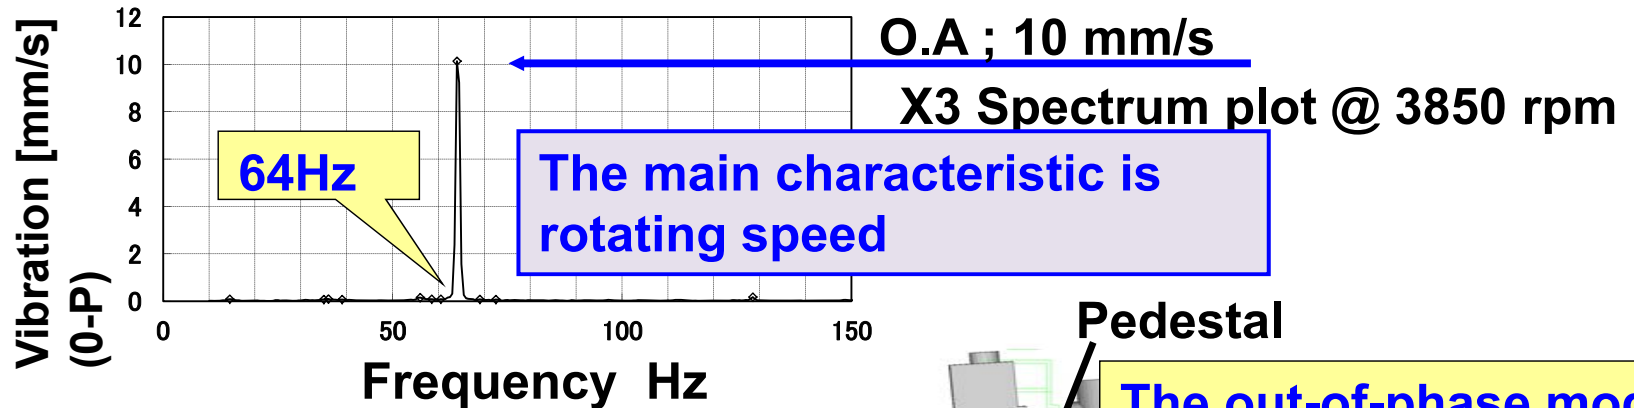
Site measurement points (No,30)

Measured vibration mode at 3850 rpm (59Hz)

The main characteristic of the vibration mode is an out-of-phase (counter-motion) mode between main pedestal and casing support

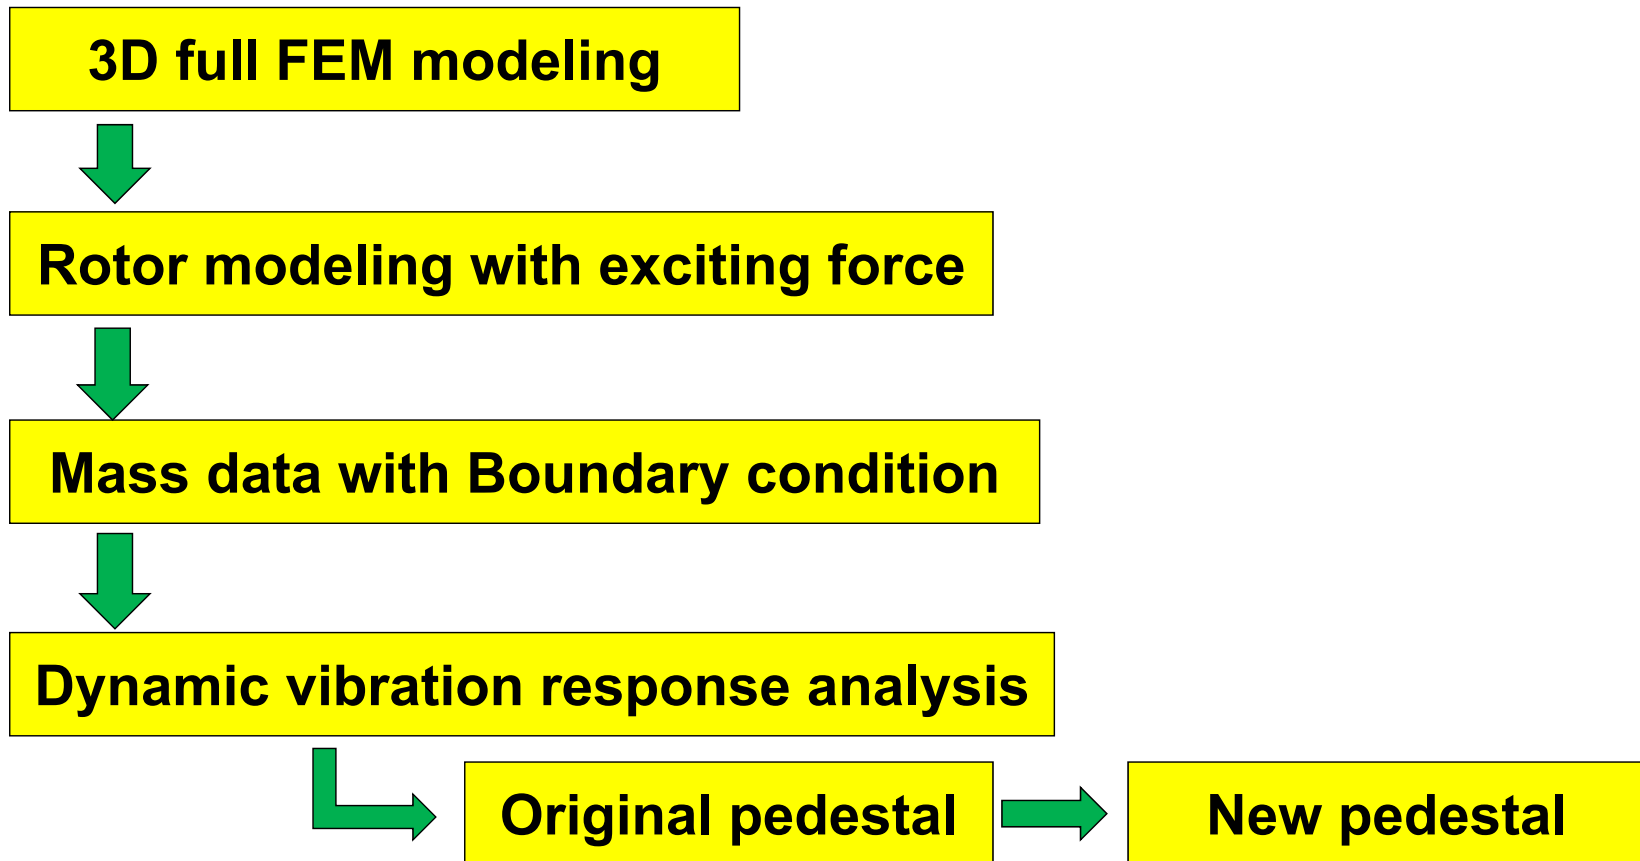
In order to clarify the vibration mechanism, it performed vibration 3D response analysis(cod-Nastran) with current bearing pedestal.

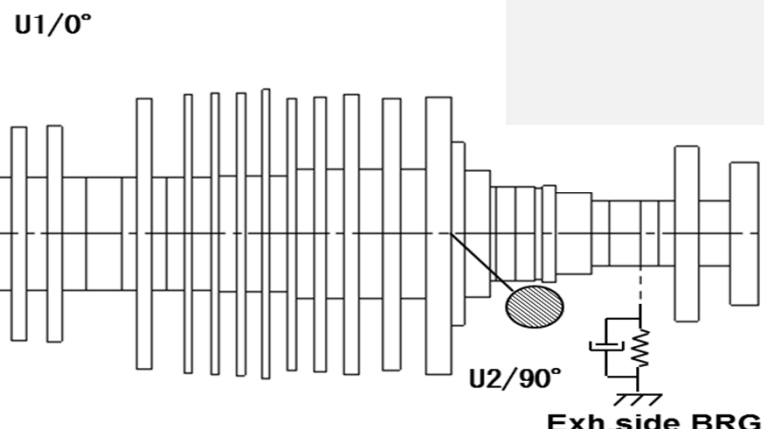
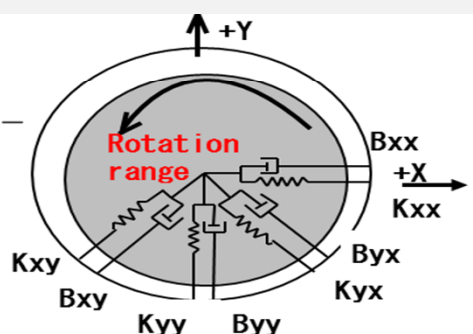
Calculation of BRG reaction force by rotor unbalance response (Code=ROT-CAE)

Rotor model :  
 1st-2<sup>nd</sup> unbalance mode  
 U=Unbalance value based 5 times  
 up API limit =66.85 kg·mm  
 (U/2=U1=U2)

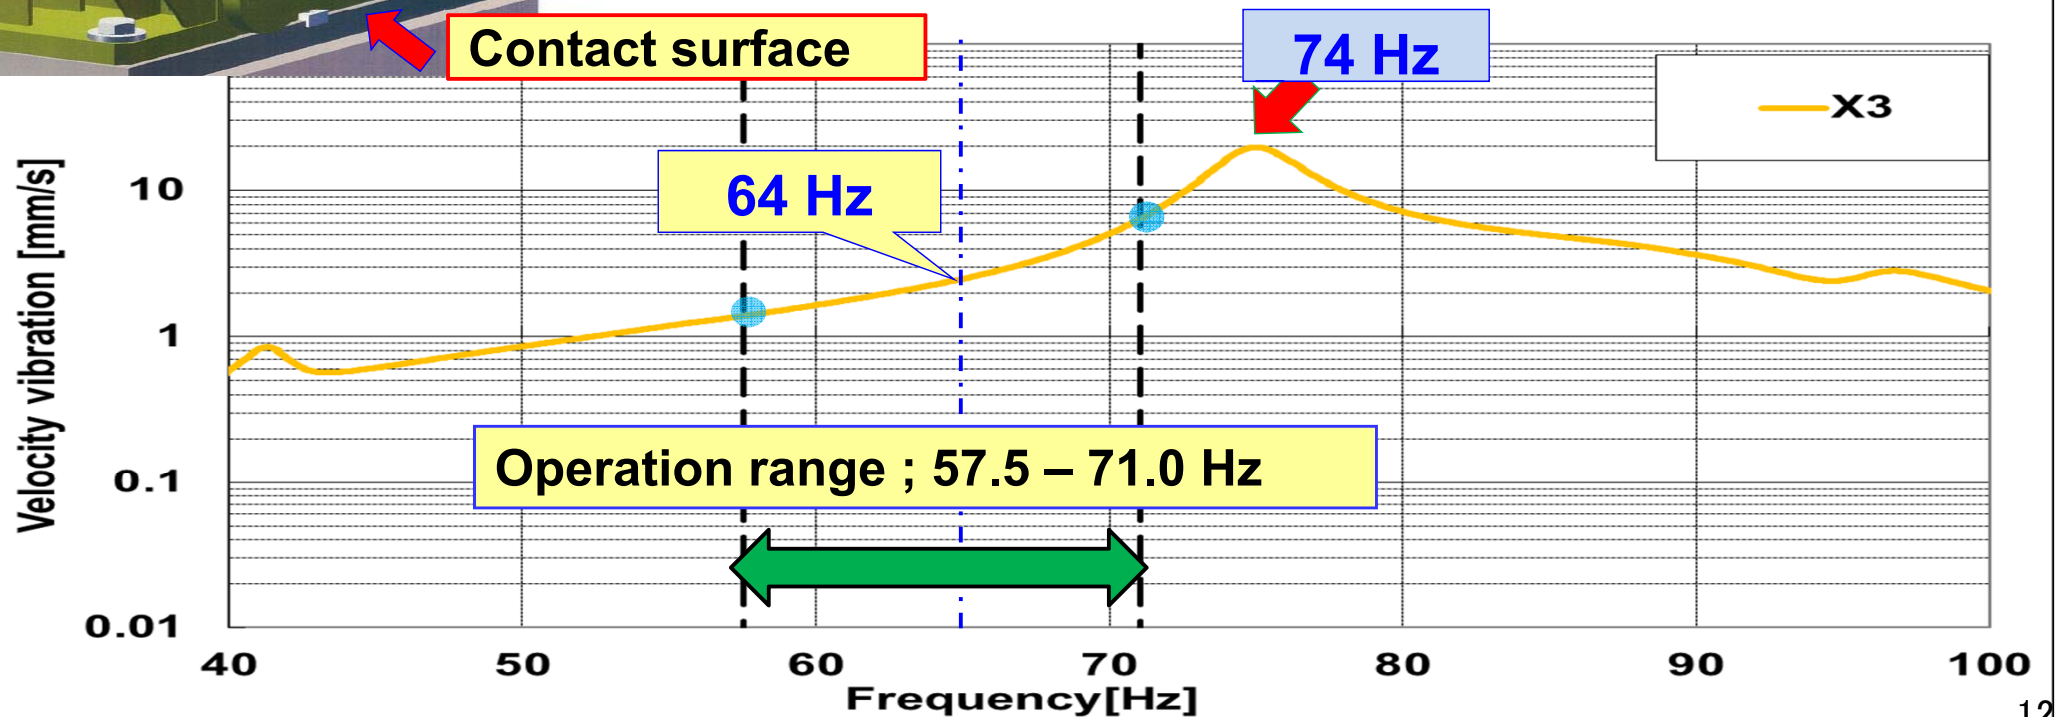
- Natural frequency 74 Hz is close to the turbine operating speed range at hot condition.
- Vibration level in analysis is from 2 to 10 mm/s 0-P around normal to maximum speed as same as site vibration level.

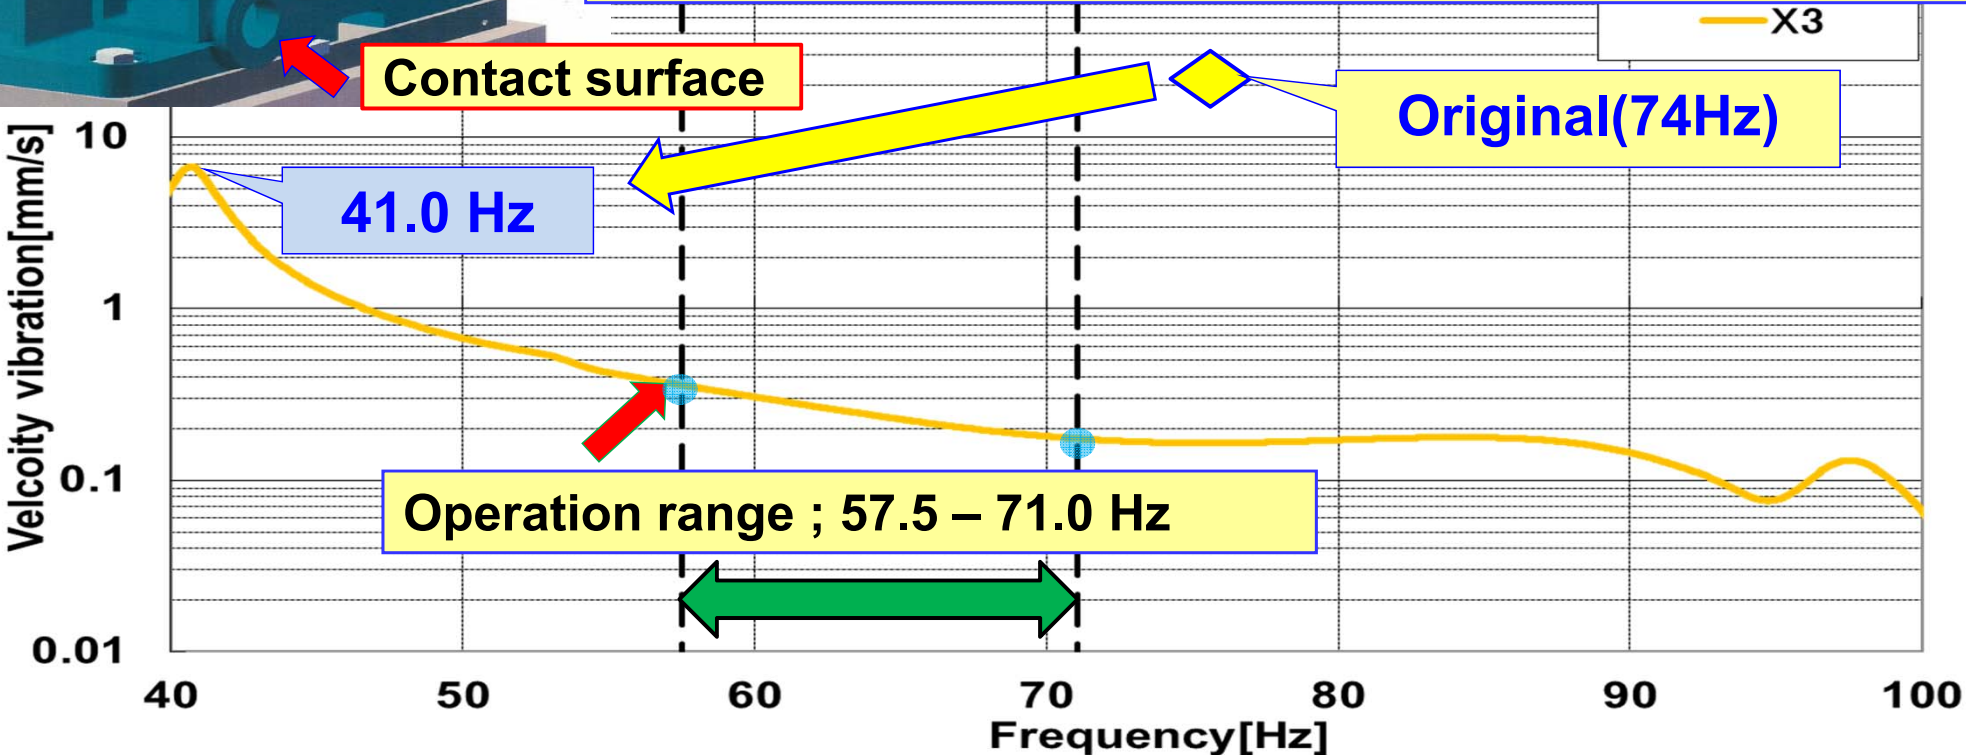
**Result;**  
a) Natural frequency 41.0Hz to be out of operation range, and satisfied with API standard (less than 48Hz).  
b) Vibration level in operation to be much lower at 0.2 to 0.4 mm/s 0-P even by 5-times of API unbalanced limit

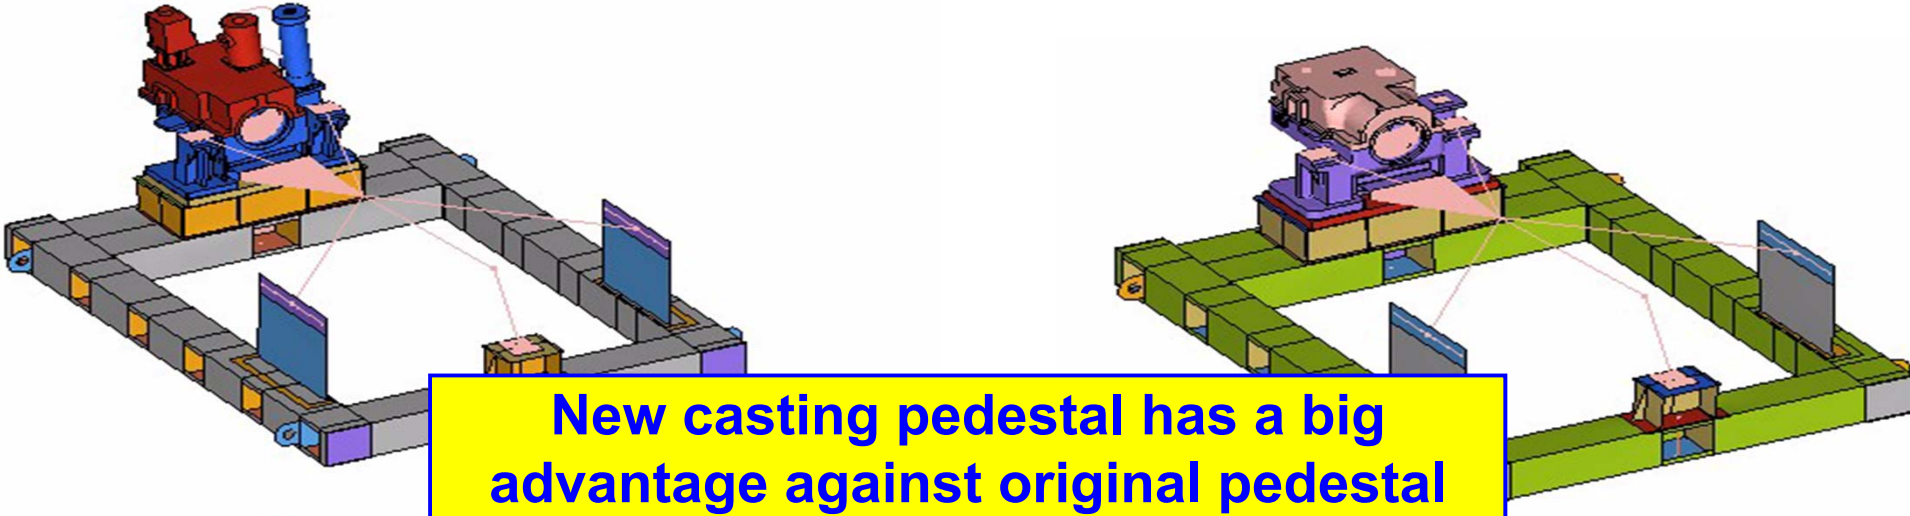
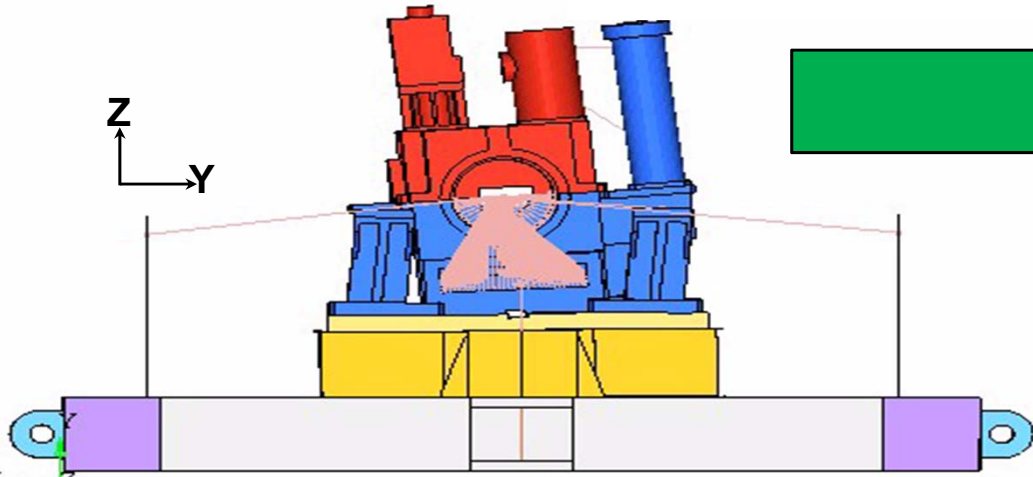
Original pedestal

Following shows vibration mode of animation for original and improved pedestal .
