ASIA TURBOMACHINERY & PUMP SYMPOSIUM  
SINGAPORE | 22 - 25 FEBRUARY 2016  
M A R I N A B A Y S A N D S

# Investigation of Process Gas compressor shaft vibration phenomena

## Investigation for Process Gas HP compressor shaft vibration phenomena

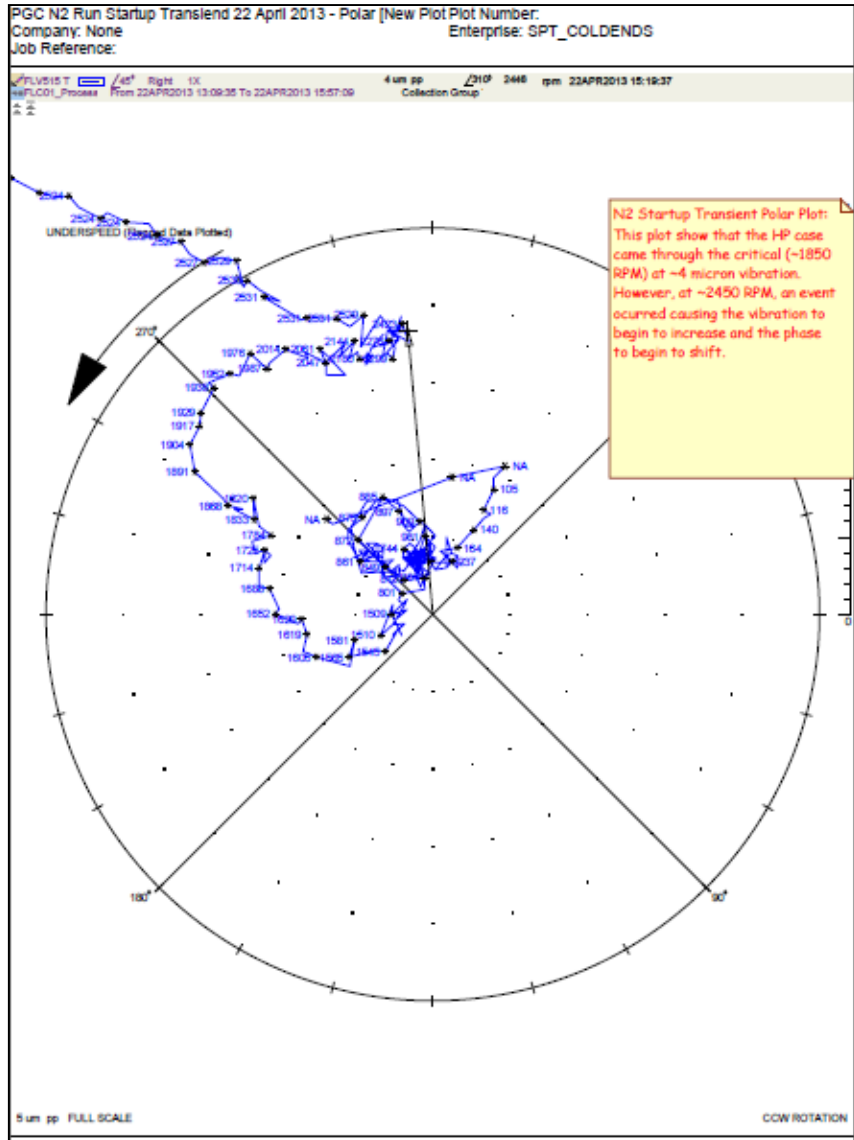
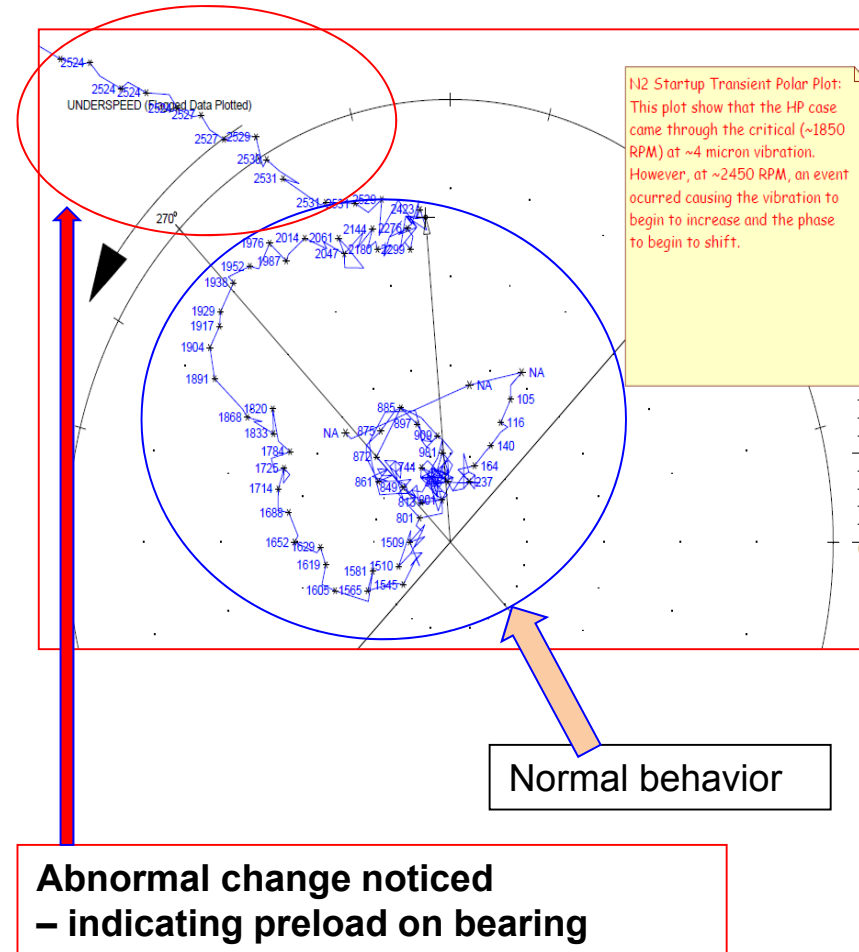
# Transient polar plots of working rotor – N2 run

- The problem was encountered during nitrogen operation before commercial operation with cracked gas at site. PGC compressors was operated with air and higher shaft vibration (approx. 45  $\mu\text{m}$ ) were observed on DE side of HP compressor, these were higher than factory tested values (approximately 10 $\mu\text{m}$  during mechanical run). After a few months, PGC compressors were operated with nitrogen and higher shaft vibration (approx. 75  $\mu\text{m}$ ) was observed on DE side of HP compressor however the vibration levels exceeded alarm levels during coast down of the machine. For both (air and nitrogen) operations, strong correlation with operating conditions (operating pressure and temperature) and shaft vibration level was observed.

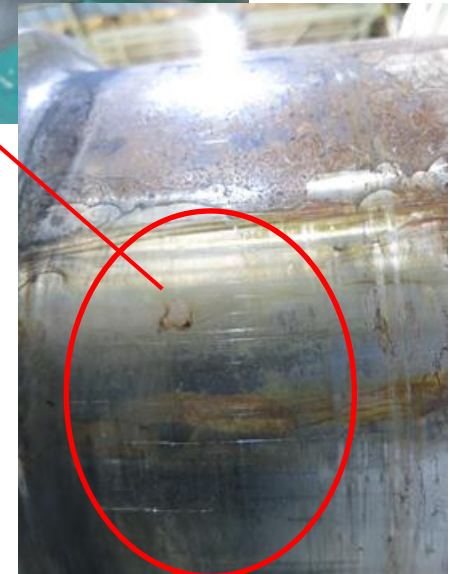
- ✓ Heavy rust was observed around HP section (4th to 8th impeller) mainly. (Stage 1-3 is 17-4PH. Stage 4-8 is SNCM 431.)

Rotor as-found condition after disassemble  
8<sup>th</sup> Impeller and shaft

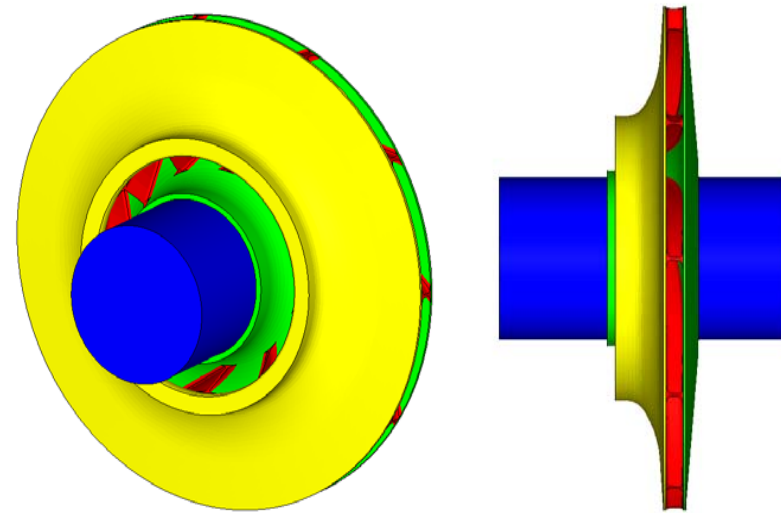
Analysis model

Item	Analysis condition
Objects	Shaft and 5 <sup>th</sup> Impeller
Speed	3982rpm(MCR)
Load	Centrifugal force + Shrink fit pressure
Assumptions	<ul style="list-style-type: none"> <li>▪ Recorded dimension was used.</li> <li>▪ Color distribution was considered as contact area. (Area is 76.6% of design.)</li> <li>▪ Thermal expansion was not considered.</li> </ul>

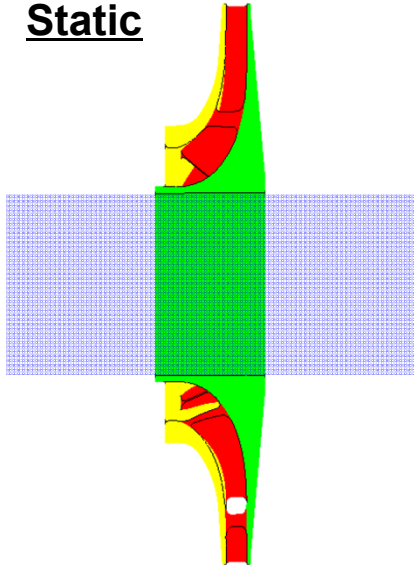
## Impeller deformation (at MCR)

(0.1489mm / on radius)

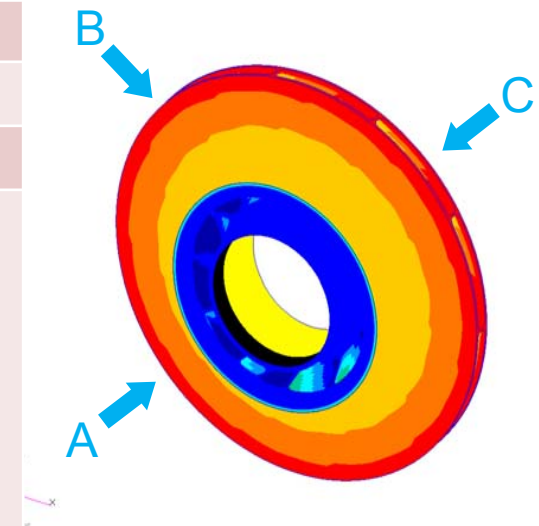
Second FEA model to estimate impeller deformation under operating pressure and speed

Item	Analysis condition
Objects	Shaft and 5 <sup>th</sup> Impeller
Speed	3982rpm(MCR)
Load	Centrifugal force + Shrink fit pressure + Gas pressure
Assumptions	<ul style="list-style-type: none"> <li>Recorded dimension was used.</li> <li>Color distribution was considered as contact area. (Area is 76.6% of design.)</li> <li>Thermal expansion was not considered.</li> <li>Suction pressure of 5<sup>th</sup> impeller : 1710kPaA(*)</li> <li>Discharge pressure of 5<sup>th</sup> impeller : 2077kPaA(*)</li> </ul> (*) Estimated as per site operation data

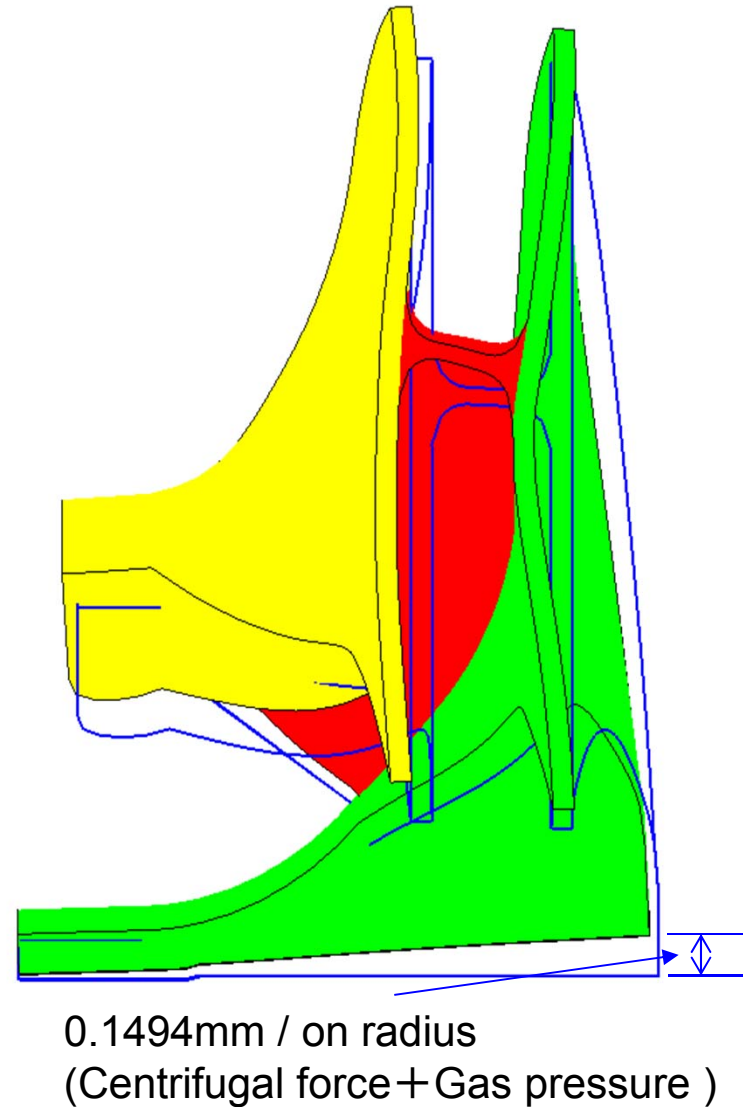
## Impeller deformation (at MCR)

- 0.0005mm of deformation at impeller inside edge was caused by gas pressure.
- The impeller deformation by gas pressure was very small comparing to the deformation by centrifugal force.

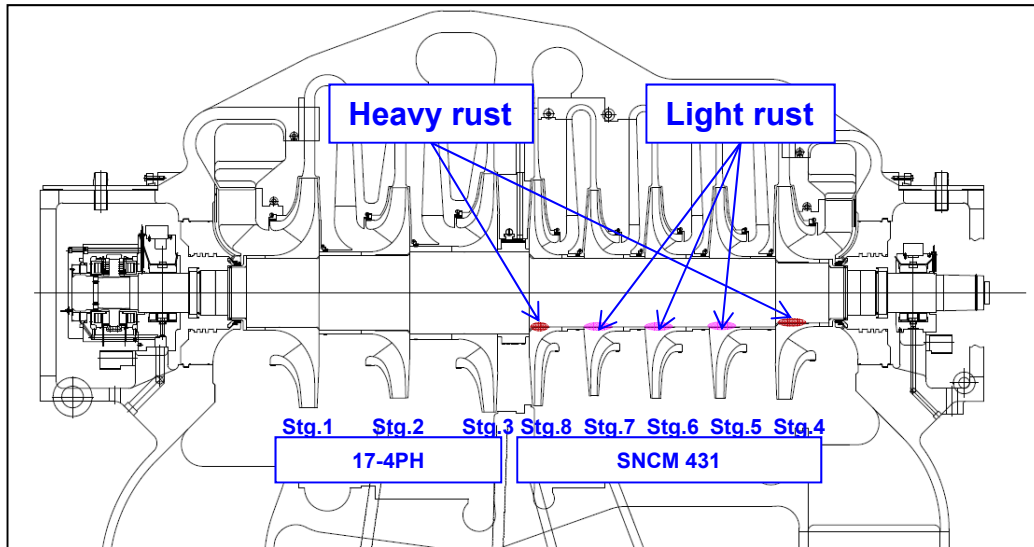
Normal condition

Thermal bending of the rotor could be caused by the rust, due to the uneven heat transfer from impeller.
