44<sup>TH</sup> **TURBOMACHINERY** & 31<sup>ST</sup> **PUMP** SYMPOSIA  
HOUSTON, TEXAS | SEPTEMBER 14 – 17 2015  
GEORGE R. BROWN CONVENTION CENTER

# Pipe Vibration Caused by Aero Excitation Resulted from a Foreign Object Lodged Inside an Impeller Passage

Dr. Zheji Liu  
Mark J. Kuzdzal  
Scott D. Wisler  
September 17<sup>th</sup> 2015

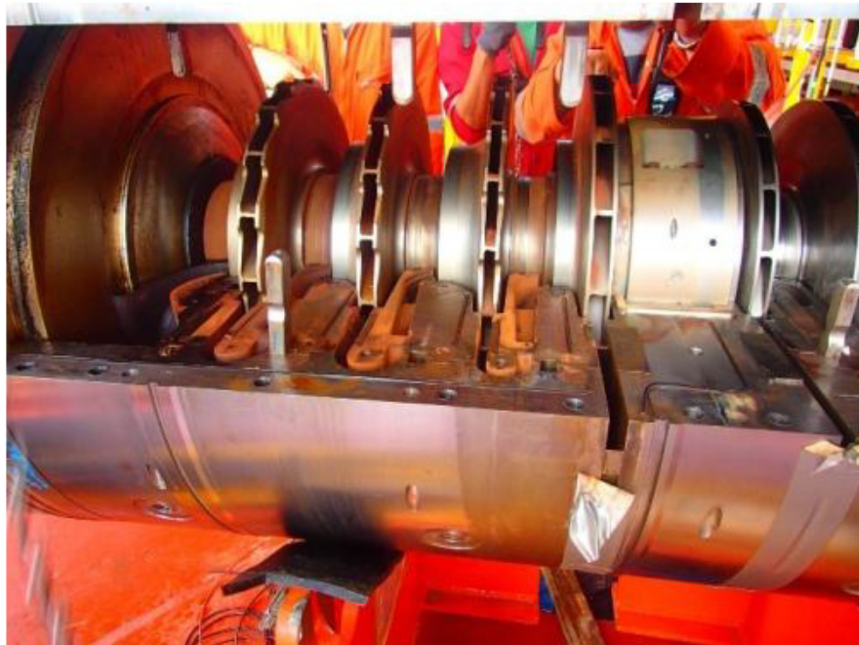
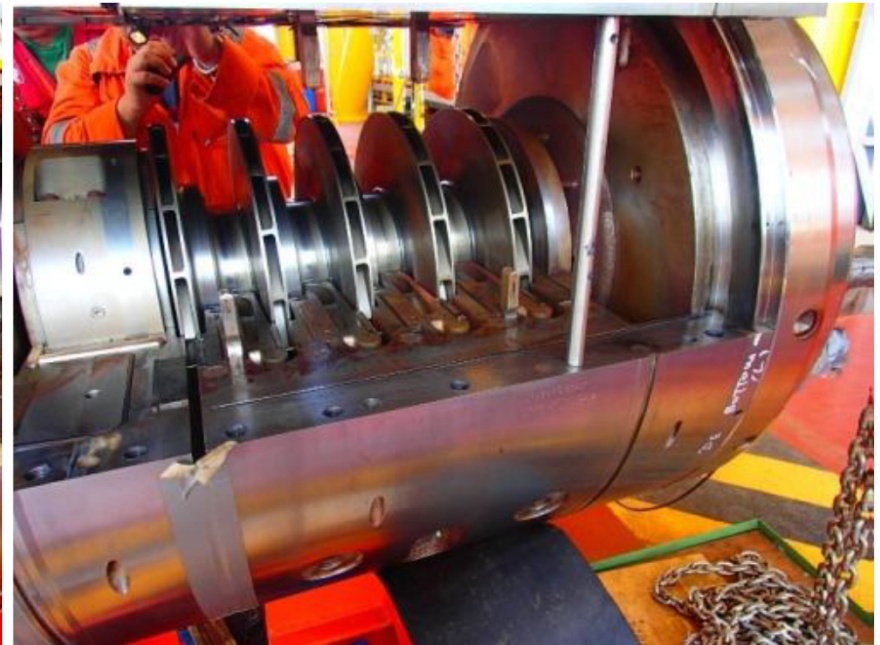
# *Compressor Configuration 9 Stage Back-to-Back*

- ◆ Three identical centrifugal compressor trains installed on a gas injection platform were commissioned in 2014
- ◆ Each train has:
  - A gas turbine driver
  - A back-to-back centrifugal compressor
    - 9 stages
    - Power = 11,122 KW
    - Speed = 11,367 rpm
    - Mole weight = 19.24
    - $P_{in}$  = 21.6 BarG
    - $P_{out}$  = 143 BarG

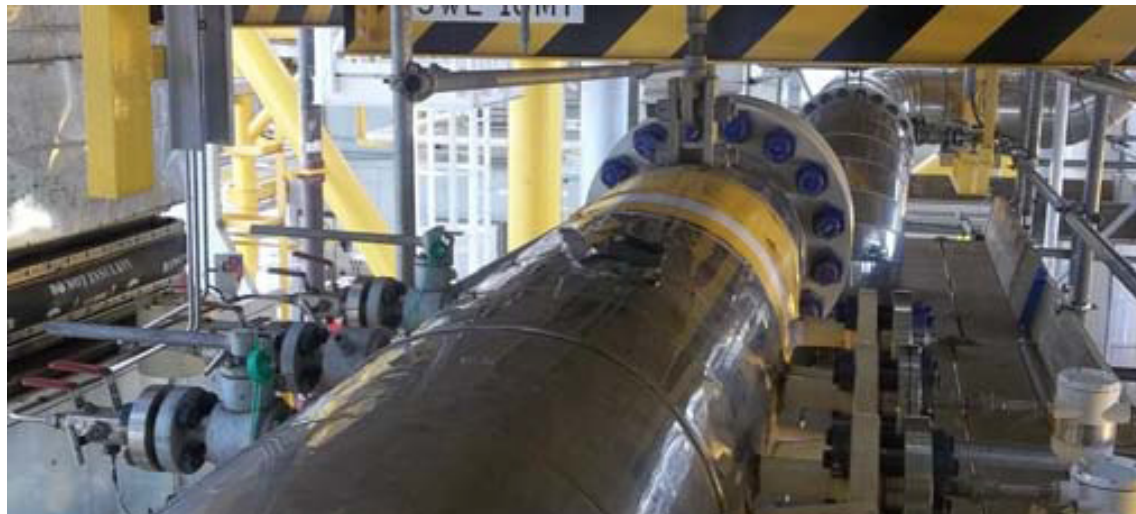
# *Pressure Pulsation Measurement*

- ◆ As resonance and mechanical excitation were both ruled out as the cause of the pipe vibration of Unit # 1, aero excitation had to be considered next.
- ◆ A dynamic pressure probe was inserted to measure the discharge pipe internal pressure pulsations of Units #1 and #3
- ◆ Purpose was to identify if there was an internal pressure pulsation difference between a Unit #1 and Unit #3
