Circulating Water Pump Resonance

Monroe Voyles, Solutions Engineer

ITT Goulds Pumps
Seneca Falls, NY

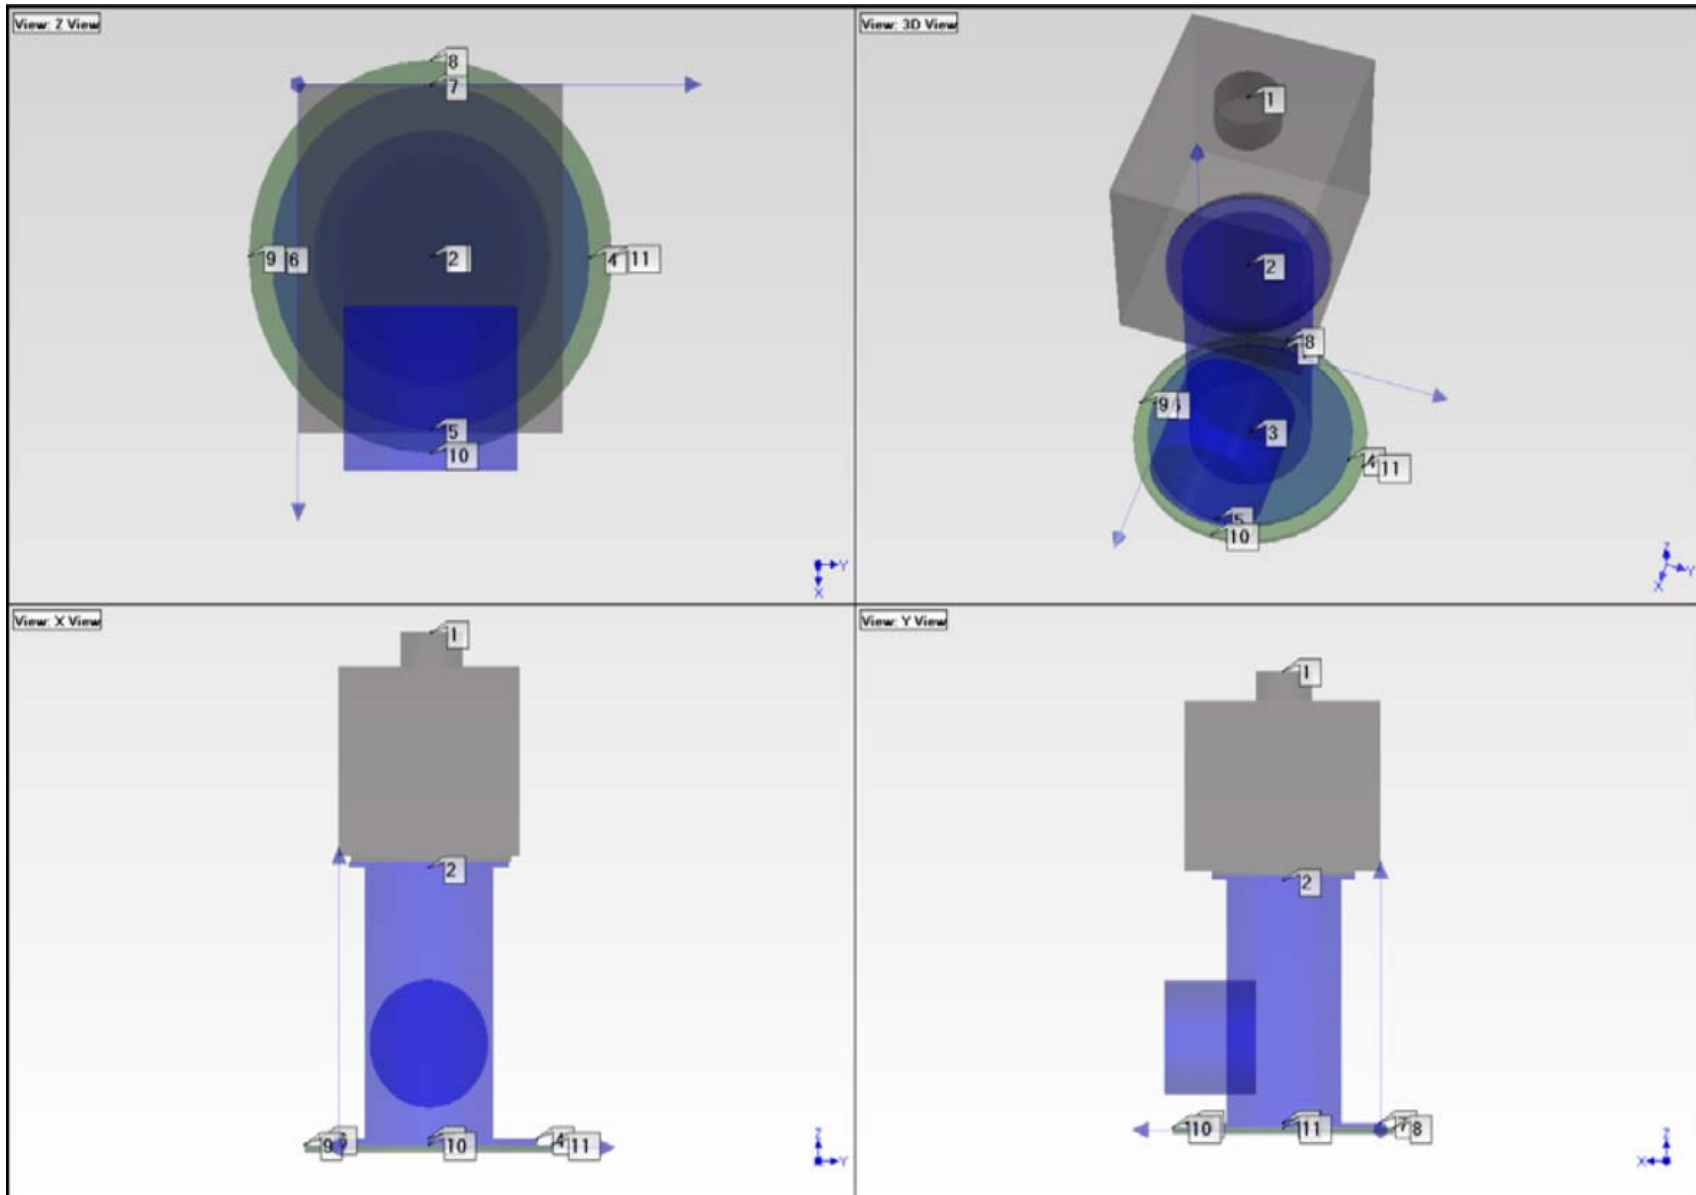
Discharge Expansion Joint

- The tie bolts were initially loose.
- Loose tie bolts allow hydraulic separation forces to be applied to the pump discharge head.
- Significant vibration changes were observed when the spare pump was started in parallel (higher discharge pressure/force)

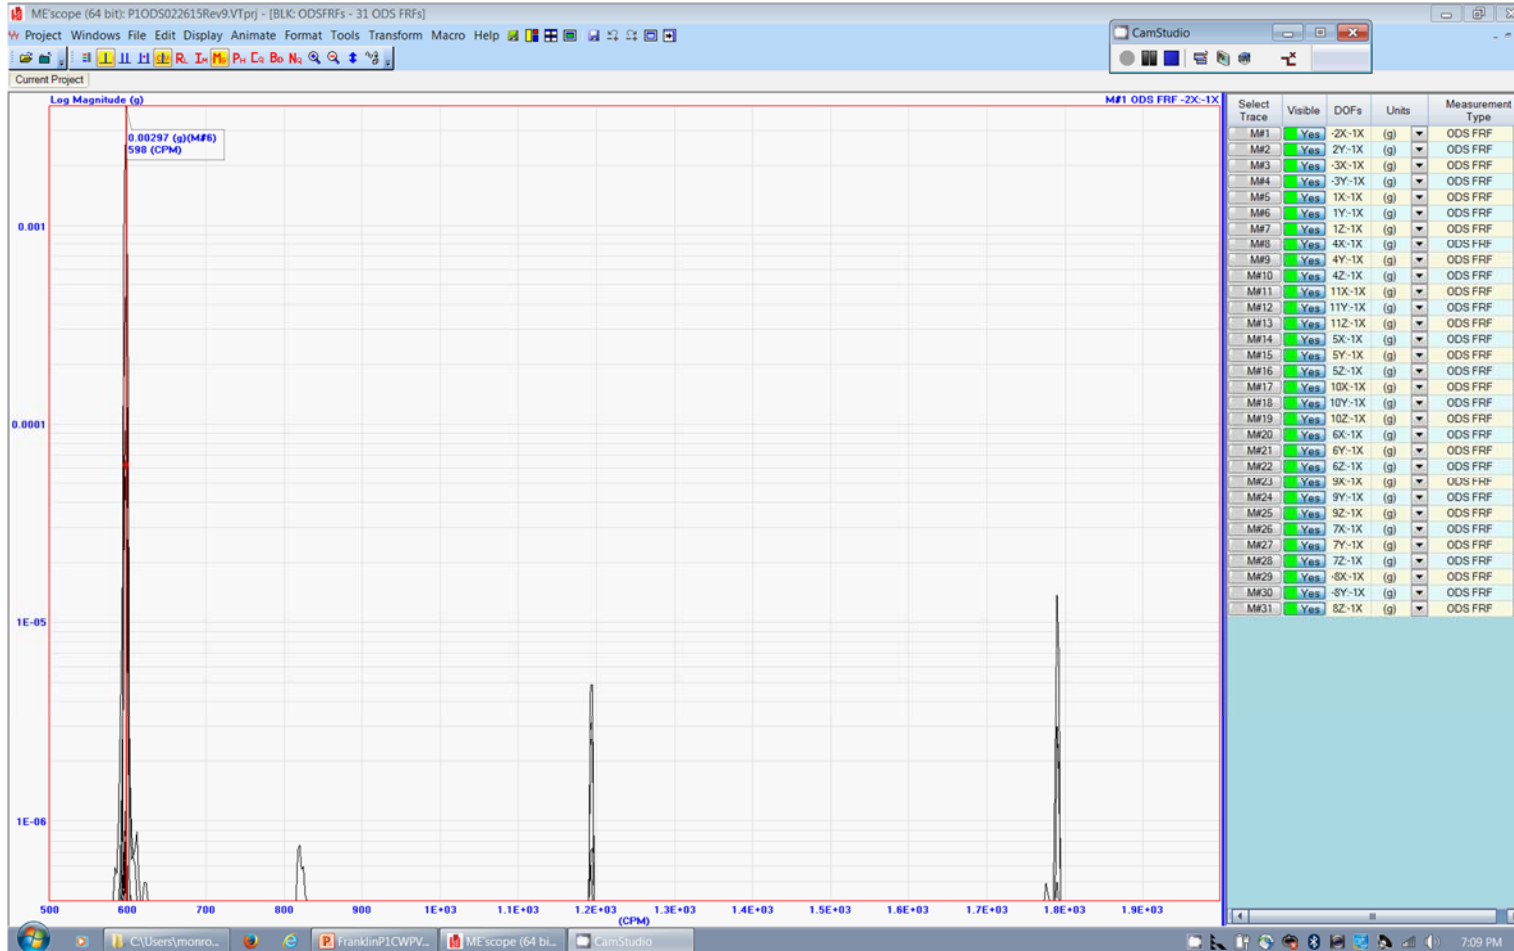
ODS FRFs

Single pump operation; all FRFs overlaid; log amplitude axis

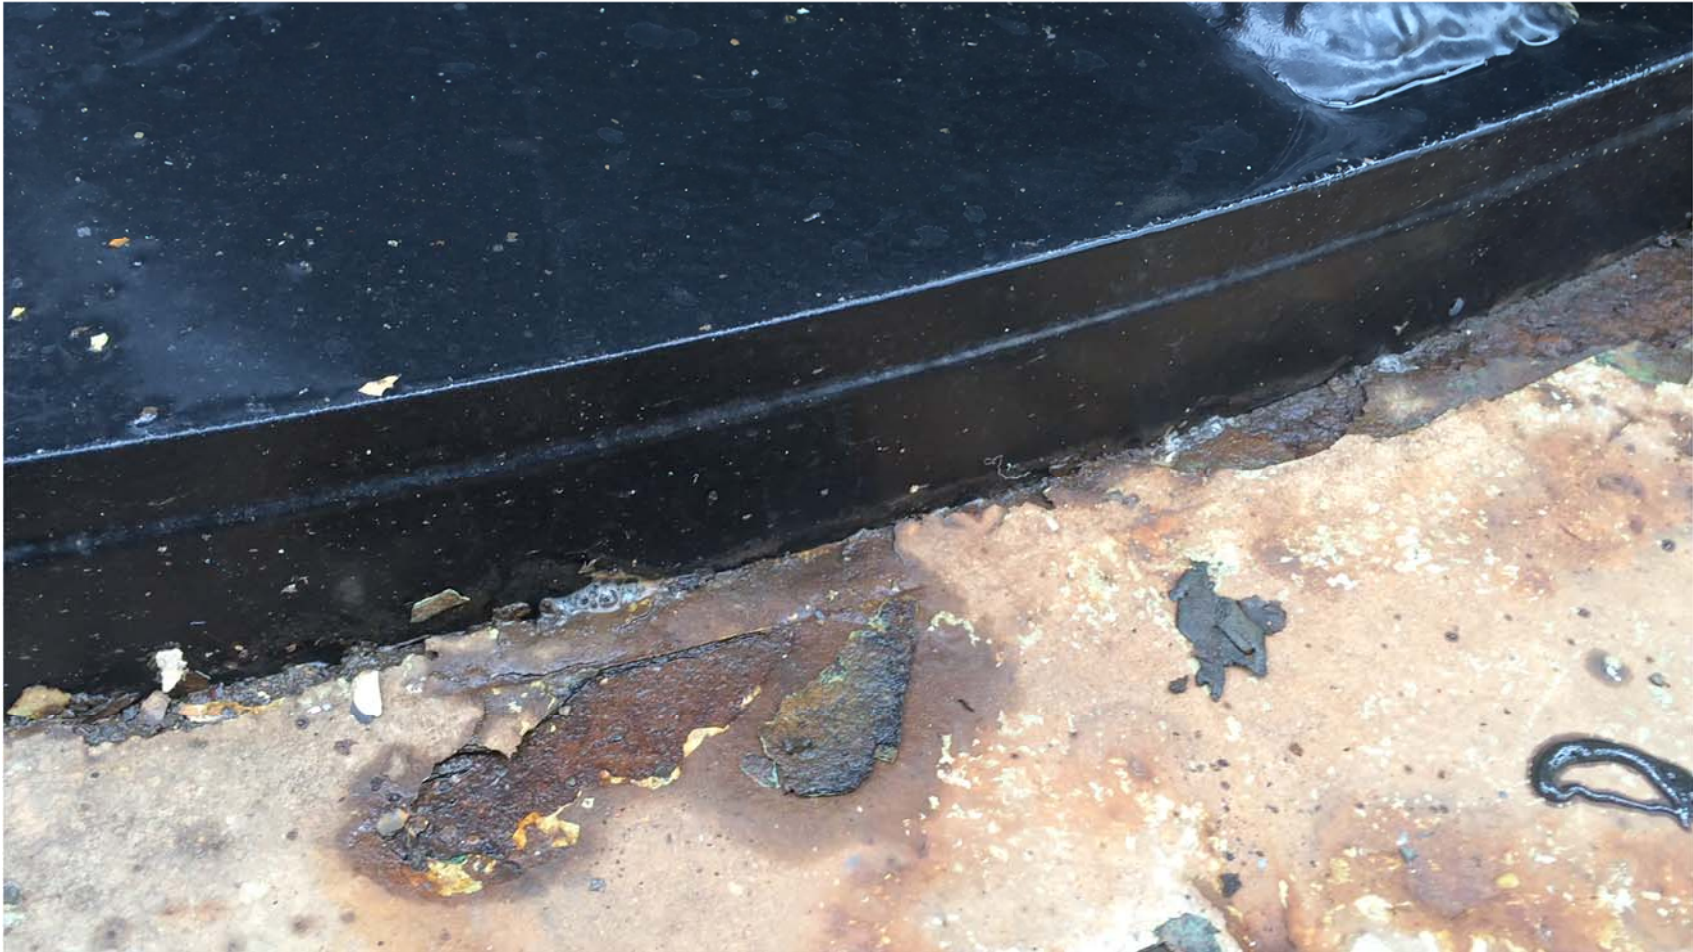
Video Of Movement/Bubbles

- Bubbles indicate relative movement
- Soleplate anchor studs were tightened to improve connection and increase stiffness of the pump/foundation system
- Nuts were tightened from the discharge moving CW viewed from the top down
- As studs were tightened vibration amplitude and phase changed
- Final vibration was decreased from .4ips rms to 0.08ips rms.

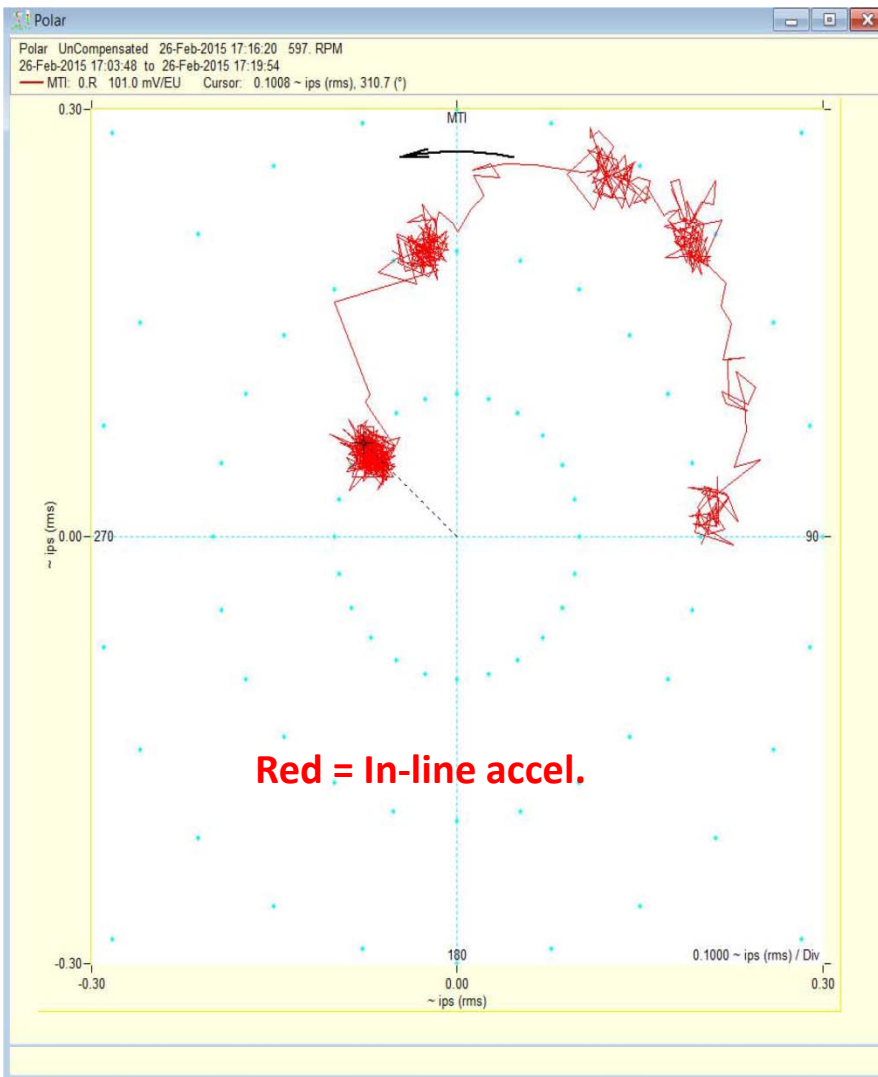
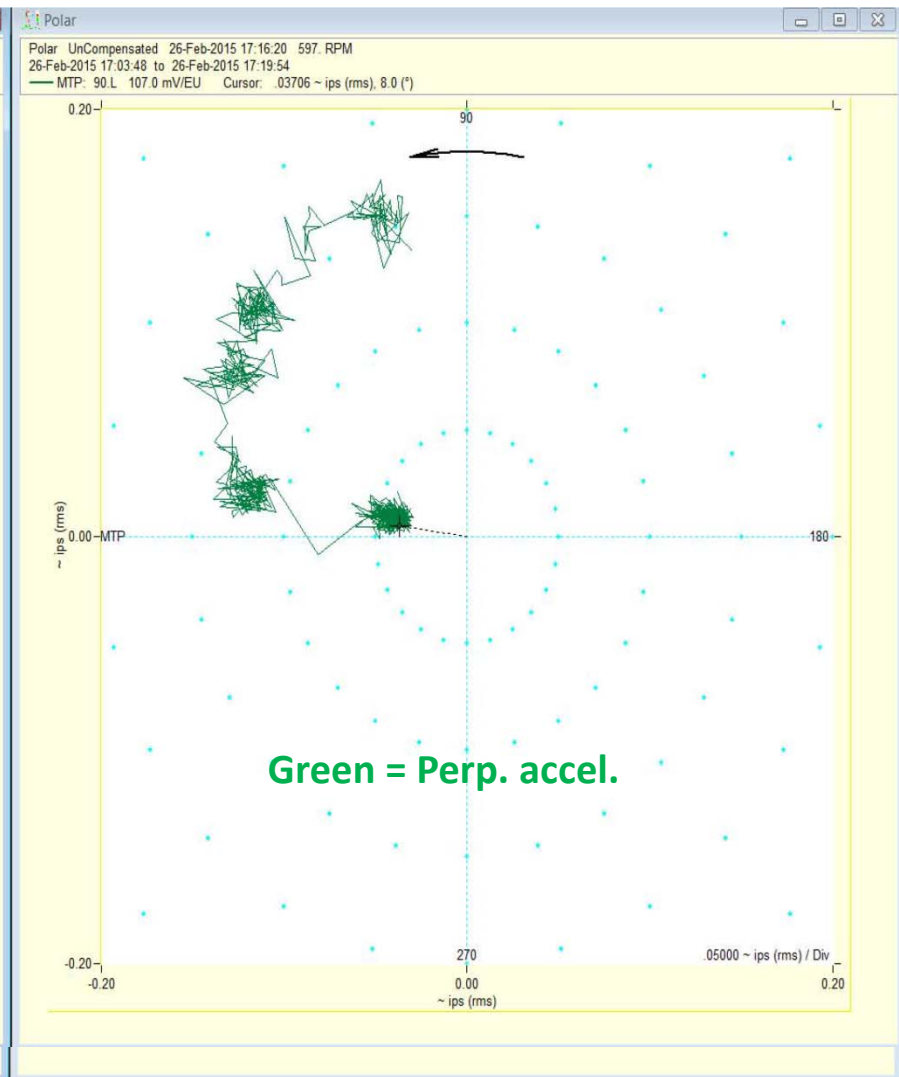
Stud Torqueing Sequence

- Stud torqueing sequence
- Waveform(1X filtered)
- Amplitude decreased 70% after soleplate anchor studs were torqued.
- Nat. freq. was raised to and then above 1X by increasing foundation/pump stiffness.

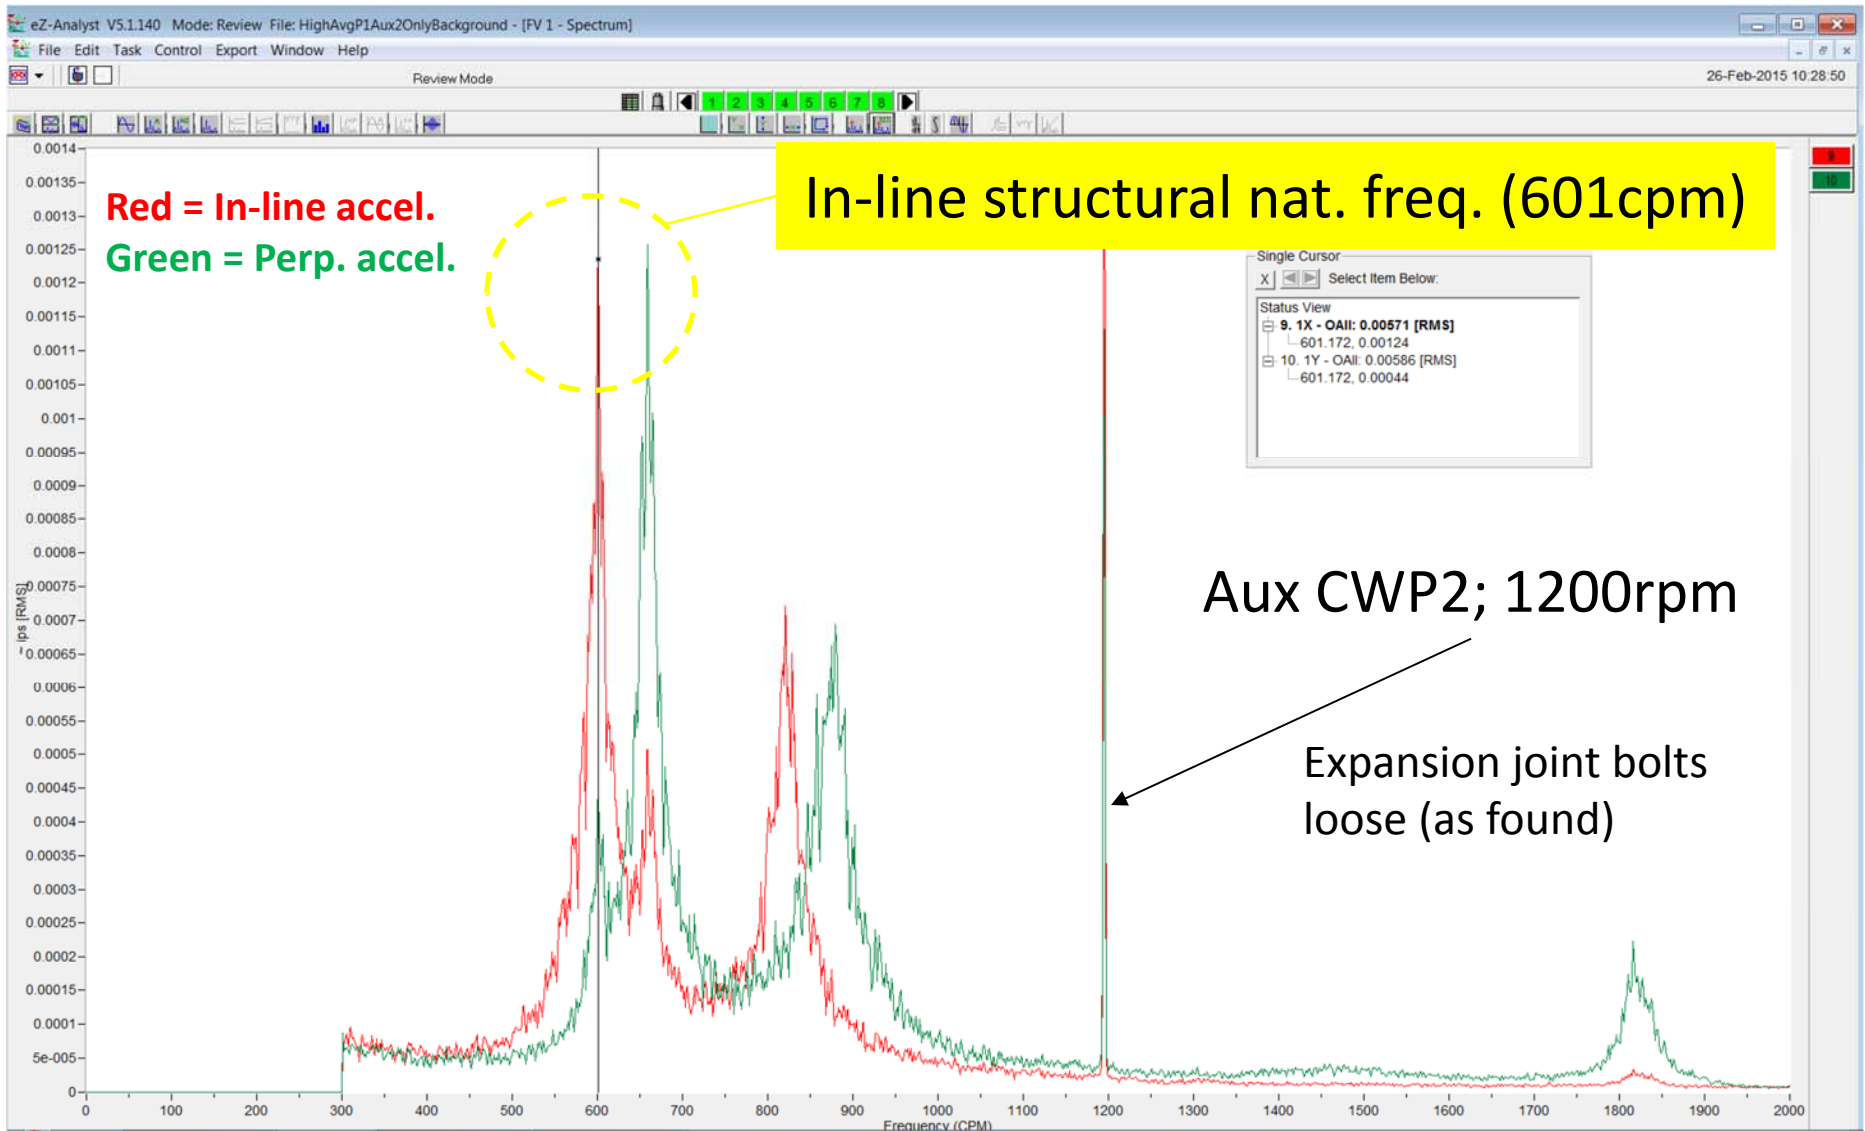
High Average/Resolution FFT

Broad-band vibration provided by Aux CWP2

<u>Condition</u>	<u>In-line</u>	<u>Perp</u>
(Before) Background Aux. CWP2 solo	<u>601</u> 820	658- 1 st mode 880- 2 nd mode
(Before) Background Spare CWP solo	582 830	664-1 st mode 889-2 nd mode
(Before) Impact	581 843	656-1 st mode 881-2 nd mode
(Final) Background tight soleplate	<u>633</u> 828	683-1 st mode 894-2 nd mode

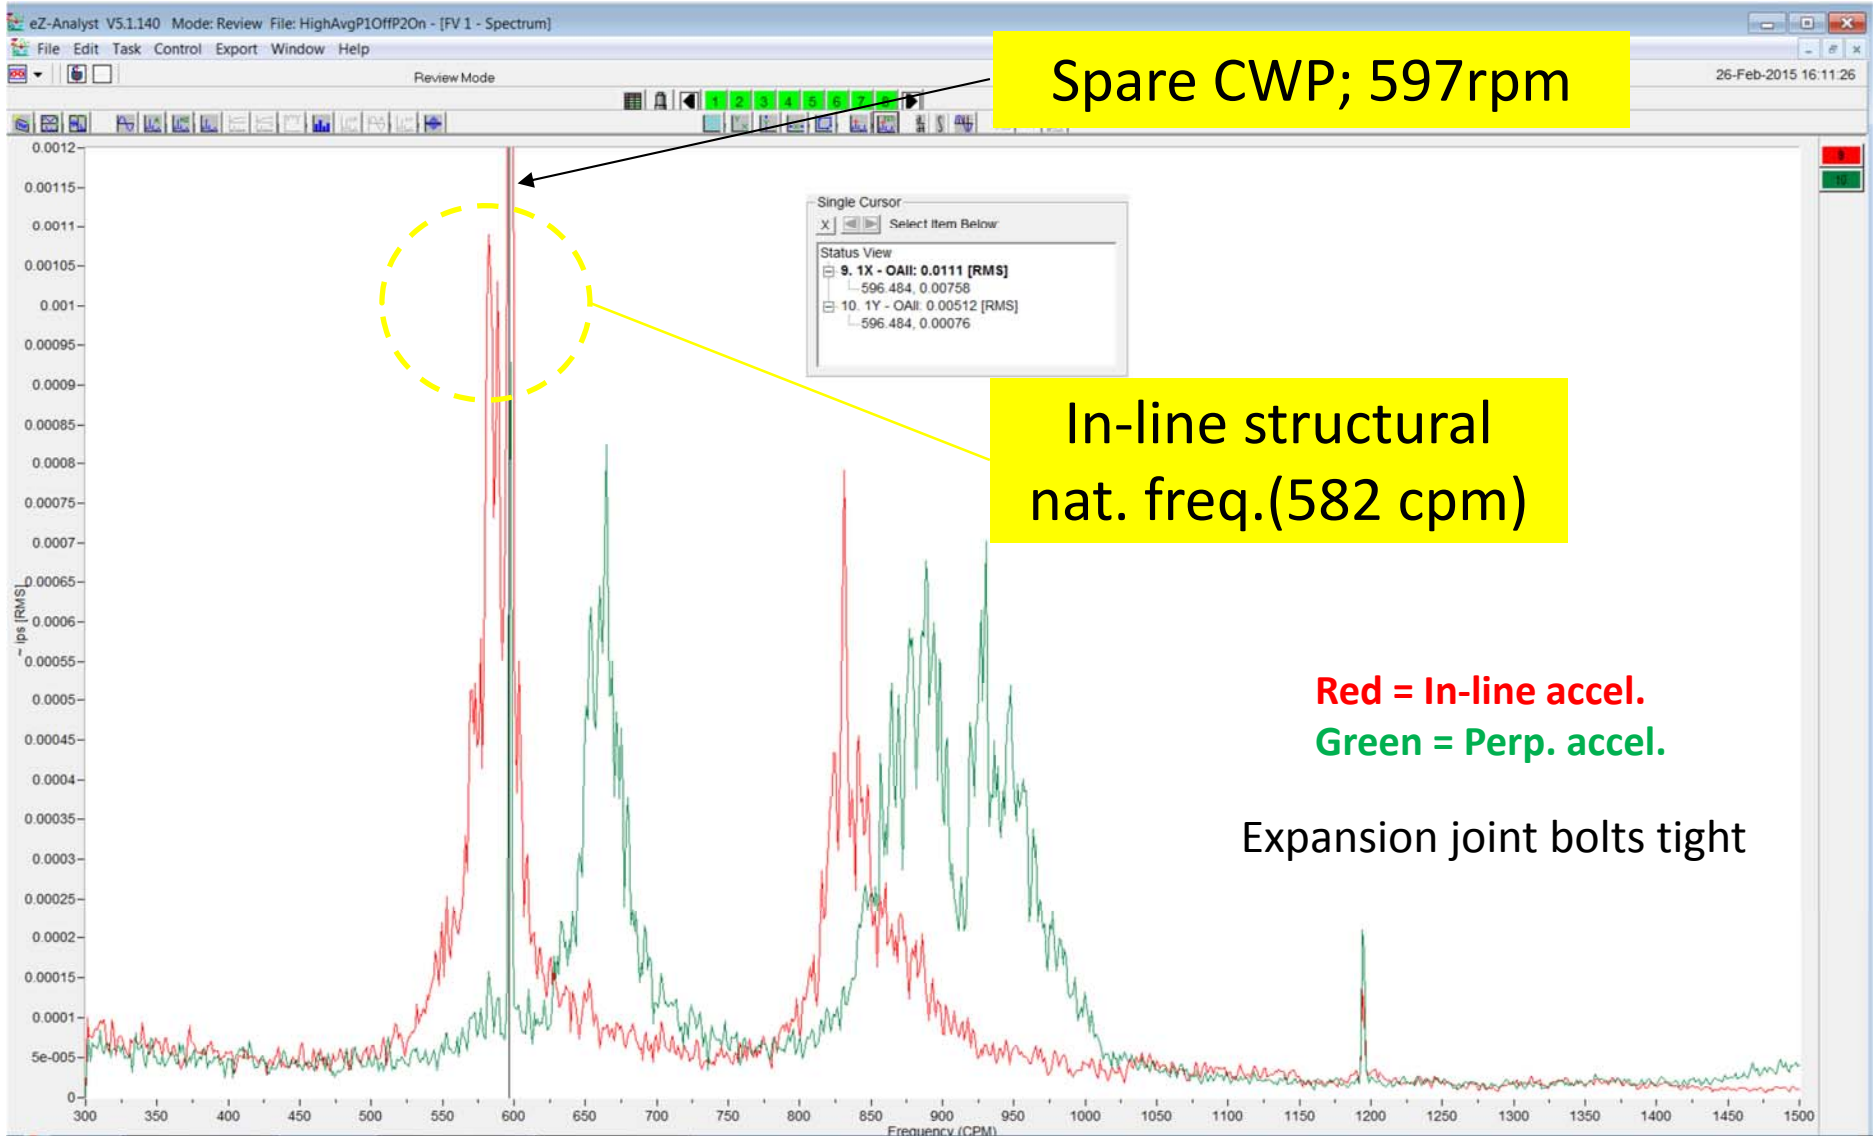
High Average/Resolution FFT

Broad-band vibration provided by spare CWP

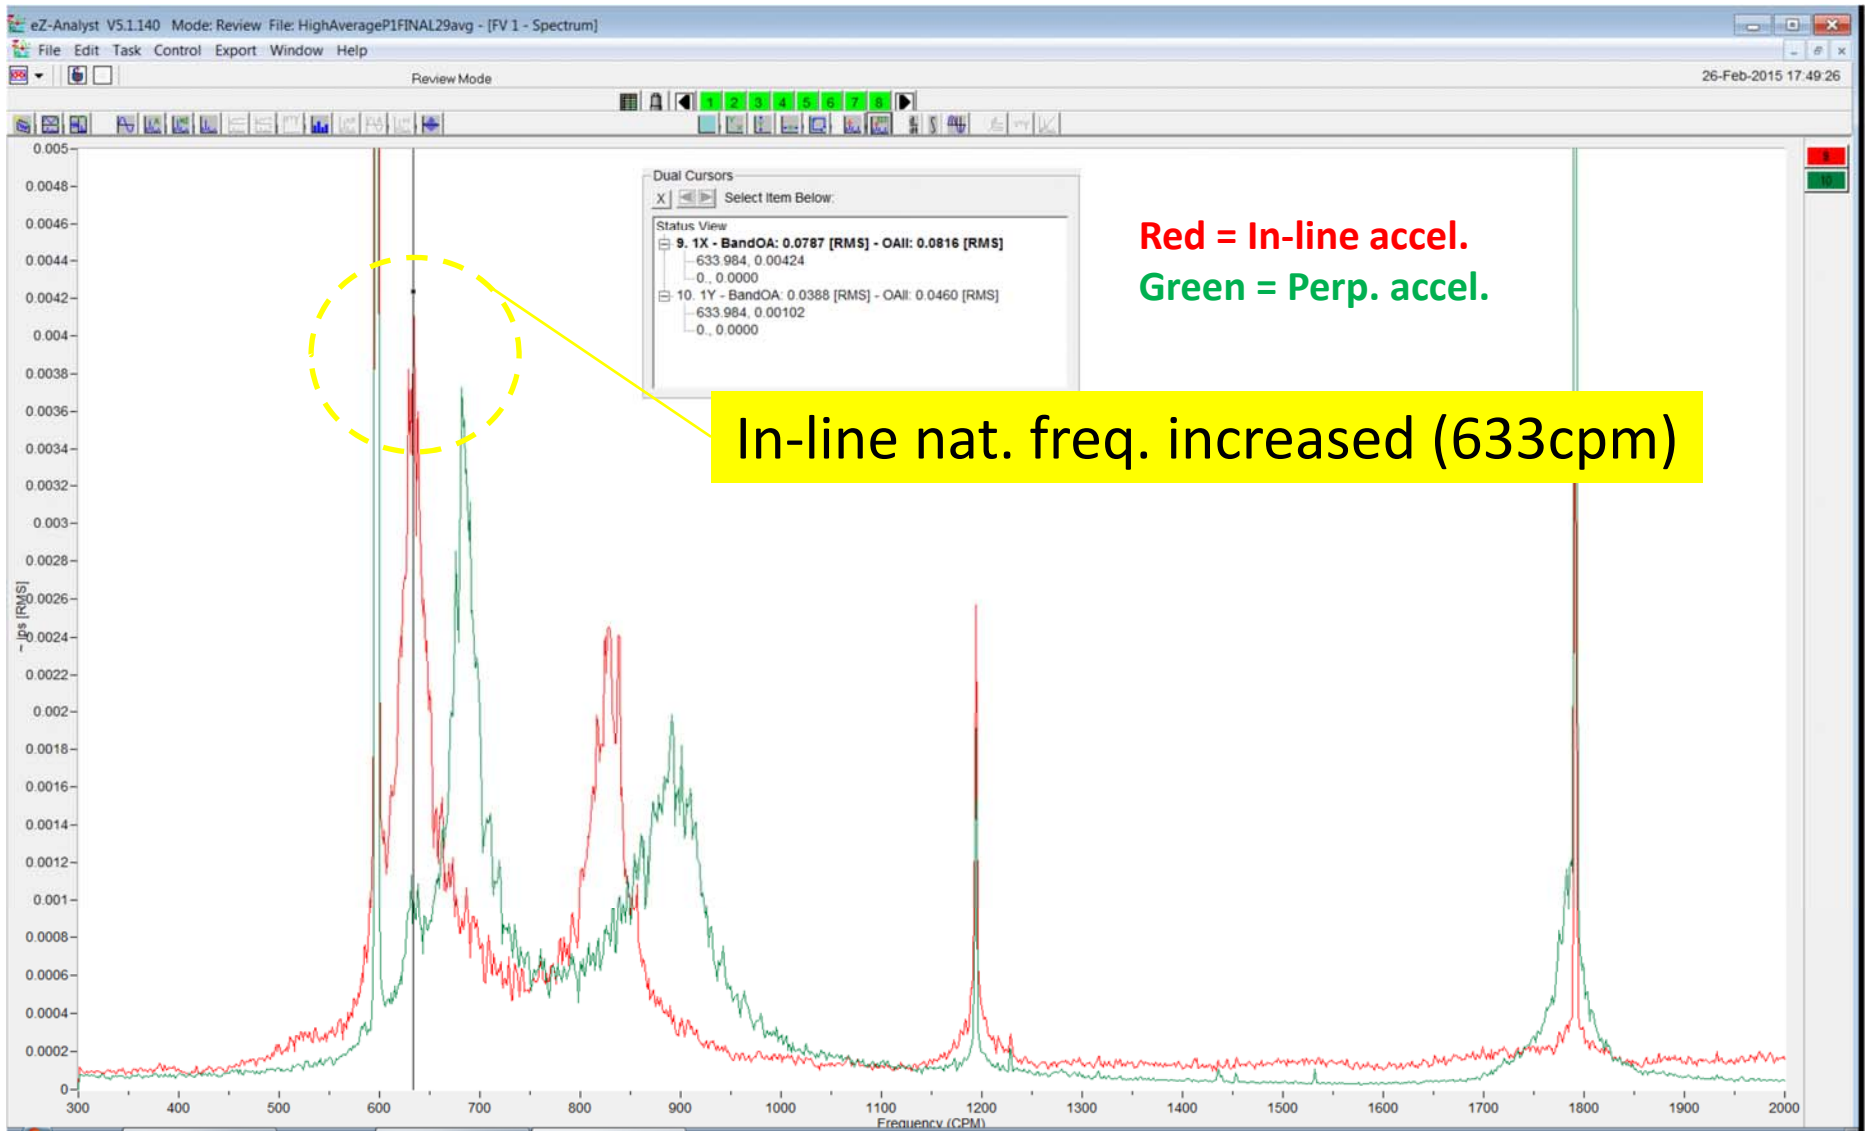
High Average/Resolution FFT FINAL/AFTER SOLEPLATE STUD TORQUEING

- The root cause of excessive vibration was a structural resonance at 1X shaft speed.
- A change in the soleplate/foundation connection likely occurred during the pump overhaul. The combination of corrosion over many years and disturbance of the soleplate during pump removal likely combined to create a “soft” interface between the pump structure and the concrete foundation.
- Reduced pump/foundation stiffness lowered the 1st or trunion mode natural frequency into the operating speed range.
- Soleplate/foundation condition should be inspected during pump removal/overhaul in the future.
