Corrosion and Materials Issues in Converting a Conventional Pump to a Canned Motor Pump.

By: Ron Carlson

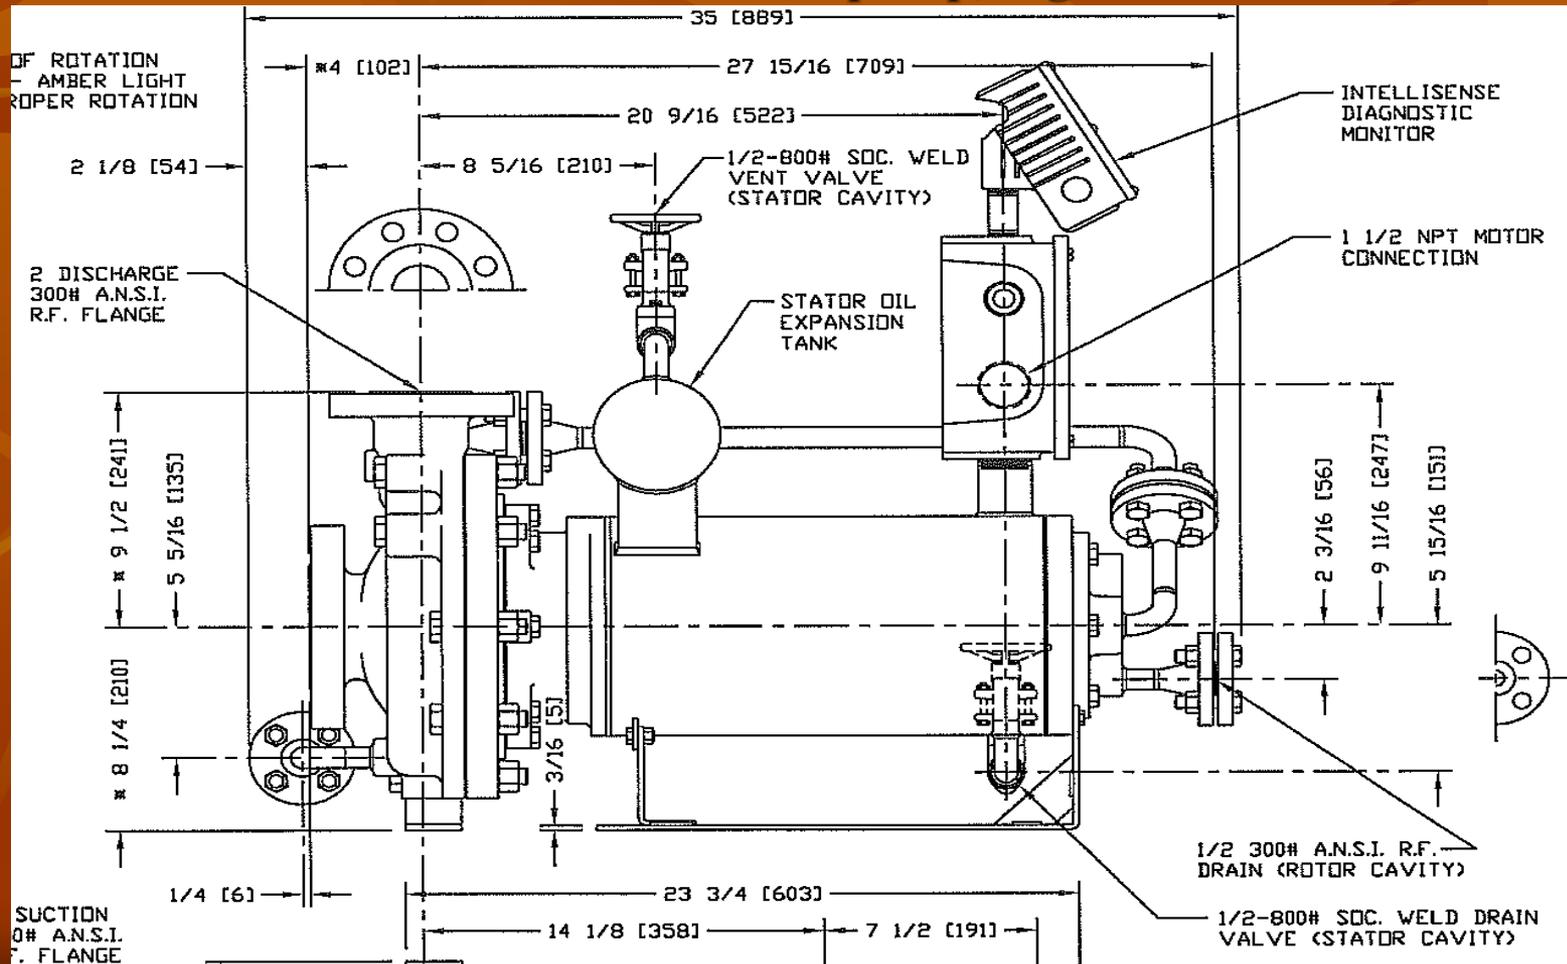
A Gulf Coast Refinery needed to upgrade or replace a pump in its' HF Alkylation unit. Product is Propane with traces of Hydrofluoric (HF) Acid. Traditional sealing design is a double seal using Isobutane as the barrier fluid. As environmental emission limits were lowered, the pump began failing Leak Detection And Repair (LDAR). Evaluation of the options lead to the decision to install a canned motor pump, Figure 1.

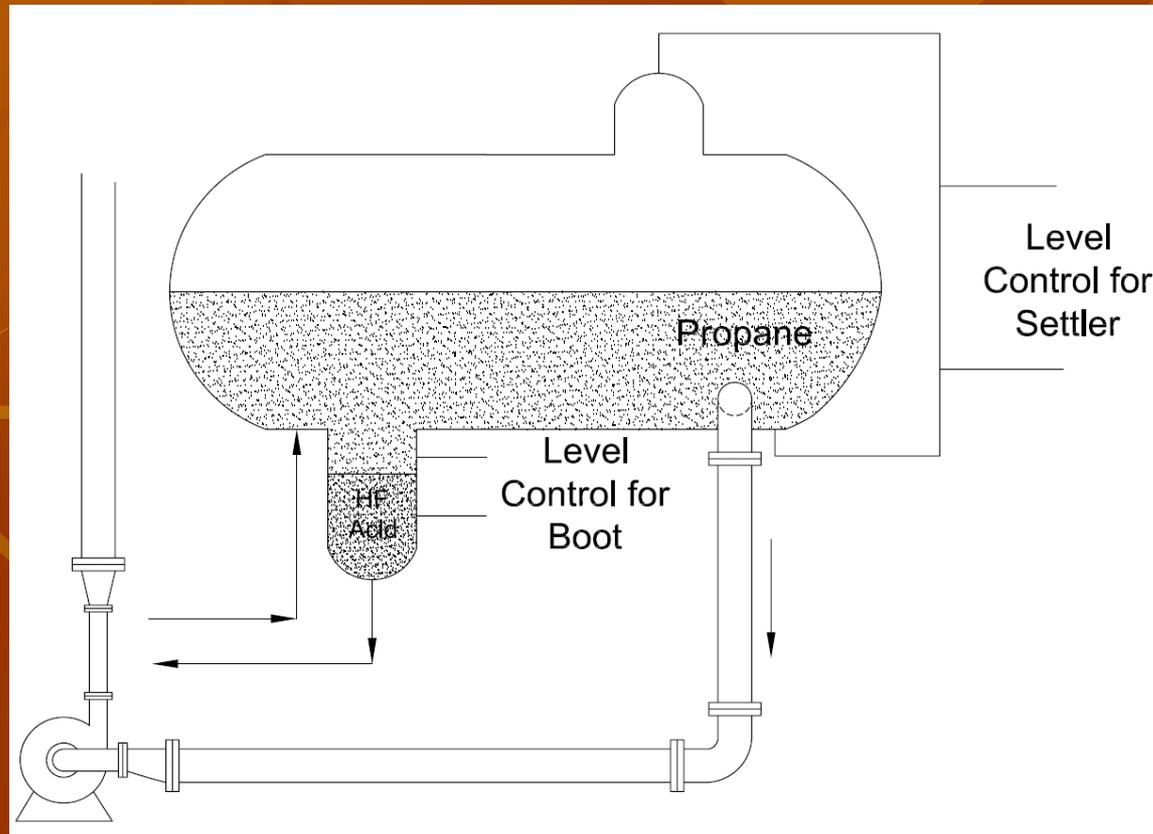
Figure 2

API 685, Annex G calls for material class S-9 for HF service, S-9 in Annex H calls for 316L rotor and stator liners with most of the pump being made of Monel. Industry experience has shown that 316L is acceptable for anhydrous HF Acid. However, Monel is the material of choice for impure HF, so Monel liners were specified, along with all of the other wetted parts. During manufacturing and testing process, we learned that the Copper in Monel prevented the bearing wear indicators from functioning properly. Recalibrating the bearing wear indicators was possible, but calibration had previously been done for Hasteloy C, which is acceptable for HF at the concentrations we run. Therefore, we changed the liners to Hasteloy C while having the rest of the pump manufactured out of Monel. The pump was installed and performed well, figure 2.
