**43rd Turbomachinery
30th Pump SYMPOSIA**

REMOTE MONITORING & DIAGNOSTICS AS APPLIED TO A RECIPROCATING COMPRESSOR HEAD

BRUCE MCCAIN, PE
ROTATING EQUIPMENT LEAD
OXY OIL AND GAS CORPORATION

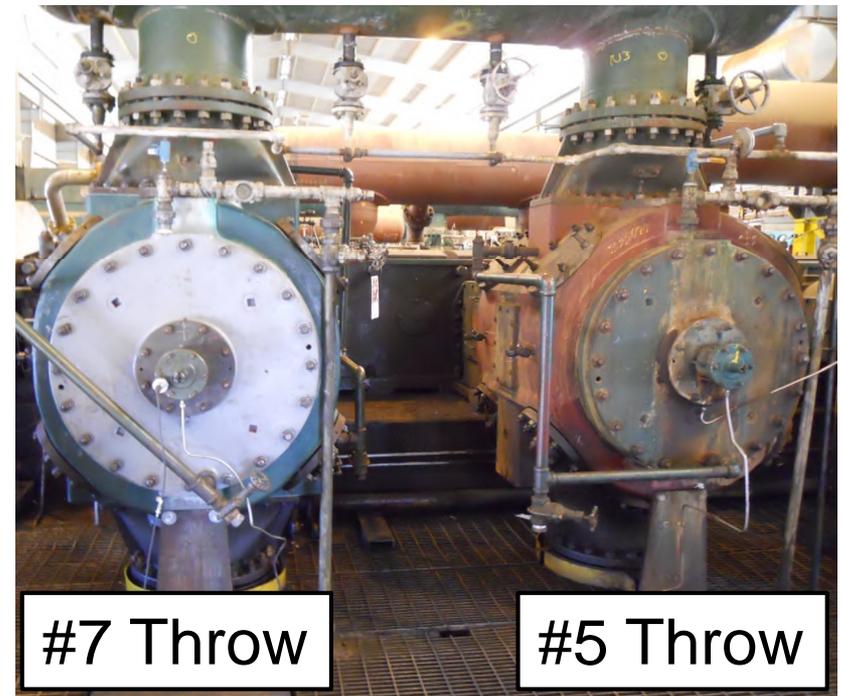
- 8 Throw, 4 Stage, 6500 hp, 327 rpm, 15" stroke
- Water saturated CO₂
- Ps = 45 psig, Pd = 155 psig, Ts = 100 deg F
- Jacket water (JW) pressure ~ 50 psig
- Two 29", 2nd stage cylinders, connected by common bottles
- #7 was a repaired head

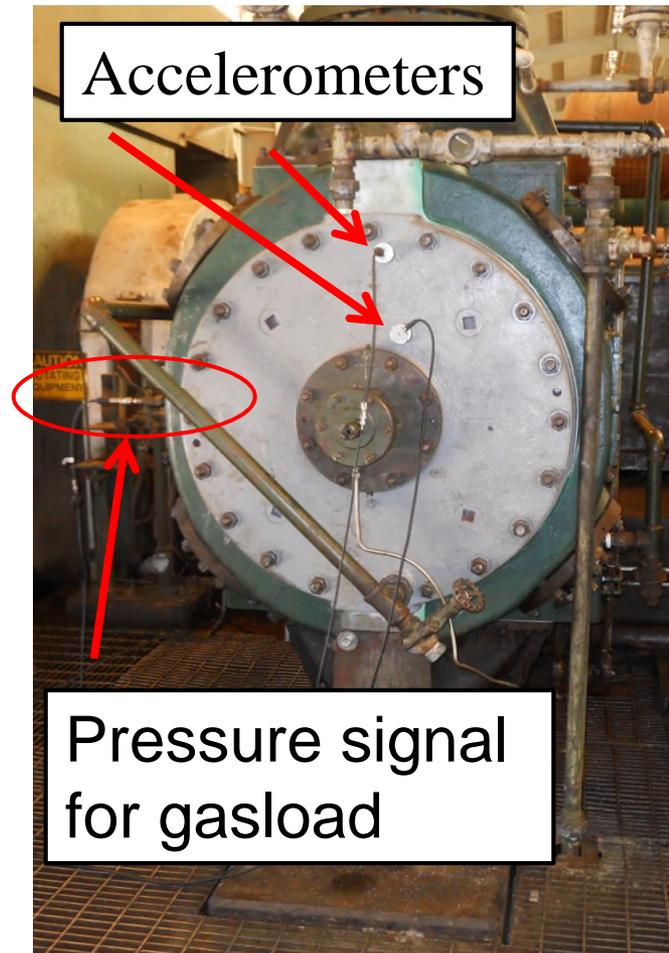
- Measured differential vibration on all 2nd stage heads (8) to establish a baseline of acceptable operation
- Established a “not to exceed” differential vibration requiring immediate shutdown based on trended amplitude and response to gasload change

- “Normal” differential vibration across outer head face of 5-7 mils
- One “repaired” cylinder head indicated differential vibration of 10-13 mils
- An alert level was established at 15 mils differential vibration based on consistent trending
- Automated alerts were utilized to provide early warning in the event of crack propagation
