**43rd Turbomachinery
30th Pump SYMPOSIA**

TWO POLE MOTOR VIBRATION DIAGNOSTICS, ANALYSIS AND SOLUTION

YU ZHAO – BHP BILLITON

NELSON BAXTER- ABM TECHNICAL SERVICES

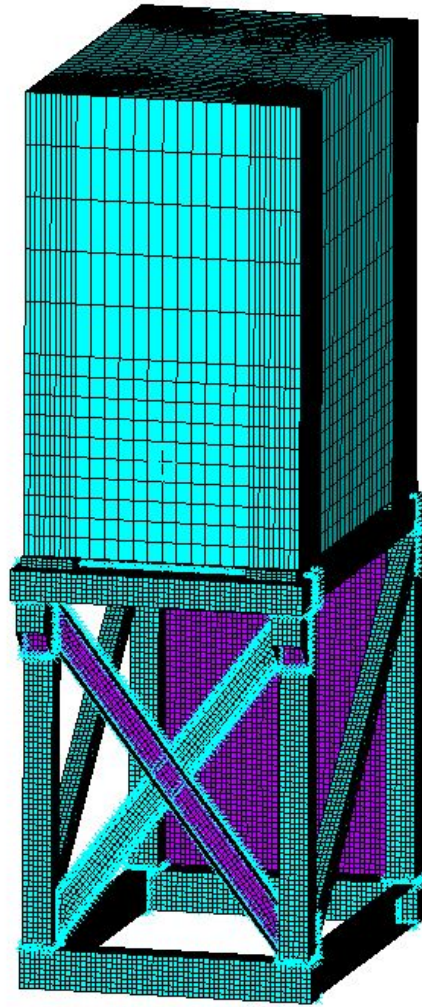
Frame--Static Structural 2

- The support has a natural frequency at 57.9 Hz, which is very close to the motor's running speed of 60 Hz
 - This resonance was likely the original cause of the foundation crack
 - Simply fixing the loose foot due to the damaged foundation did not and will not solve the resonance problem
 - This mode must be pushed away from the motor's synchronous excitation
