# APPLICATION OF REPAIRS TO TURBOMACHINERY EQUIPMENT IN OIL REFINERY, CHEMICAL, AND POWER GENERATION PLANTS

**Phillip Dowson**

**David Dowson**

The Elliott Group

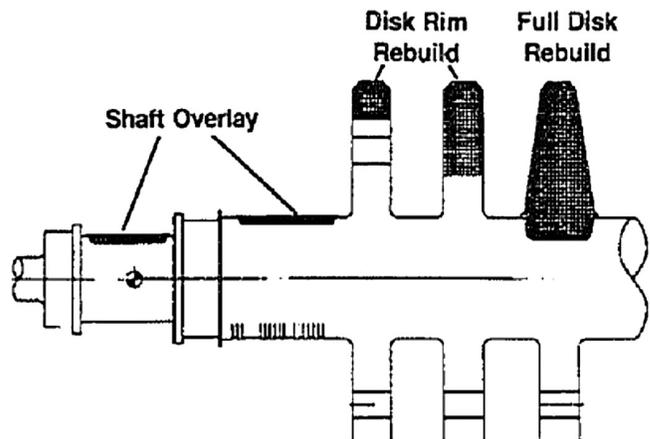
Figure 8. Types of Weld Repairs.

As was stated for compressor shafts in the last 20 years numerous turbine shafts have been successfully repaired by the authors' company and to date are operating as designed. Figure 8 shows the three basic types of repairs used on integral forged rotors:

- Full disk stage rebuild
- Disk rim rebuild
- Shaft journal surfaces

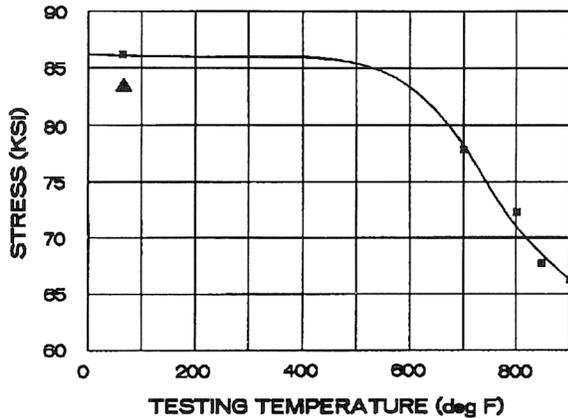
The tested base metal properties and chemistry were a very good match to the proprietary and proven low alloy steel filler material. Figures 15 and 16 show the comparison of the weld metal (curve) and the base metal data (triangle data point). From the data, it can be seen that the mechanical properties of the weld, met or exceeded the properties of the base metal with the impact properties/toughness being significantly better when comparing both impact energy and FATT.

Figure 15. Comparison of Weld Metal Yield Strength to Tested Base Metal Data (Triangle).

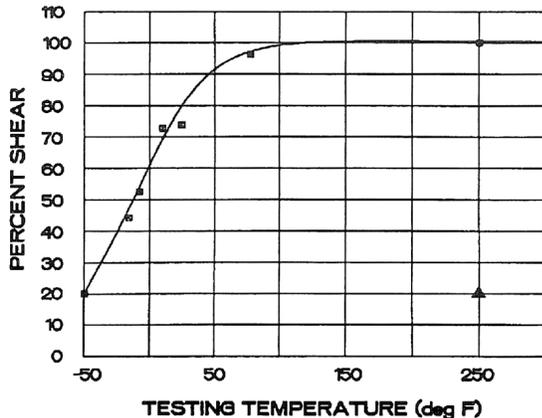
Figure 16. Comparison of Shear Percent of Weld Metal to Tested Base Metal Data (Triangle).

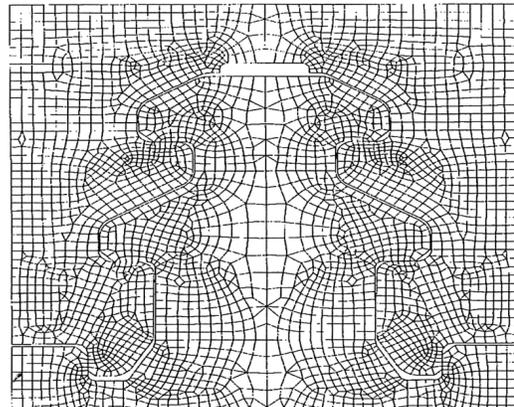
Figure 17. FEA Model of Blade Root and Disk Rim.

In order to confirm the stress analysis results of the customer's consultant and to review the stress levels against the authors' company internal design criteria, a steady-state, axisymmetric, 2-D finite element analysis was completed for both the blade root and disk rim. The model was generated from dimensions acquired through reverse engineering using a five-axis coordinate measuring machine and manual measurements. The engineering FE model of the blade root and disk rim is shown in Figure 17.

The configuration of the disk rim was a tangential entry male fir tree and the blade root was a female fir tree type. The calculated stresses are shown in Figures 18 and 19 for the blade root and disk, respectively, and were all within the authors' company design criteria when considering both centrifugal and steam bending stresses. Goodman factors also exceeded the criteria for fatigue margin. It should also be noted that the high stress location of the blade root corresponded with the failure location. However, the crack locations on the disk were not at the maximum stress location in the pressure land fillet radii, but rather at the end of the pressure land where fretting was noted. This evidence suggests a fretting fatigue mechanism caused by blade vibration and high contact stresses were the reasons for the disk cracking (Figure 20).
