PREVENTING UNDETECTED TRAIN TORSIONAL OSCILLATIONS

ABSTRACT

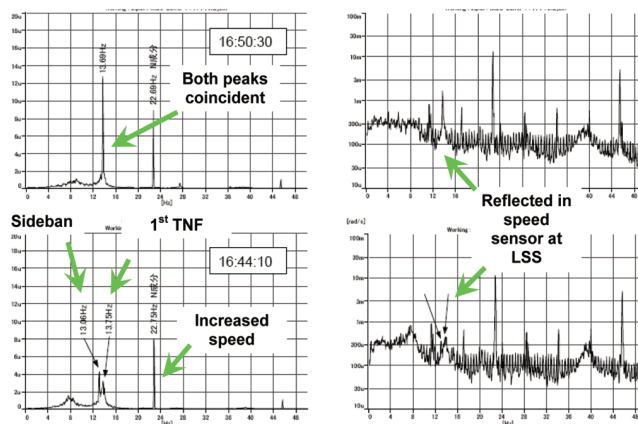
Figure 24. Case 6 Torsional Oscillation and Sidebands.

One confusing fact of this failure was the apparent conflicting reports of high cycle fatigue (HCF) after 2000 hours of service. Over that period, the coupling would have experienced 190,000,000 cycles at the frequency in question greatly exceeding typical cycles necessary for HCF. What the low speed torsional measurements did reveal was the existence of VFD sidebands produced by the pulse width modulator. These sidebands are a function of the VFD output speed. Figure 24 displays the torsional oscillation of the train as one such sideband is coincident with and, then as speed is increased, moves away from the first torsional natural frequency (1TNF). When the two pulsations were coincident, it was found that the torsional oscillations produced exceeded the HCF stress level of the high speed coupling. Since HCF would happen only at specific operating speeds, this intermittent behavior explained why the failure did not occur sooner (closer to $1E6$ cycles.) Torsional response levels of the high speed coupling were related to reexcitation of the 1TNF by the VFD control algorithm. In the end, the problem was resolved by installing a completely new algorithm to decouple the electrical and mechanical systems in play on the machinery train. Torque oscillation measurements had been done on the low speed shaft with a laser vibrometer, and did not pick up excessive vibratory torque. Testing was done again with a strain gage system, and the slightly different torques measured versus analysis were reinput into the models to determine the magnitude of the torques at the high speed coupling between the gearbox and first compressor. The torques were again found to be acceptable, but still did not explain the failure based on the coupling supplier's analysis.

In the end, it was decided to just eliminate the odd frequency vibration, by reprogramming the VFD controller. This was done and the train is running now as designed.

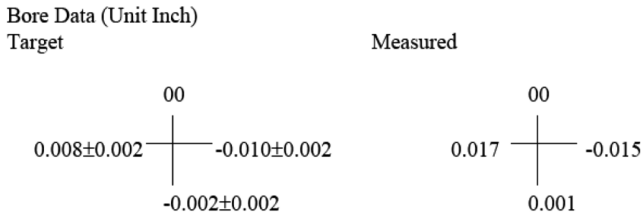
Figure 28. Case 7 OD Alignment Data .

The cracking of the subject coupling sleeve was produced by a high cycle fatigue failure mechanism under torsional loading. One of the causes (under investigation) of the subject failure was a high frequency, cyclic loading of the coupling caused by the signal from the variable frequency drive. Another was excessive misalignment that was well above the target tolerances when checked (Figures 28 and 29).
