Repeated failures on 2nd stage impeller linked to blade natural frequency excitation.

Problem Statement

- ❑ Three Stage integrally geared air compressor used for process air.
- ❑ Second stage impeller failed after 11 hours of operation.
- ❑ The failure occurred after a rebuild for a different failure and there was no spare impeller.

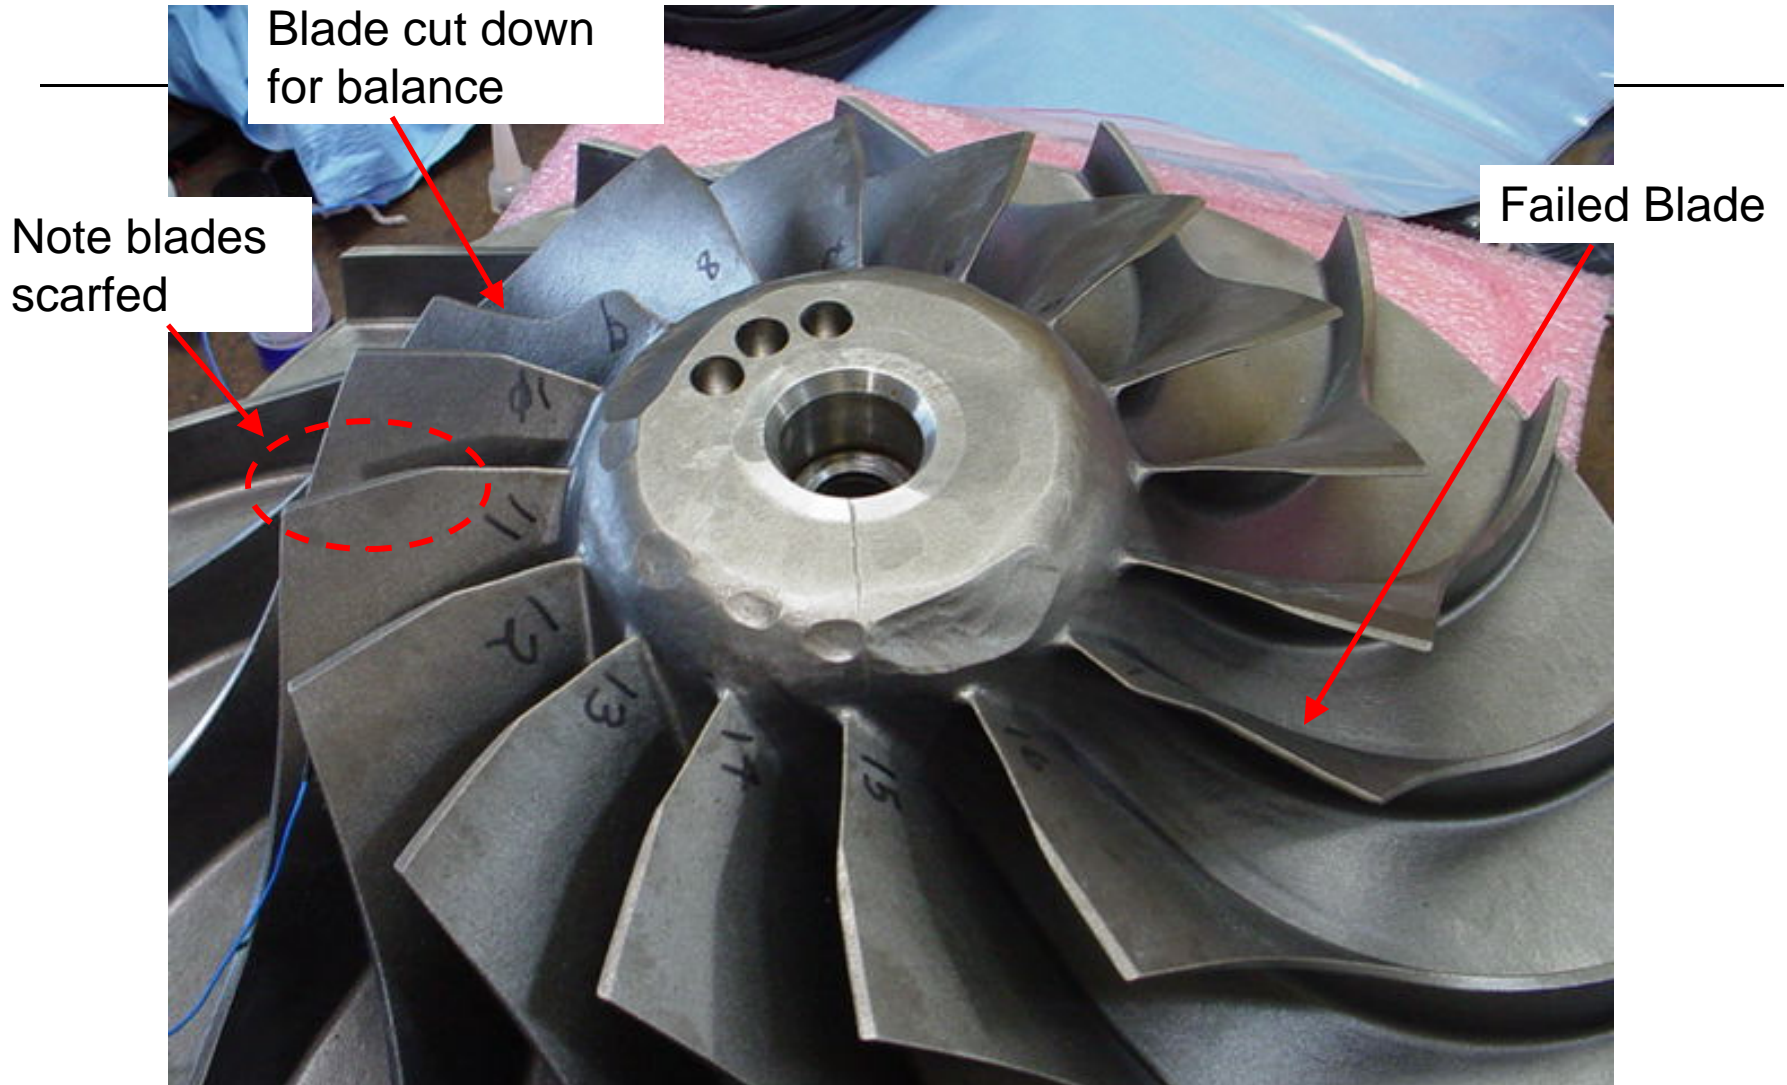
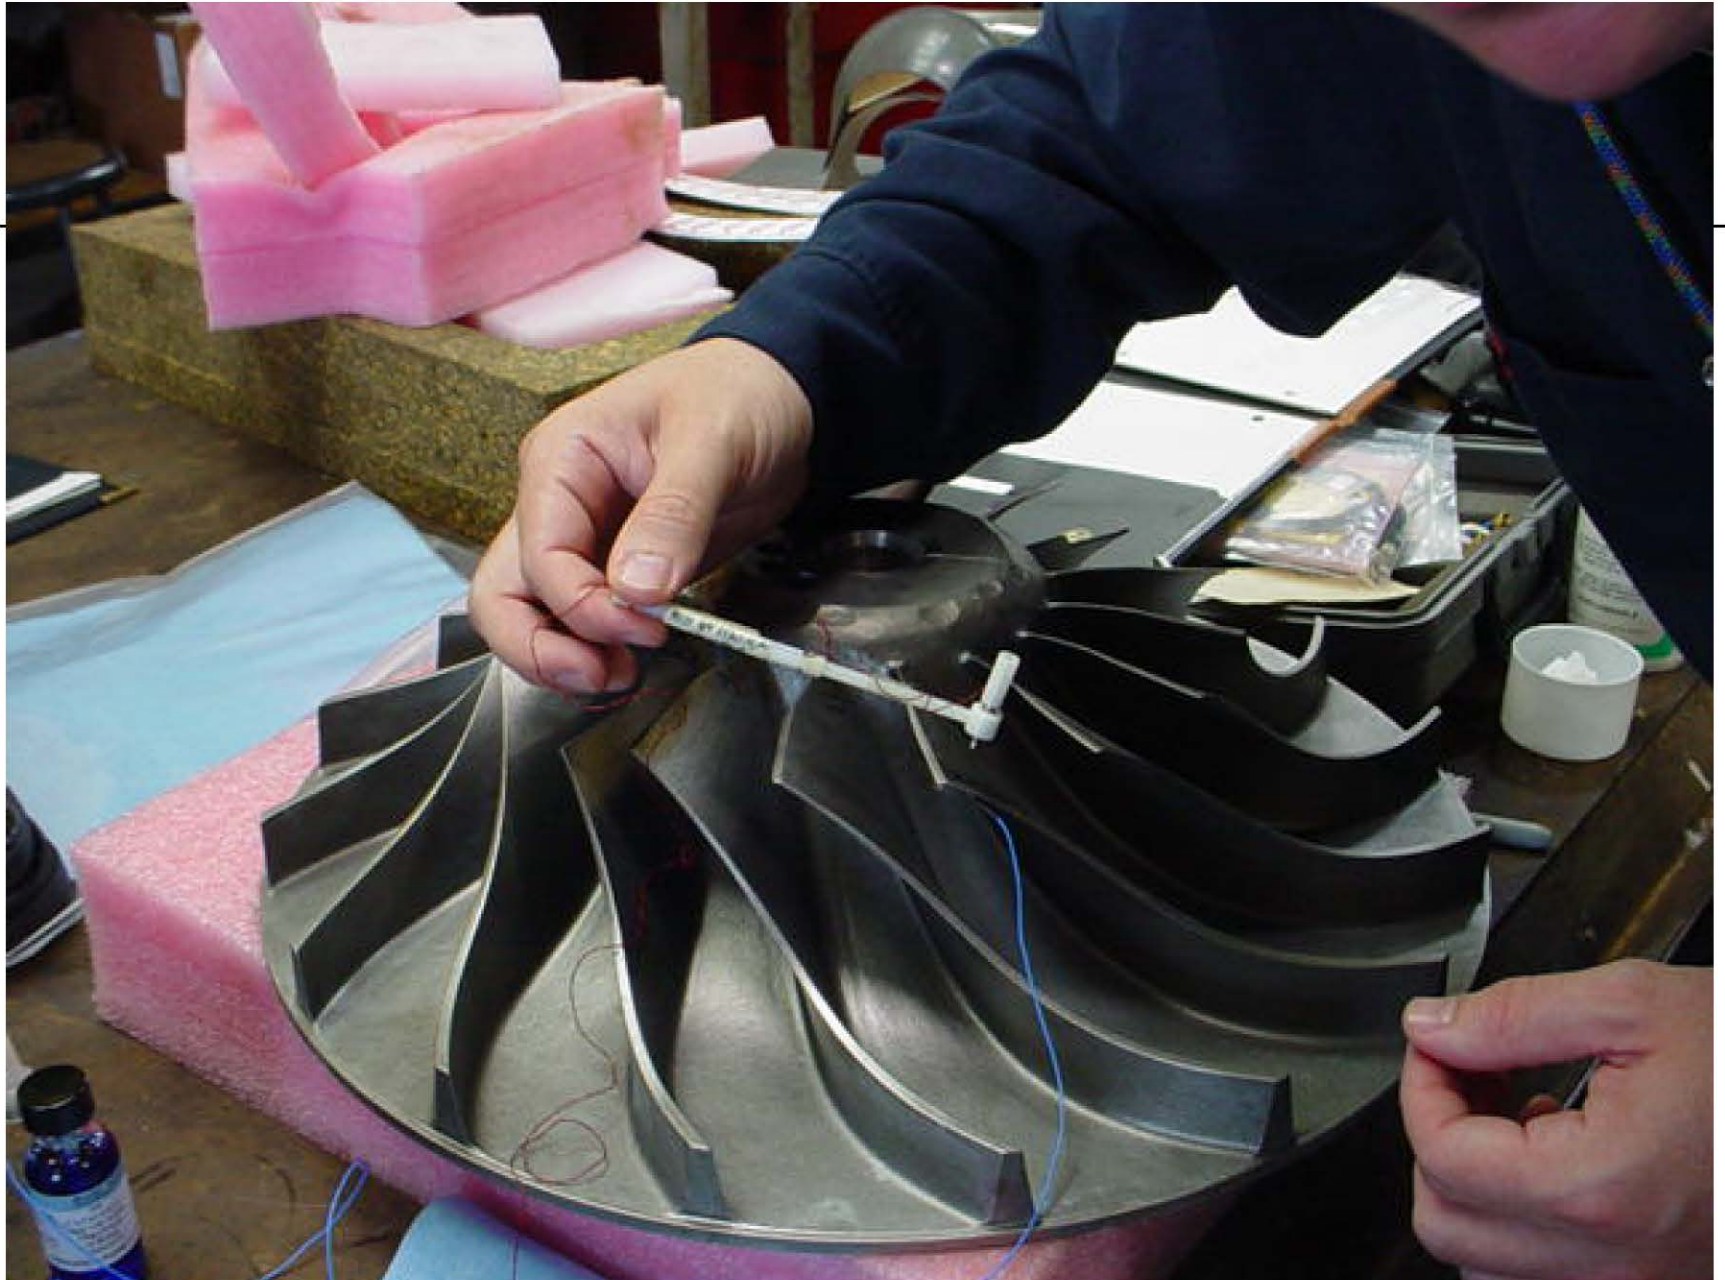
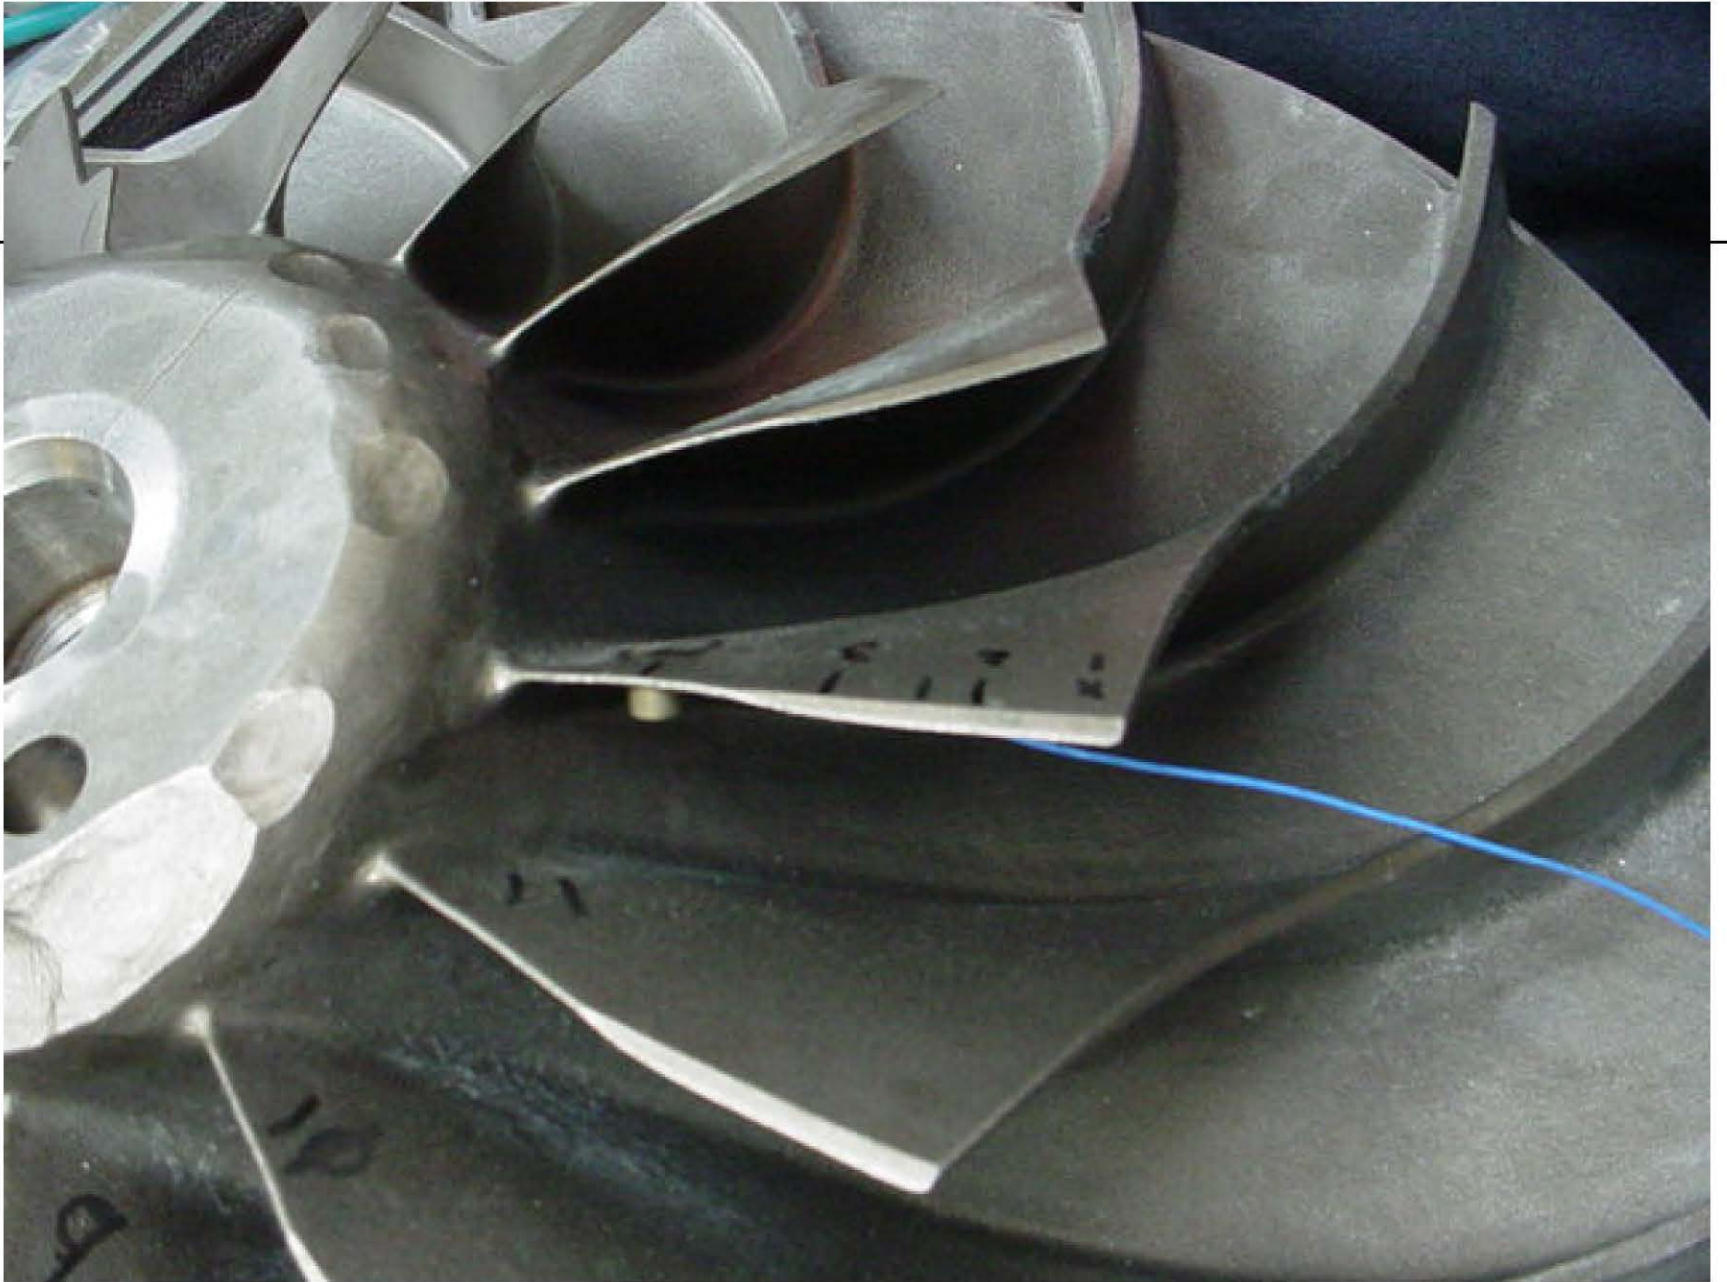
Measurement on first cast impeller

- Used the measured frequencies and calculated effects to estimate the original natural frequencies of the blades
- The natural frequencies of the blades were right at blade pass frequency

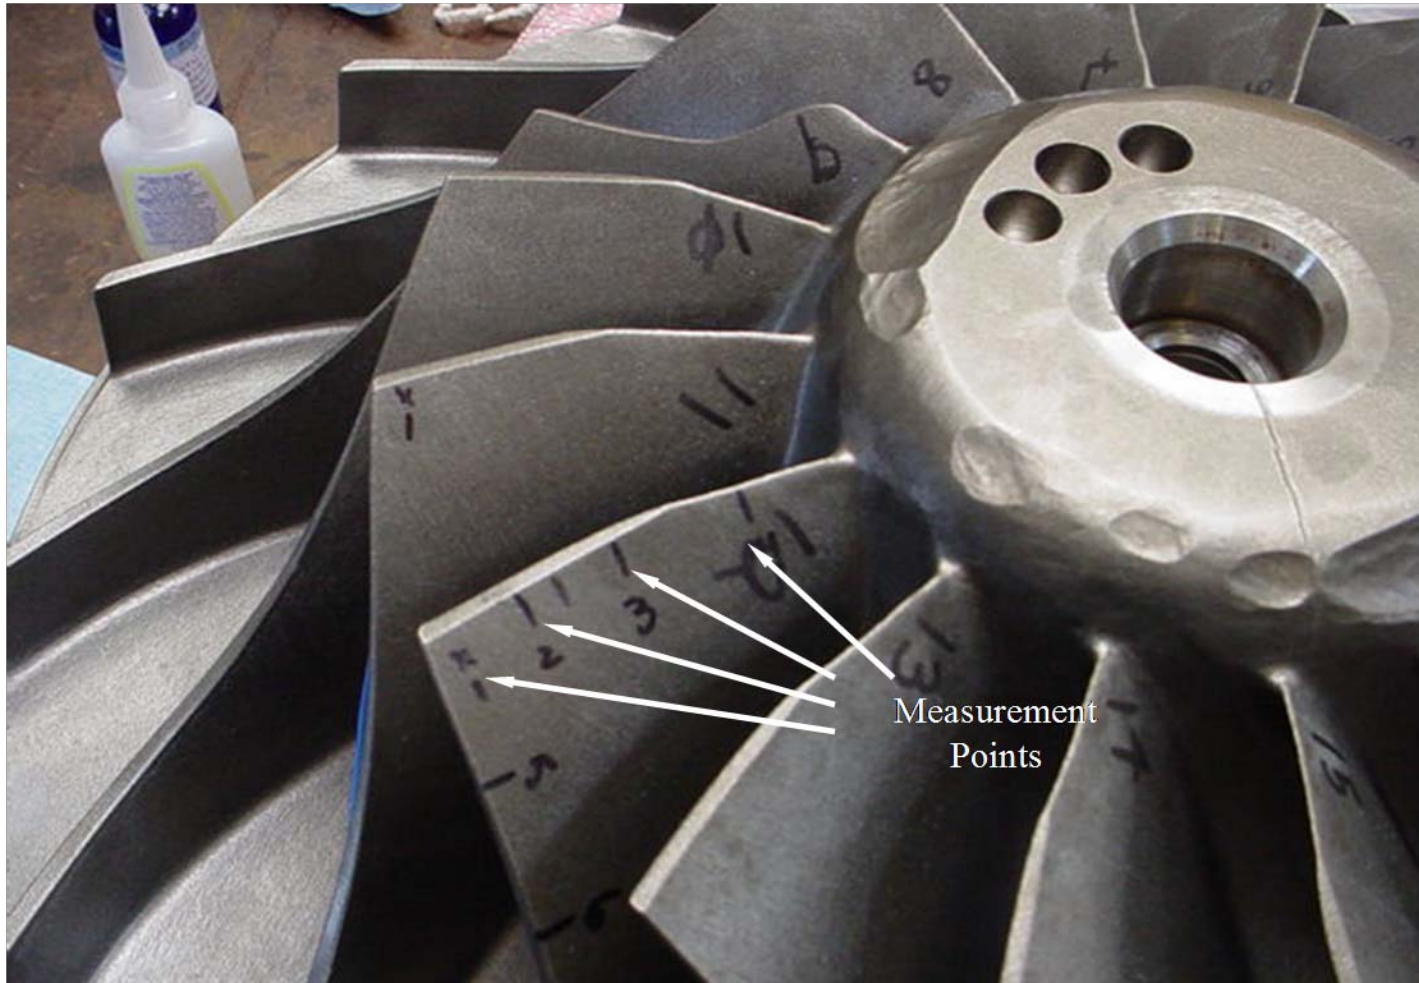
Use multiple points to verify mass loading and estimate effect

- One of the draw backs of the technique used in this impeller is that the mass of the accelerometer affects the measurements
- This results in measured frequencies lower than in reality
- This effect is normally referred as *mass-loading*

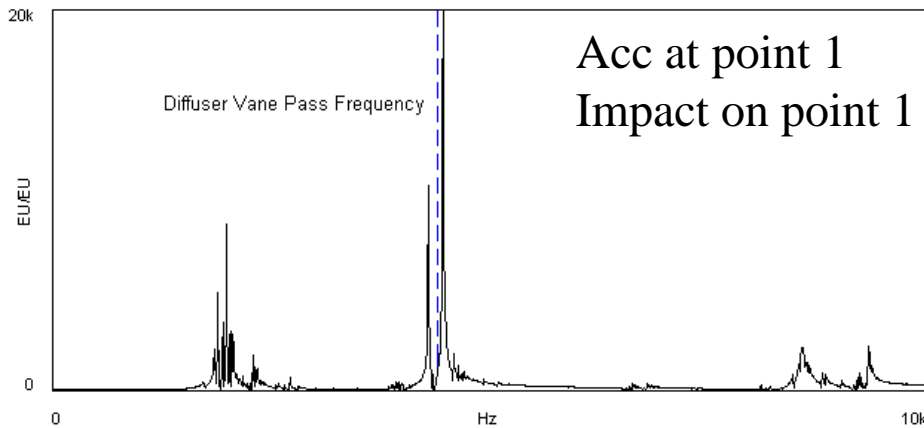
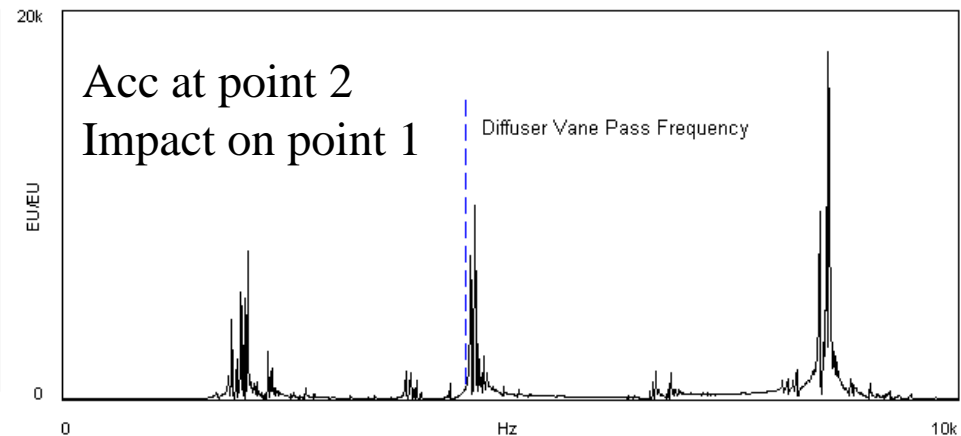
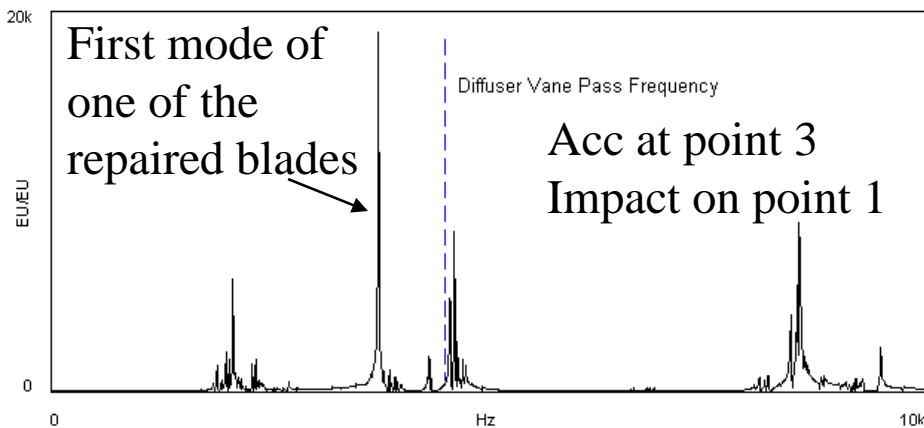
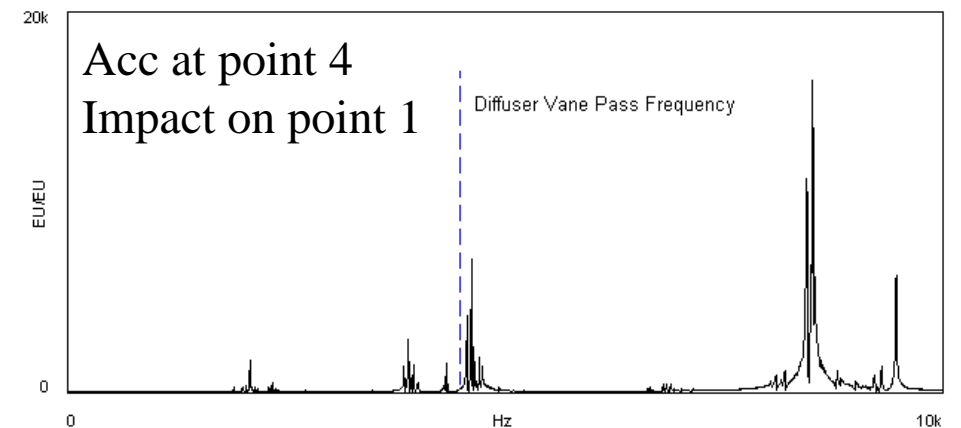
Use multiple points to verify mass loading and estimate effect

- By moving the accelerometer to different locations it is possible to estimate the effect of the accelerometer mass and subtract it from the measurements.
- One has to be aware that the resonances from other blades also show up on the measurements.
- The challenge is to figure out which frequency corresponds to each blade

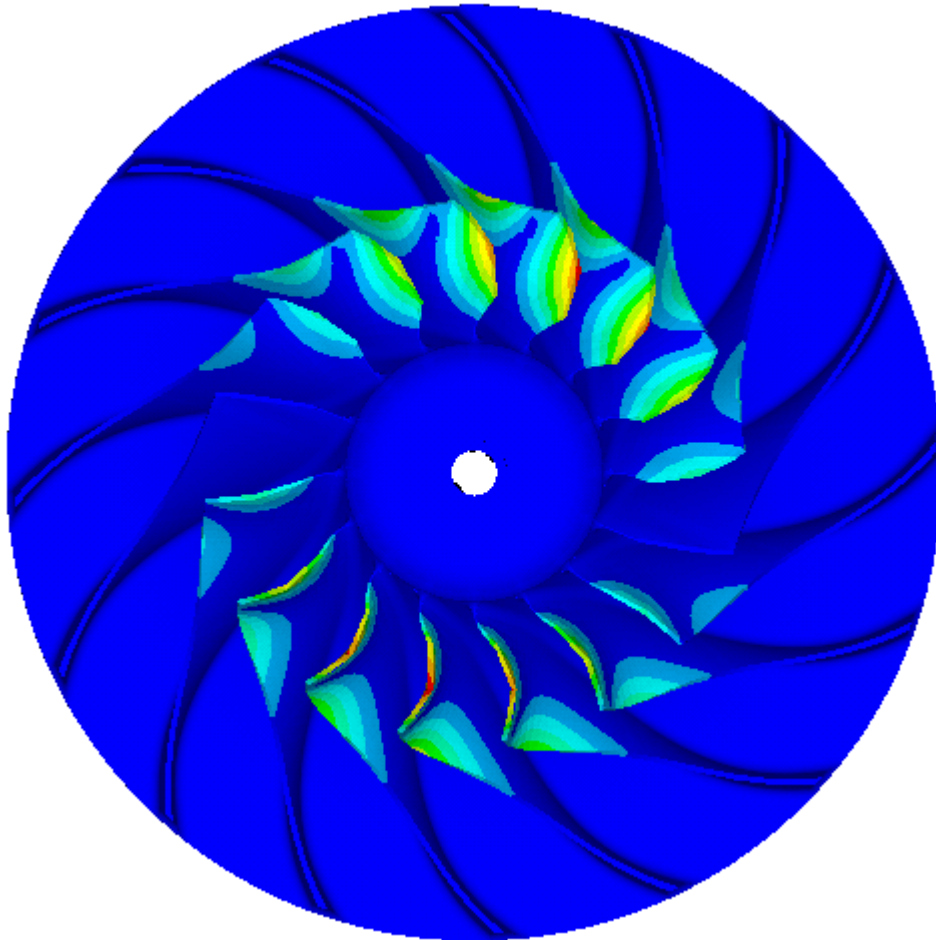
Use FEA to calculate stiffening effect due to centrifugal force and scarfing

- When the impeller rotates, the centrifugal force stretches the blades, increasing their natural frequency
- Cutting the blade down (scarfing) reduces the mass of the blade and increases its natural frequencies

- From FEA model of the impeller it was calculated that scarfing increased the natural frequencies of the blades by 4%. Remember that at the time of the tests the blades were already scarfed so we had no way to test the original blades.
- The centrifugal stiffening for this impeller was calculated at 0.4 %

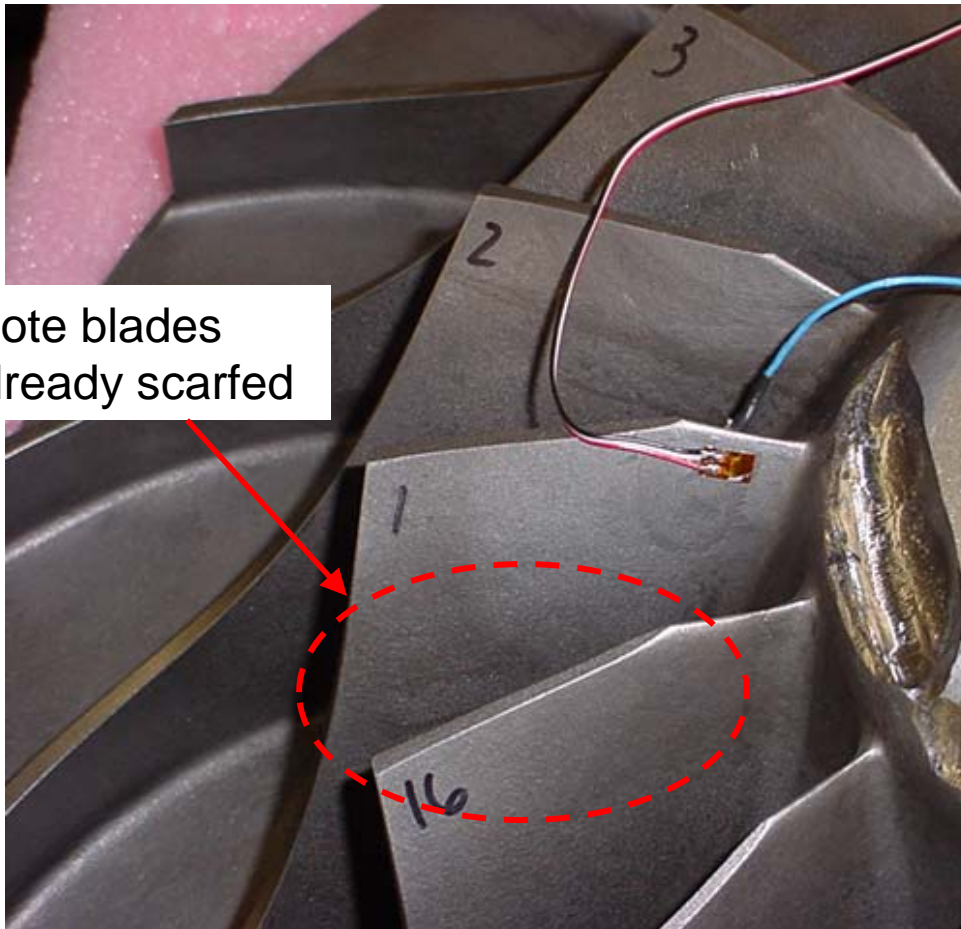
Measurements on the second cast impeller

- ❑ Cast impeller
- ❑ Tried using a strain gage to measure the response
- ❑ Kept the accelerometer to prove the method
- ❑ Used a similar technique as on the first cast impeller

- Used the measured frequencies and calculated effects to estimate the original natural frequencies of the blades
- Without the scarf, the blade natural frequencies would have been right at blade pass frequency

- ❑ Impeller was rejected after inspection based on crack found on blade 16
- ❑ NDT did not identify any obvious defects on blade 8. There was a small surface defect but not enough to account for the difference in frequency.
- ❑ The OEM sent the impeller for analysis. Blades 8 and 16 were cut for inspection and analysis
- ❑ Casting defects were found on both blades giving additional reasoning for going to forged impellers.

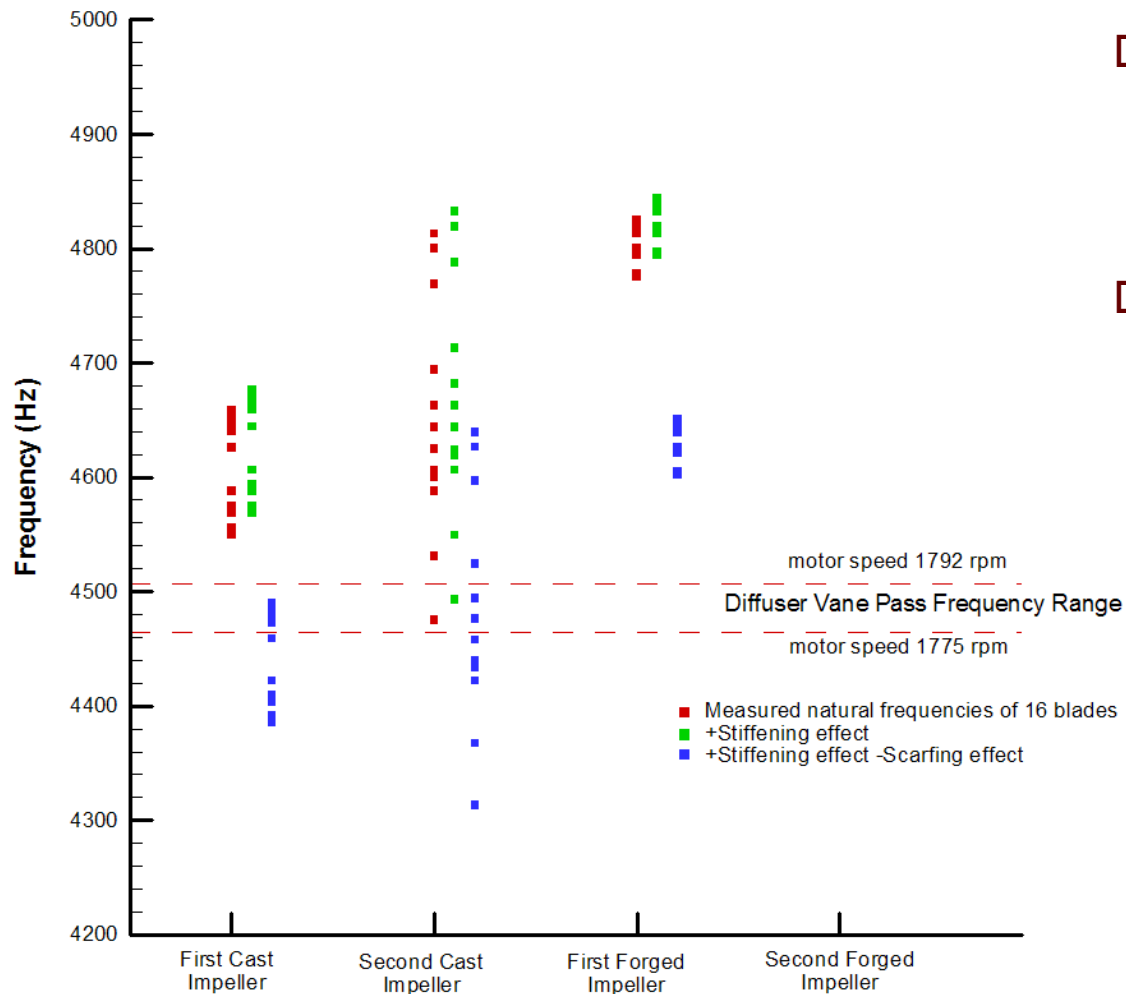
Summary for first forged impeller

- In this case the natural frequencies are closer together
- Repeatable frequencies indicate that the manufacturing process produce more consistent results

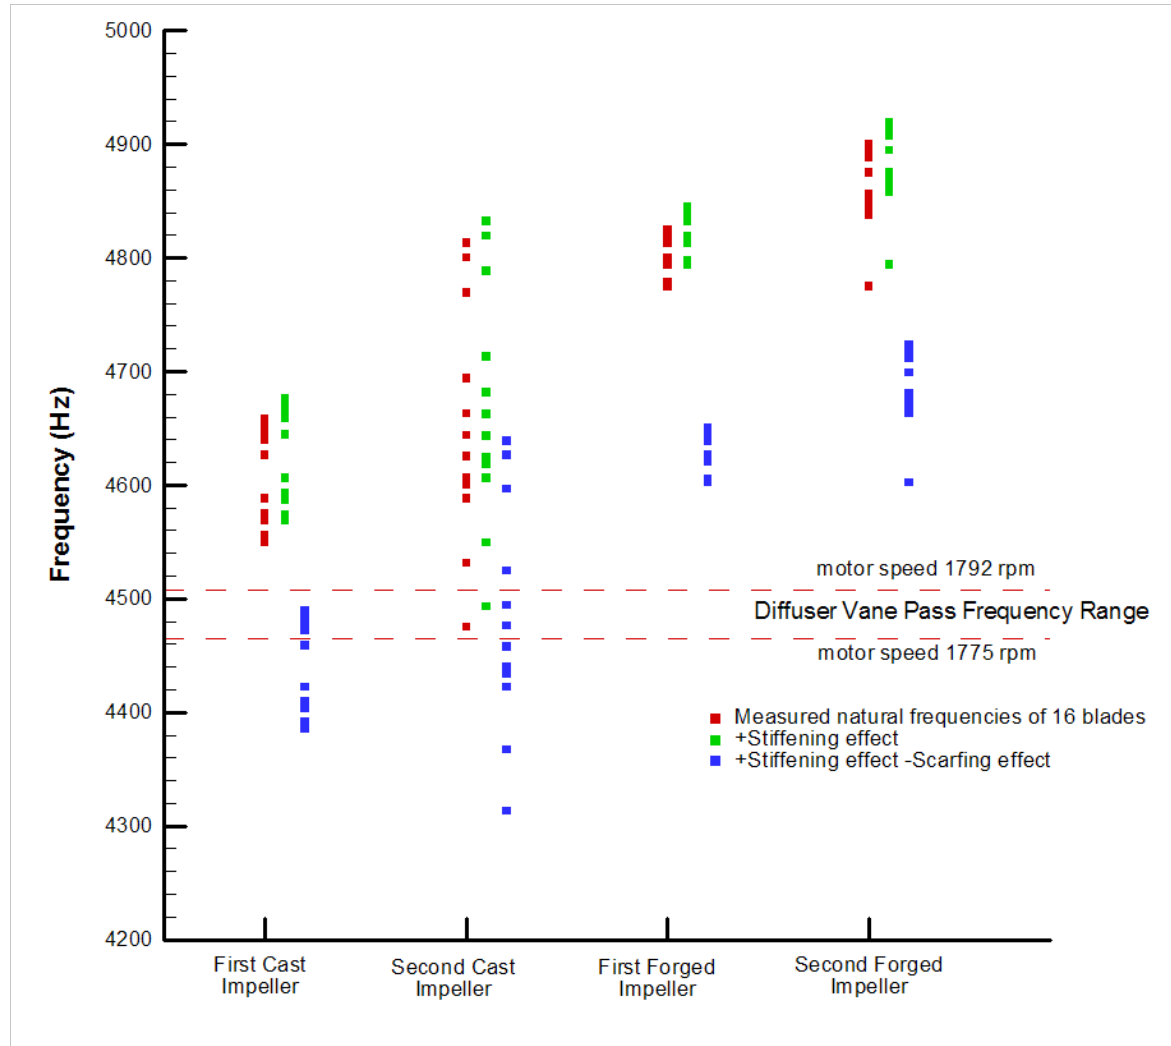
Summary for all impellers

- Several measurement techniques were presented to measure blade natural frequencies
- Using strain gages at the root of the blades produce the best results since they do not introduce mass loading on the measurements
- Natural frequency measurements identified defects on the blades of the second cast impeller

- OEM implemented corrective actions:
 - For this application, the correction was to switch to an impeller machined from a forging.
 - Added a second magnetic particle inspection (after shotpeening) for all impeller castings. Since 2005 the OEM has not experienced a repeat inclusion or failure of an impeller due to inclusions.
 - The impeller foundry identified the skimming procedure of the molten pot as the process needing correction and reinforced this process.
