# **75 MW Turbine-Generator** **Journal-Thrust Bearing Upgrade**

# **ABSTRACT**

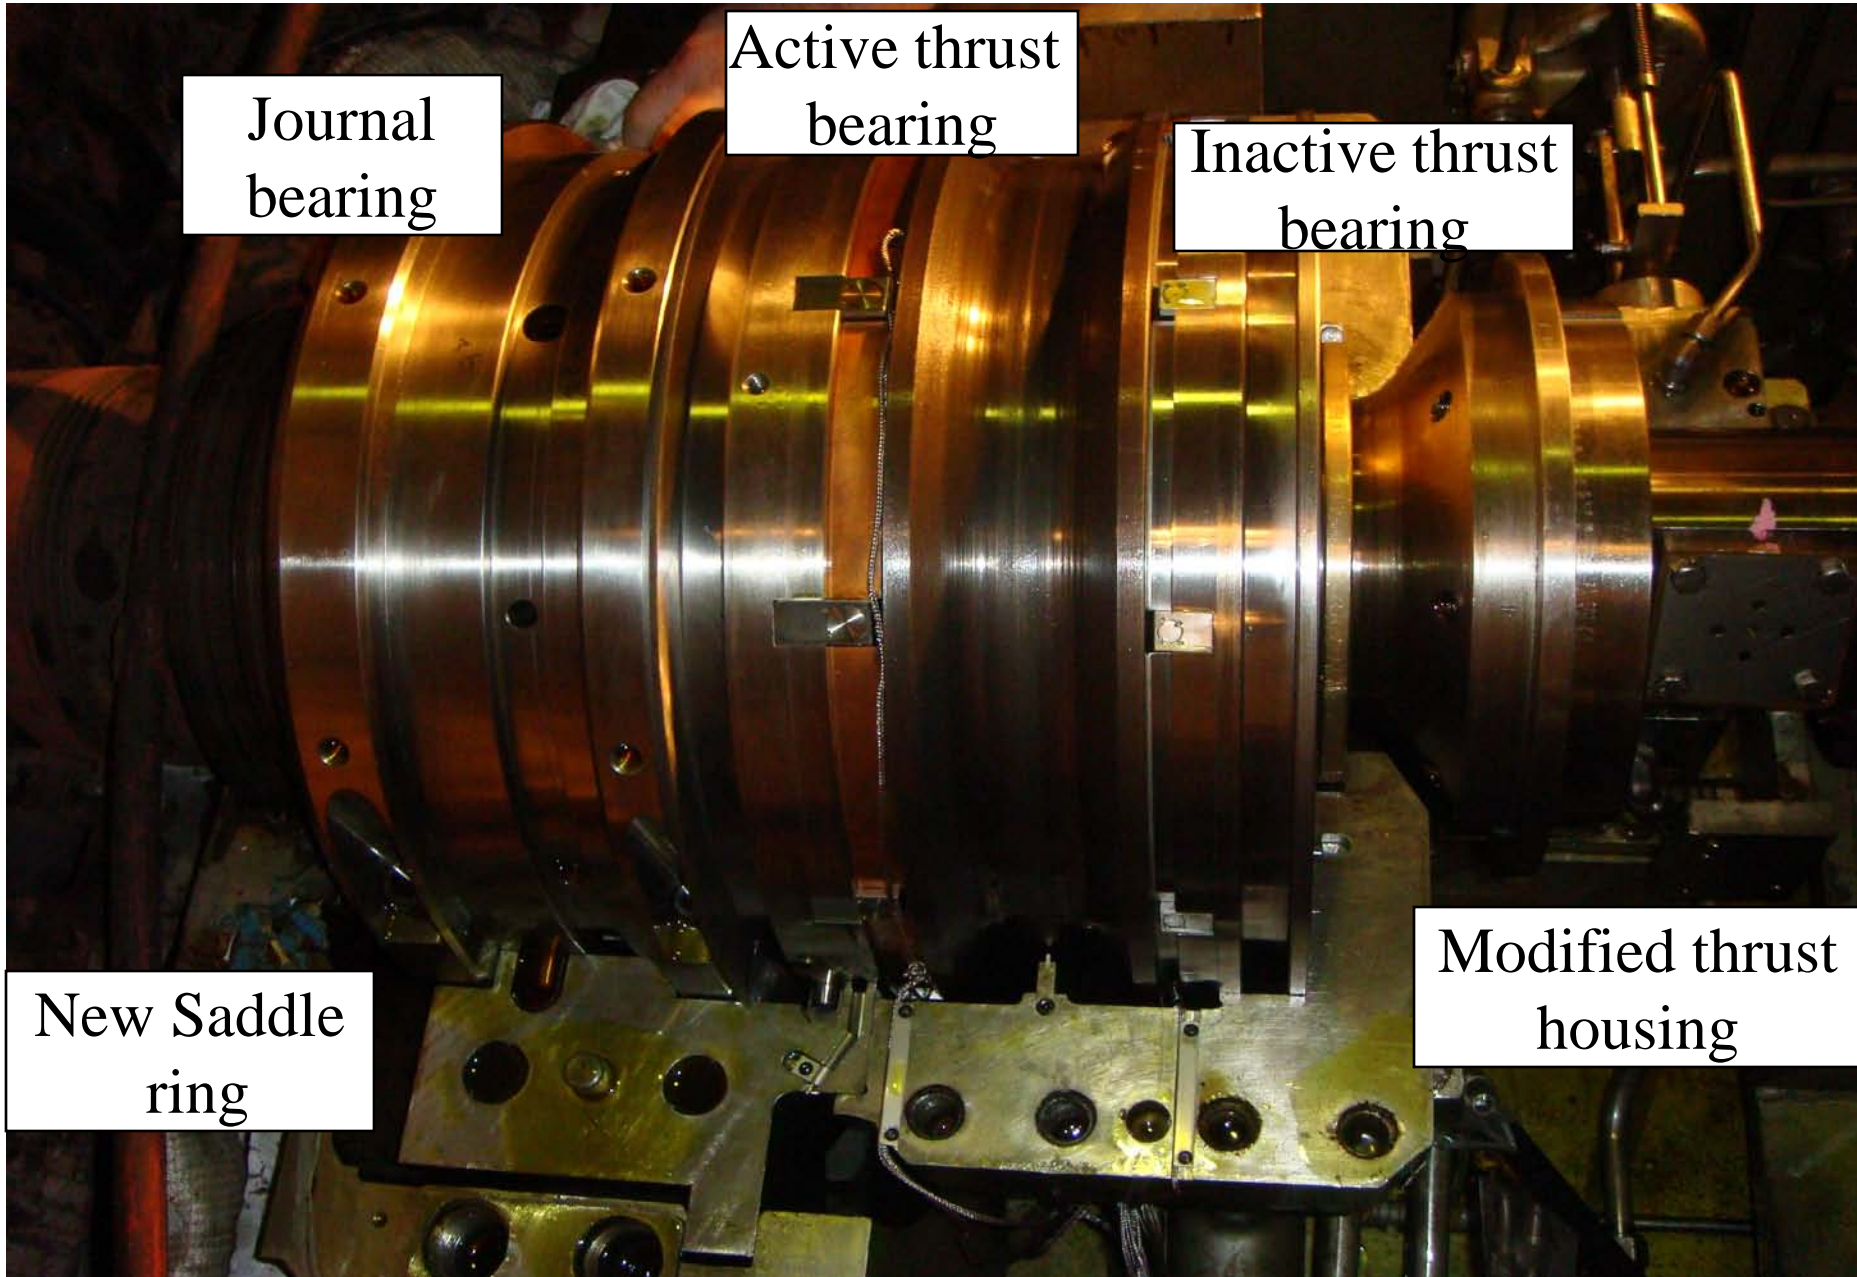
# Upgraded Bearing Assembly

A combination journal-thrust assembly was designed and installed in the front standard of the turbine. This assembly incorporated fully equalized ball & socket 56% offset pivot tilting pad thrust bearings with directed lubrication, a ball & socket tilting pad journal bearing, and a new saddle ring.

The new saddle ring has a cylindrical fit for the journal bearing assembly, and it is bolted to thrust housing. This allows much simpler settings, installation, and maintenance of the whole assembly.
