#### Steam Turbine Pipe Strain Case Study Texas A&M Turbomachinery Symposium

Kevin Yates The Dow Chemical Company September 2008

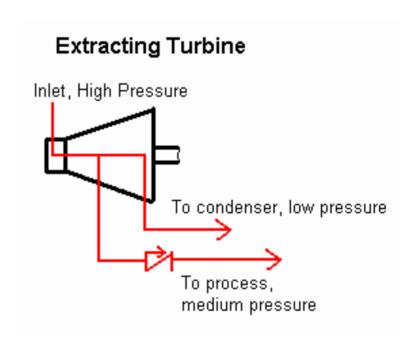
•New 50,000 Hp steam turbine installation •Replaced dual driver arrangement (gas and steam turbines) •1,250 psig steam service, chrome-moly piping Steam piping designed and fabricated with field weld requirements and witness points

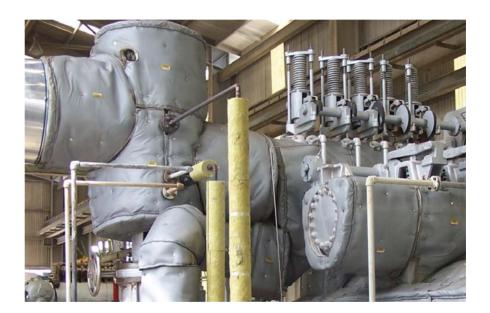
Installation completed on time
Field welds and pipe strain witness points conducted
Monitored pipe strain via shaft end indicator movement
Successful startup with no known pipe strain

Turbine shutdown due to unrelated maintenance issues
Difficulty in removing inlet flange bolts
Galling and pipe strain after only 6 months of runtime
