**Case Study:
Charge Compressor Turbine Vibration – Diagnostics/Risk Assessment**

Reducing downtime and sustaining high production rates are essential for companies to remain competitive. A 36MHP steam turbine experienced sudden high vibration. Through use of vibration analysis, selective external case cooling, and altering of specific operating conditions, continued safe production was provided for eight months until an overhaul opportunity became available.

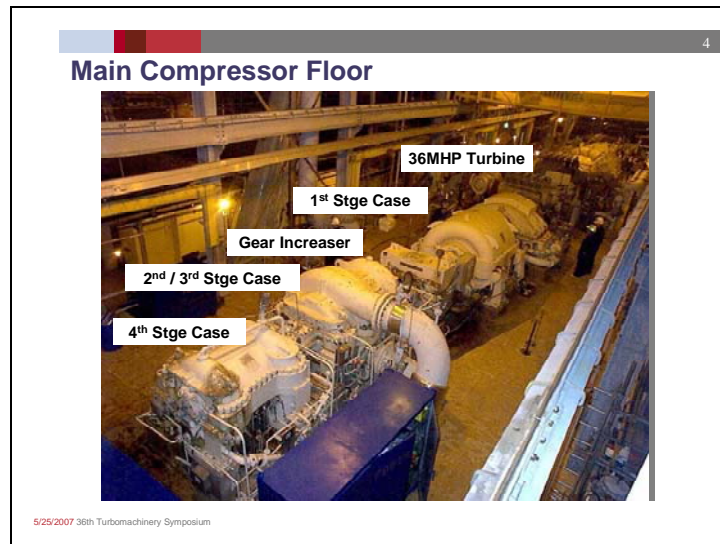
Slide 4

- This is a view of the main charge gas compressor deck showing the steam turbine and the 3-case, 4-stage layout of the machine train.
