A Sub-Synchronous Vibration Problem:

Trapped Fluid in Compressor Coupling Spacer

Diagnosis and Resolution

John E Sutton
Chevron Energy Technology Company Pty Ltd
Perth, Western Australia
john.sutton@chevron.com

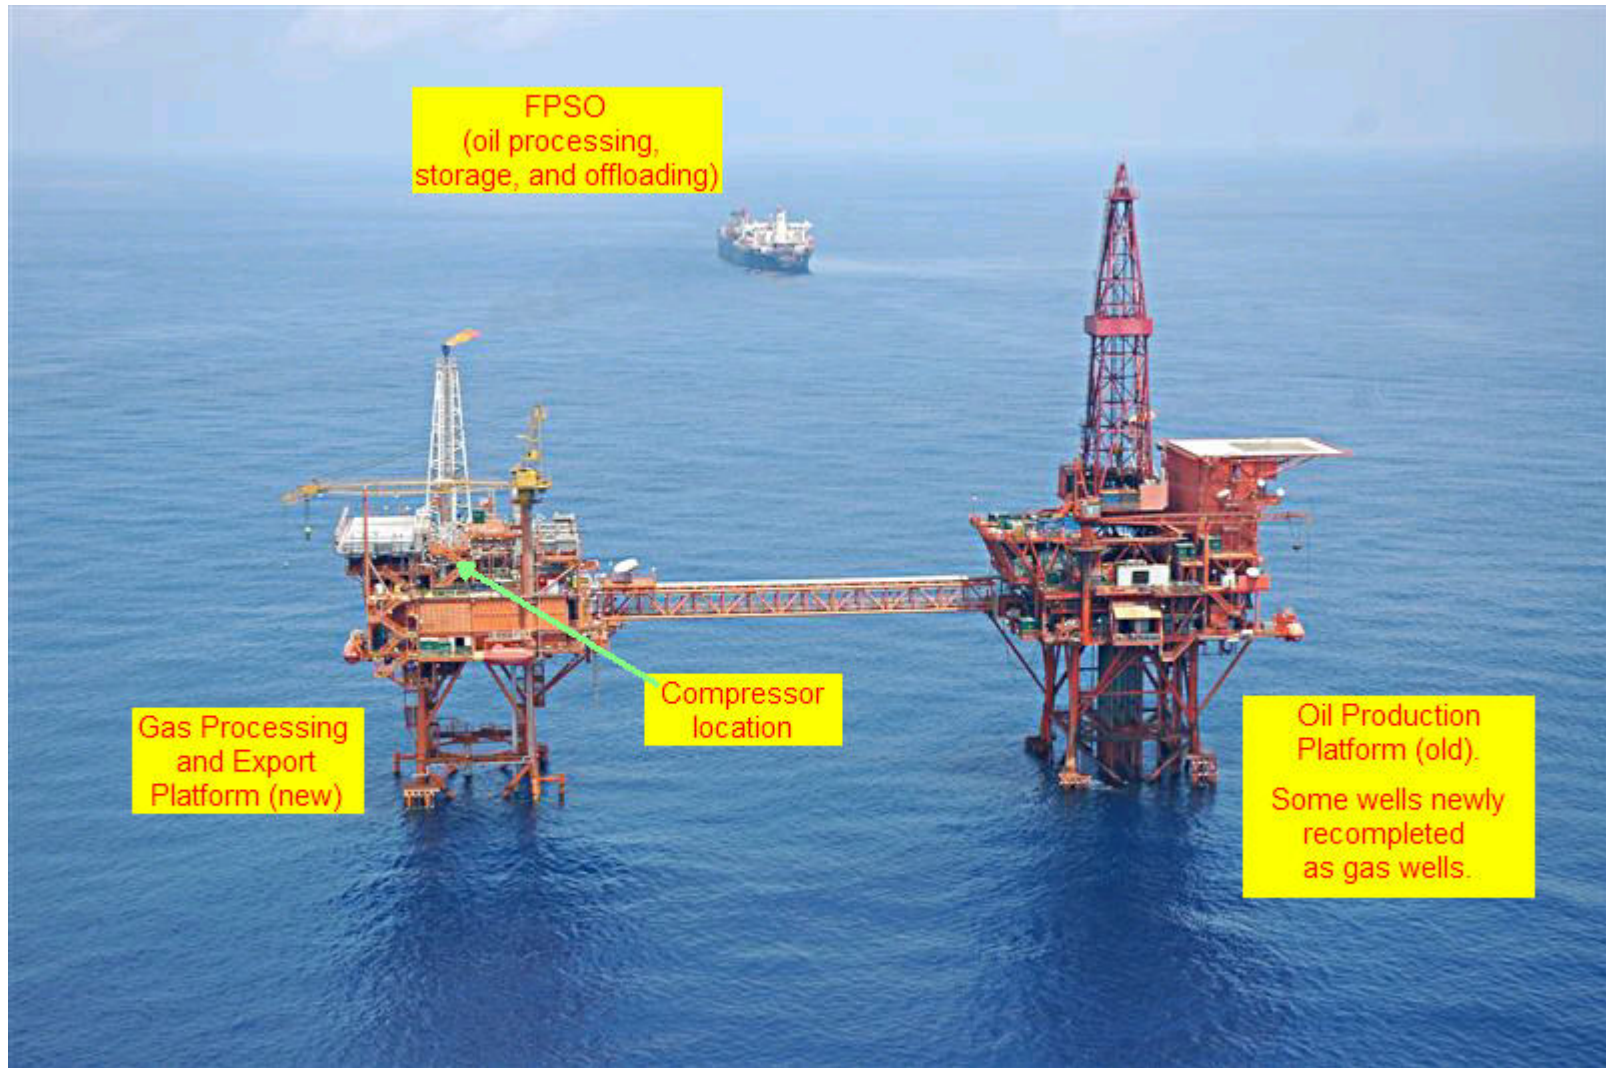
Compressor Location

The Recovery Gas Compressor on a new offshore gas platform would run for only a short time before developing vibration in the driven end shaft bearing, near the coupling to the power turbine.

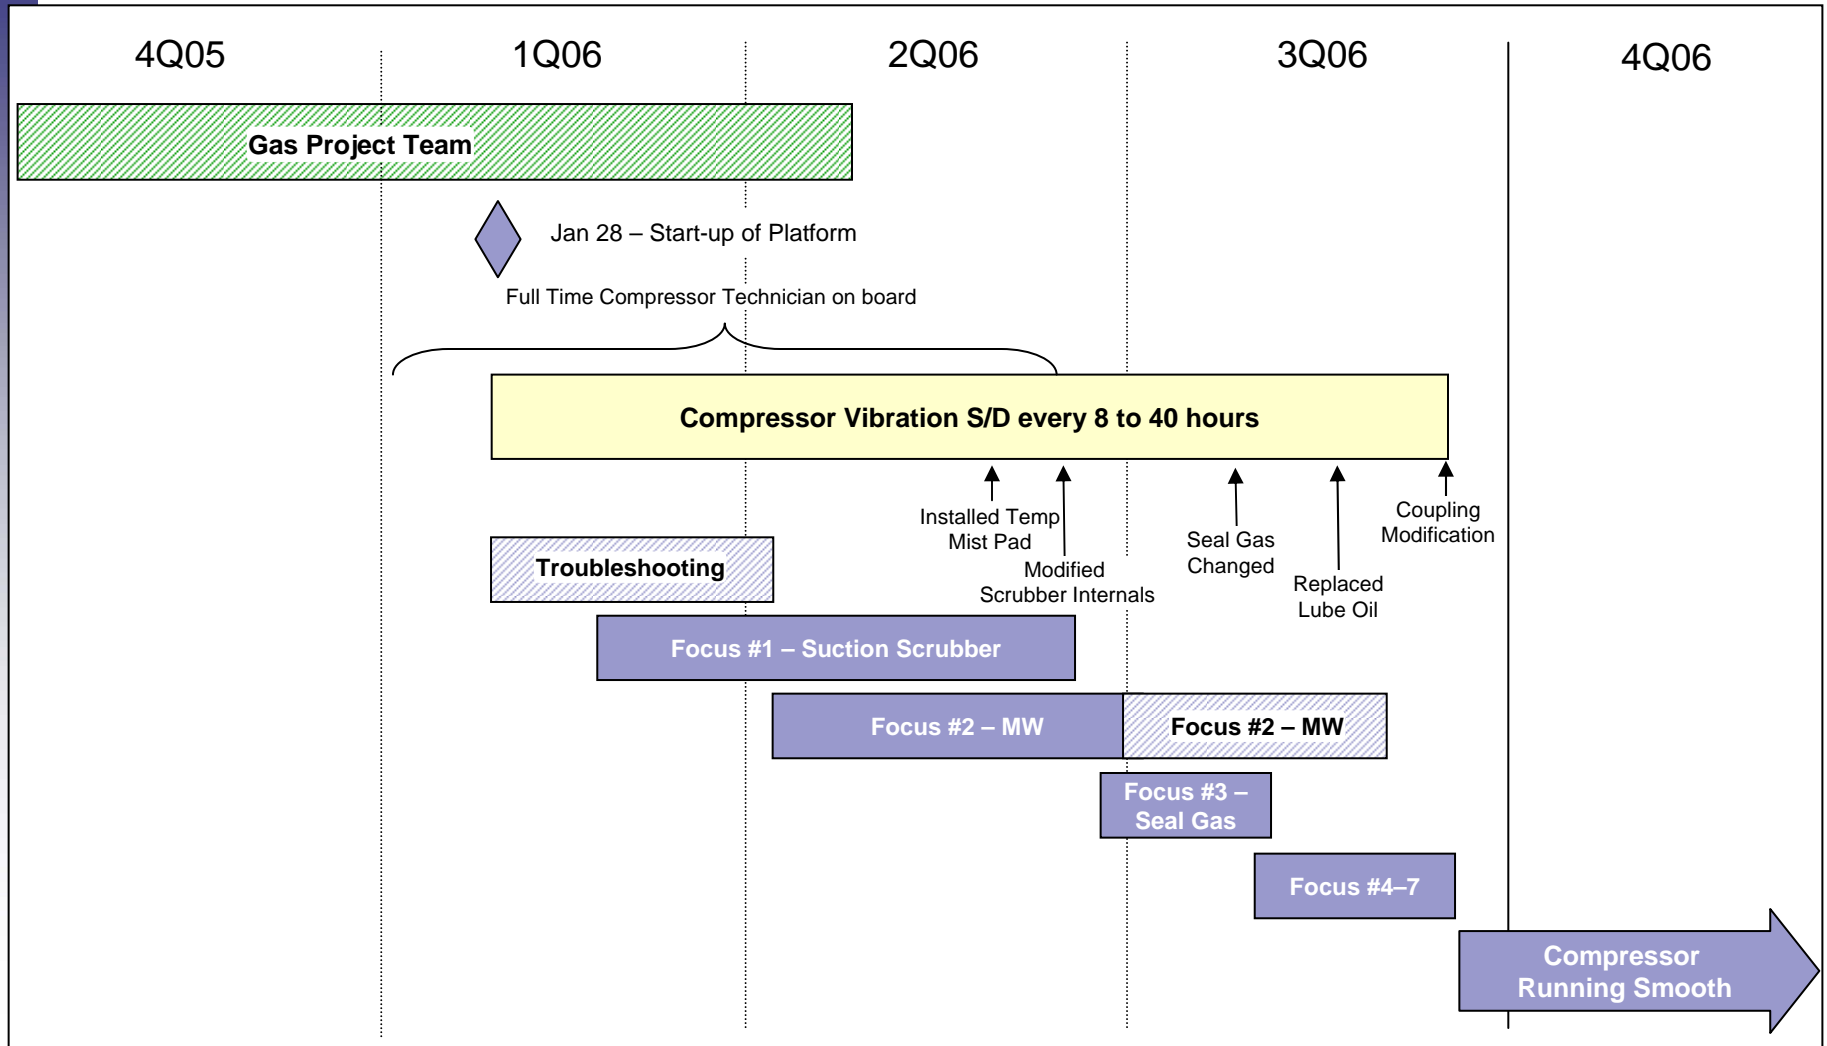
Compressor Vibration Timeline

**Compressor running smoothly
from 14 September 2006**
