# REPAIR TECHNOLOGIES OF MECHANICAL DRIVE STEAM TURBINES FOR CATASTROPHIC DAMAGE

Mitsubishi Heavy Industries, Ltd.

## ABSTRACT

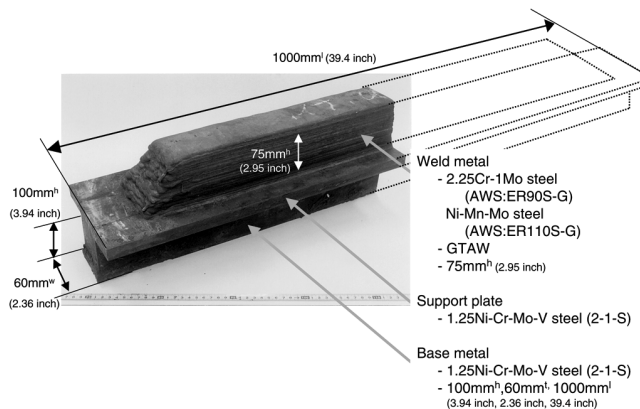
Figure 6 shows the appearance of the test piece after welding. Both types of weld material were welded to a bar shaped rotor material (1.25Ni-Cr-Mo steel). The weld metal was formed with a thickness of 75 mm (2.95 inches) on the bar by gas tungsten arc welding (GTAW). Optimum welding conditions were selected to avoid defects and these were controlled constantly throughout the welding process to obtain uniform heat input to the bar. Table 5 shows the welding and PWHT conditions for the test pieces.

Figure 6. Appearance of Welded Test Piece in Laboratory Scale Test.

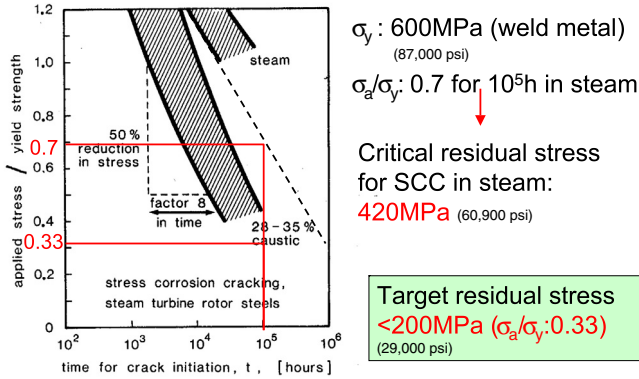
Figure 7 shows the relationship between stress and time to SCC initiation reported by Speidel and Bertilsson (1984). Based on these data, it is estimated that the critical stress that causes SCC after 105 hours of operation is 420 MPa in a normal steam environment. Considering the safety factor, the target residual stress on the weld metal was set at 200 MPa.

Figure 7. Estimated Critical Residual Stress for SCC. (Courtesy Speidel and Bertilsson, 1984)

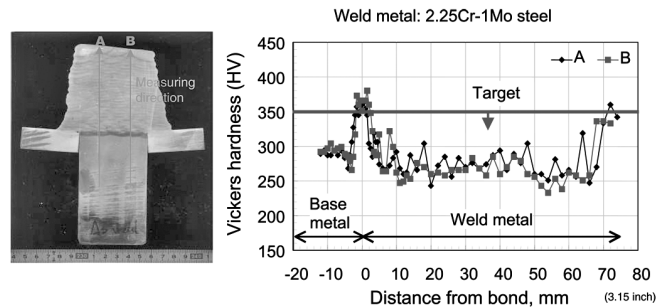
Table 6 shows results of the mechanical tests on test pieces welded using 2.25Cr-1Mo steel and heat treated for 10 hours at 585°C and 600°C (1085°F and 1112°F). Figure 9 and Figure 10 indicate distribution of hardness on the welded test piece and the heat treated piece at 600°C (1112°F).

Figure 9. Distribution of Hardness on Welded Test Piece.

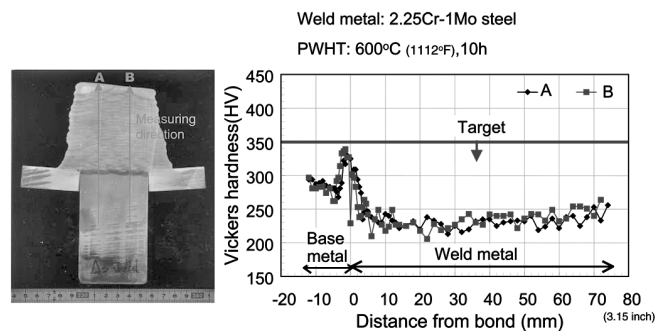
Figure 10. Distribution of Hardness on Heat Treated Test Piece.

Hardness on the surface of the weld metal was measured. Figure 16 indicates the measured hardness. The measured hardness of 240 to 270 HV is almost the same as that of the final bead on the laboratory test piece heated at 600°C (1112°F) as shown in Figure 10. Therefore, it can be estimated that the hardness of HAZ was also reduced within 350 HV.

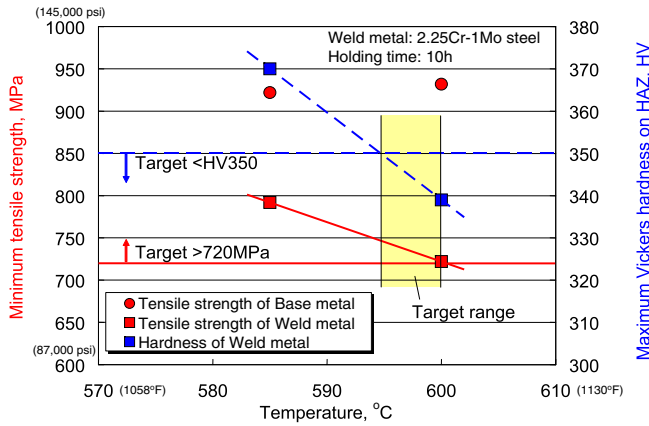
Hardness, tensile properties, and impact value on both heating temperatures satisfied the target for the weld metal and the requirement for base metal, except for hardness heated at 585°C (1085°F). Figure 11 shows the relationship of maximum hardness and minimum tensile strength with PWHT temperature. Hardness and tensile strength of the weld metal tends to become weaker as the welding temperature becomes higher. On the other hand, tensile strength of base metal is almost constant in the temperature range tested. This tendency comes from the high temperature properties of base metal.

Figure 11. Relationship Between PWHT Temperature and Mechanical Properties.

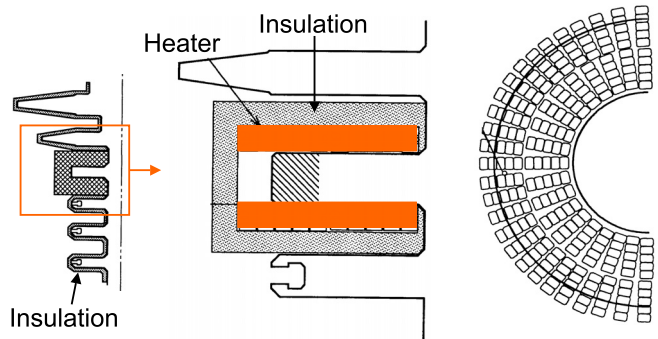
Local heating was applied for the PWHT. Layout of the heater was decided based on the result of a finite element analysis to reduce the thermal stress around the edge of the heating zone due to temperature distribution. Figure 14 shows the schematic view of the heater layout. The rotor was suspended vertically during heating to avoid bowing due to the influence of gravity on the horizontal rotor layout.

Figure 14. Heater Layout on Local PWHT for Welded Disk.

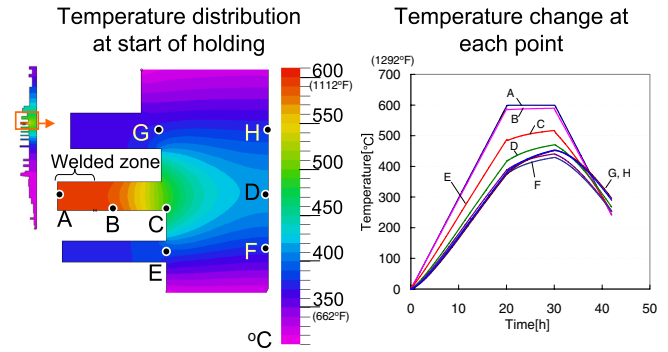
Figure 17 shows the temperature distribution at the start of temperature hold after heating and the temperature change at each spot for positioned heaters. The temperature at the root of the heated disk and adjacent disks was less than 450°C (842°F). Therefore, temperature at the root of the disk should be maintained at more than 450°C (842°F) to satisfy the target residual stress.

Figure 17. Estimated Temperature Distribution on Local PWHT for Disk.

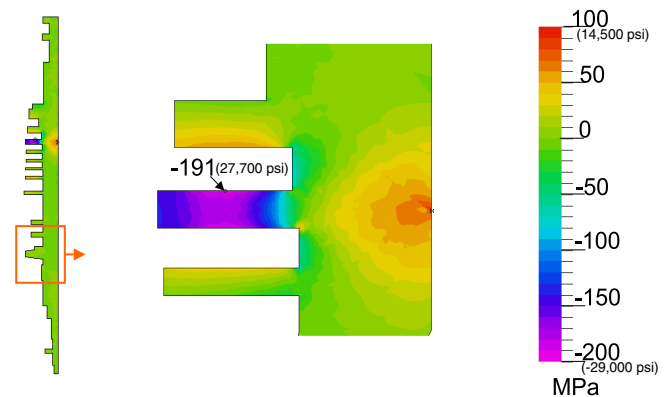
Figure 18 shows the distribution of circumferential stress around the heated disk at the start of temperature hold. Circumferential

stress is around -200 MPa on the weld metal. This means that the weld metal is compressed by the disk during heating. This stress is turned into tensile stress after cooling down. It is presumed that the compression stress during heating changes into tensile stress by creep deformation.

Figure 18. Estimated Circumferential Stress Distribution on Local PWHT for Disk.

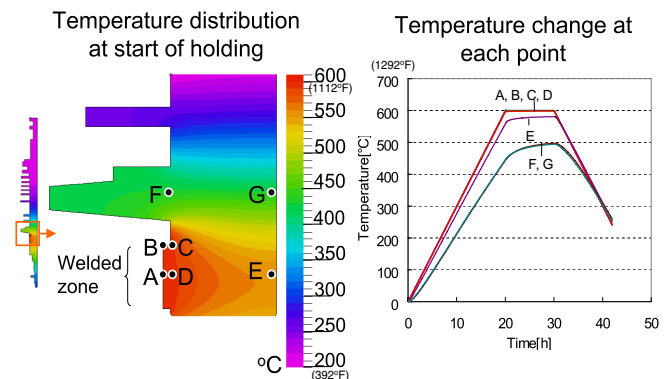
Figure 19 shows the temperature distribution at the start of temperature hold and the temperature change at each spot for positioned heaters that satisfy the uniform temperature on the whole surface of the weld metal. The center of the shaft's heated portion is more than 500°C (932°F). This means there is a higher possibility of unfavorable deformation by welding of the shaft and PWHT than that for the disk.

Figure 19. Estimated Temperature Distribution on Local PWHT for Shaft.

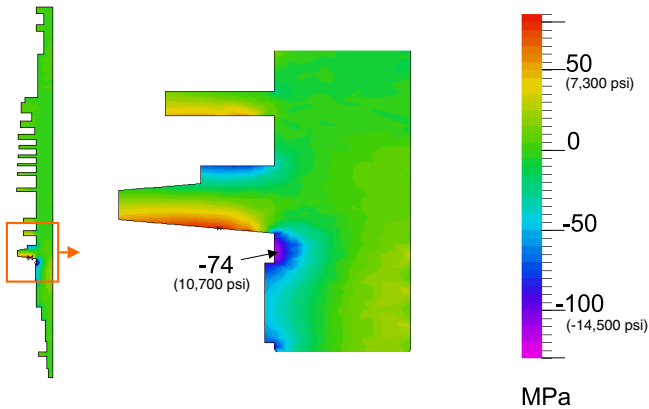
Figure 20 shows the distribution of circumferential stress around the heated shaft at the start of temperature hold. The stress around weld metal is low and the compressive stress is 75 MPa maximum in a circumferential direction around the edge of the heater. Therefore, it can be determined that the residual tensile stress on the shaft is lower than that on the disk. Bending residual stress around 80 MPa can be estimated on the disk adjacent to the heated portion. This is almost the same as that on the shaft.

Figure 20. Estimated Circumferential Stress Distribution on Local PWHT for Shaft.

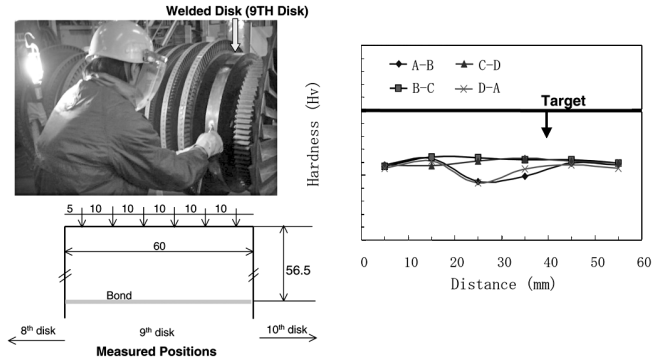
Figure 22. Hardness of the Welded Metal for the Actual Rotor.
